ACE HOME INSPECTION

INSPECTION REPORT
124 Main Street
Knoxville Tennessee 37918

INSPECTED BY
Dave Ellis,
License No. 2885
Ace Home
Inspection

INSPECTION DATE
📅 3/6/2024
🕒 12:30 PM

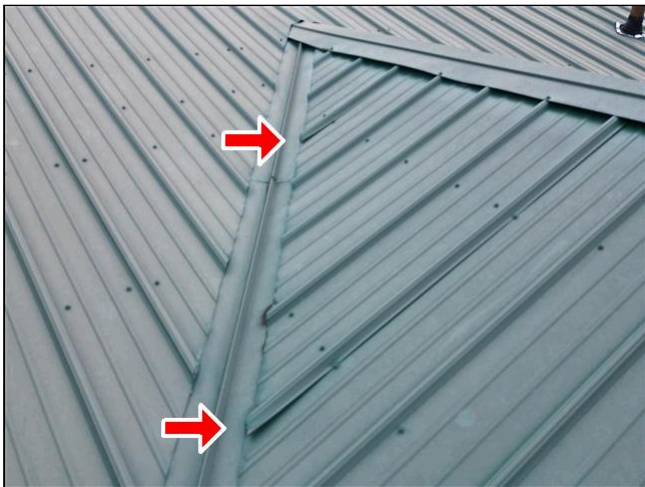
1.0 Item 3 (Picture)

1.0 (1) Loose screws and minor separation was located in various areas which can allow water intrusion. Further evaluation and repair by a licensed roofer is recommended.

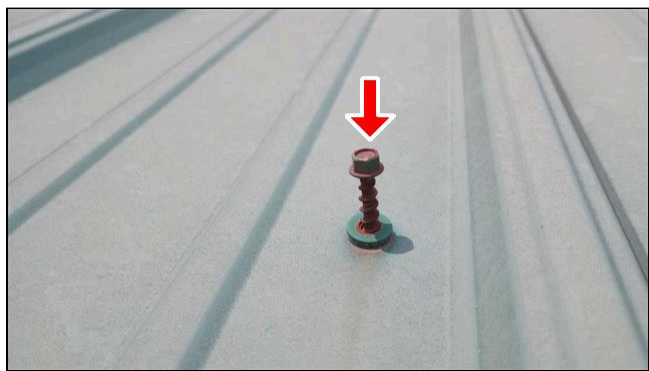
1.0 Item 4 (Picture)

(2) Rust was located on some of the screws which can facilitate deterioration and allow leaks. Replacing these screws as desired by a licensed roofer is recommended per regular maintenance. Also see previous

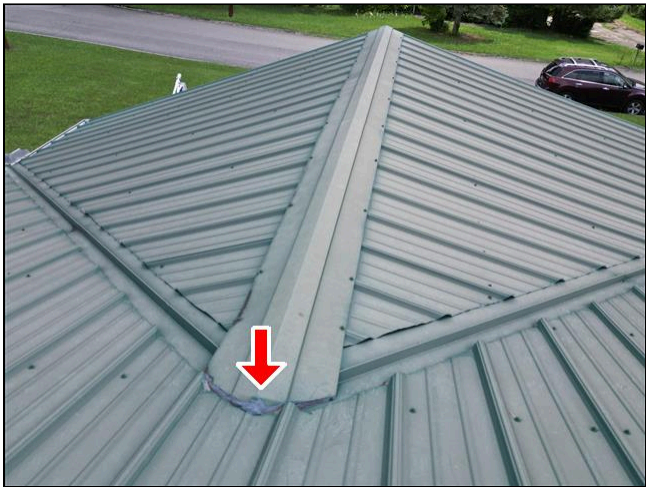
1.0 Item 29 (Picture)

(4) Sealant is being used in various areas which has a tendency to fail. Continued monitoring of these areas and below for any changes is recommended.

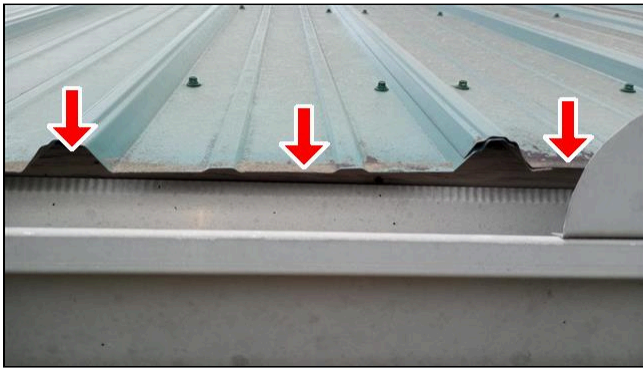
1.1 Item 1 (Picture)

1.1 (1) Drip edge flashing is missing at the eaves which may allow water penetration and contribute to

deterioration. Correction by a qualified person is recommended.

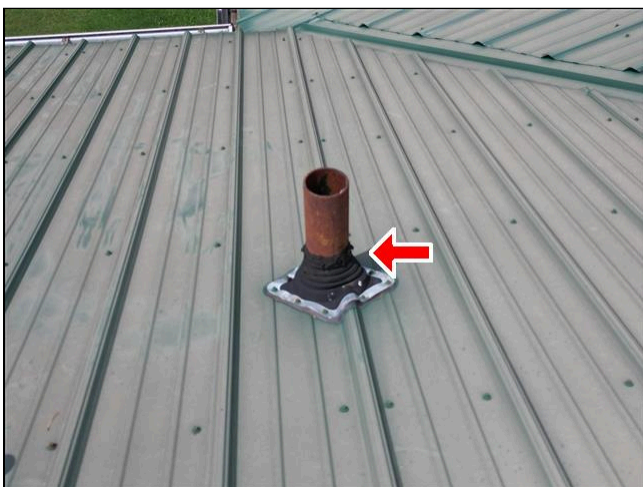
1.2 Item 1 (Picture)

1.2 Failed seals were located at some of the roof penetrations which may allow water intrusion. Repair as needed by a licensed roofer is recommended.

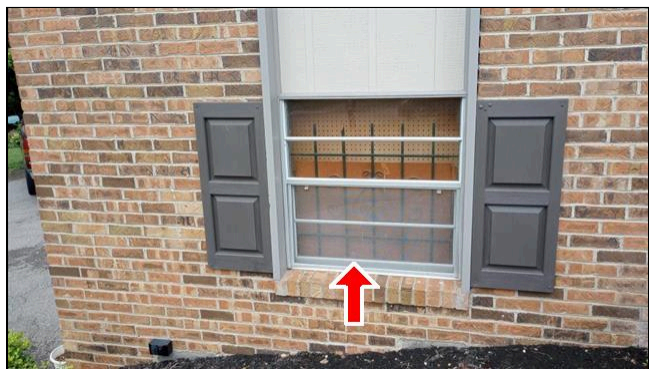
2.2 Item 1 (Picture)

2.2 (1) A broken window pane was located at the front exterior. Repair by a qualified person is recommended.

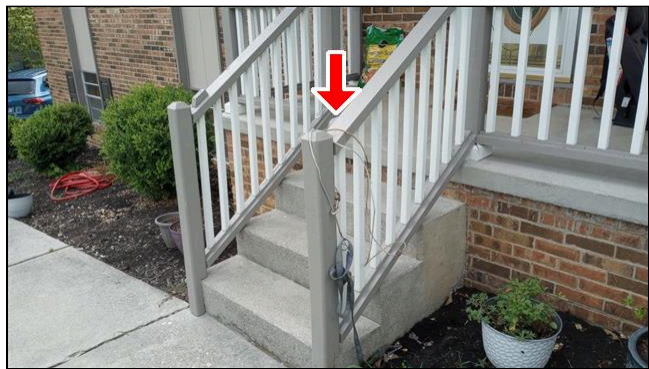
2.3 Item 1 (Picture)

2.3 (1) Re-securing the loose handrails by a qualified person is recommended for improved safety.

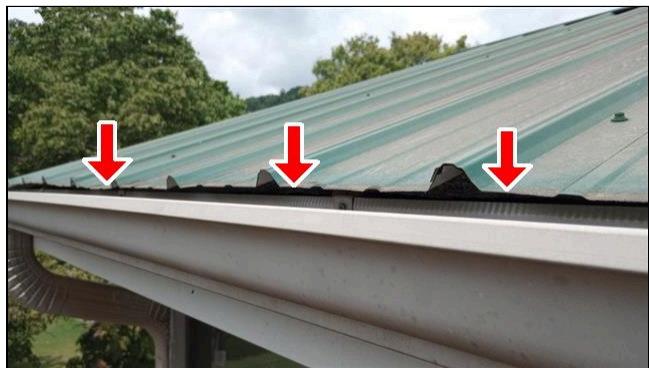
2.5 Item 1 (Picture)

2.5 (1) Moisture damage is located to roof sheathing at the rear exterior and many areas were not visible. Further evaluation and repair by a qualified person is recommended.

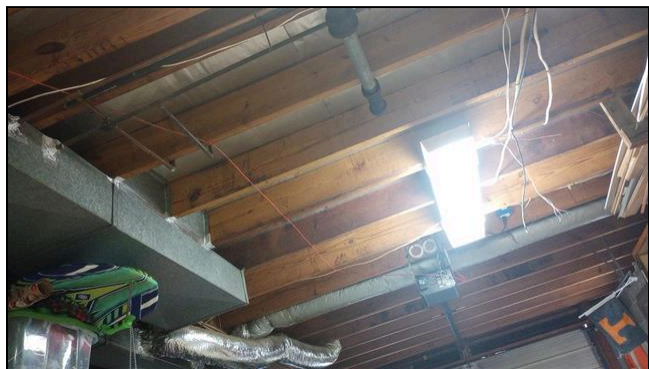
3.1 Item 1 (Picture)

3.1 (1) Gaps (exposed floor structure) were located to the fire separation wall/ceiling between the garage and dwelling. Repair by a qualified person is recommended for improved fire protection.

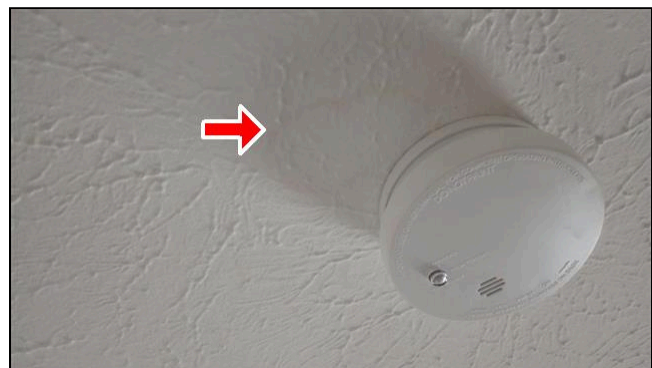
4.0 Item 1 (Picture)

4.0 Minor staining was located to the ceiling in the first guest bedroom which indicates a possible or previous leak, however no current moisture was detected when tested. Cleaning and further monitoring for any changes is recommended.

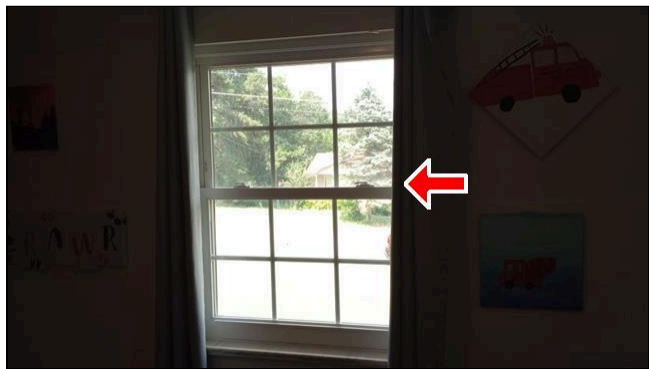
4.6 Item 1 (Picture)

4.6 Windows in the guest bedrooms appear to have a sprung rod which may make operation difficult. Further evaluation and repair as desired by a qualified person is recommended.

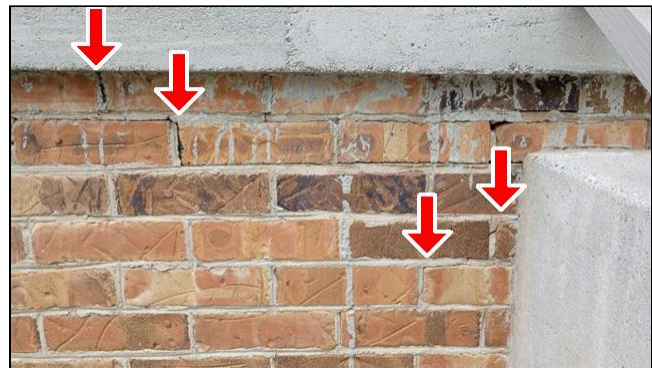
5.0 Item 1 (Picture)

5.0 (1) Minor step cracking was located to the brick at the front exterior which indicates possible or previous movement. Resealing and continued monitoring for any changes is recommended.

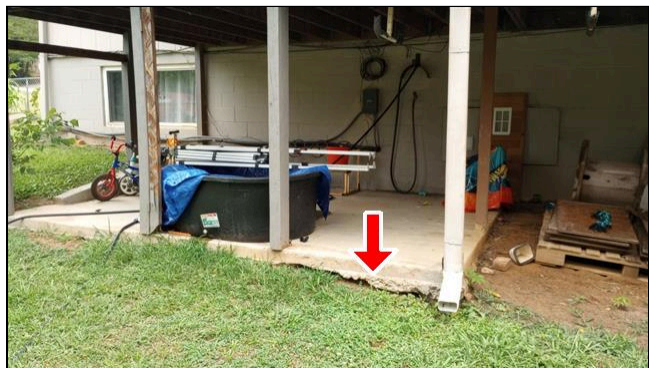
5.0 Item 3 (Picture)

(2) Soil erosion was located below the rear patio and deck footing. Correction is recommended to help prevent future damage.

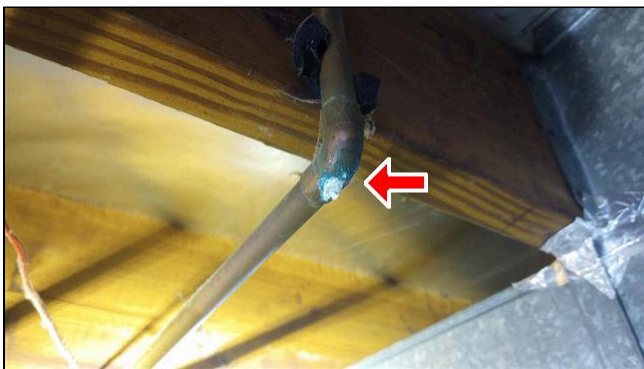
6.1 Item 1 (Picture)

6.1 (1) Staining and corrosion was located to a water supply line(s) at the garage which indicates a possible/previous leak, however no current moisture was detected when tested. Cleaning and continued monitoring for any changes is recommended.

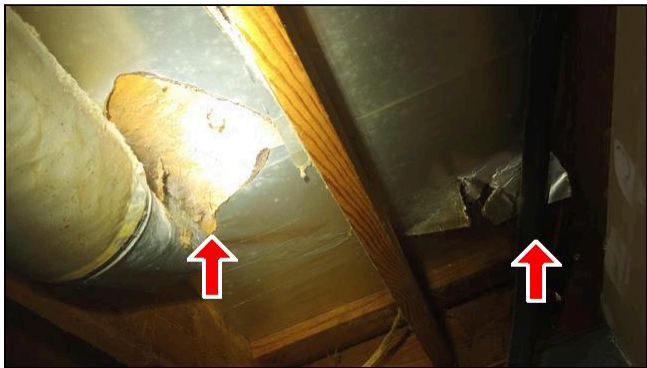
9.1 Item 1 (Picture)

9.1 Minor damage was located to the foil insulation at the subfloor in the garage. Repair as desired by a qualified person is recommended for improved energy efficiency. Installation of batt style insulation as desired by a qualified person is also recommended for the same reason.

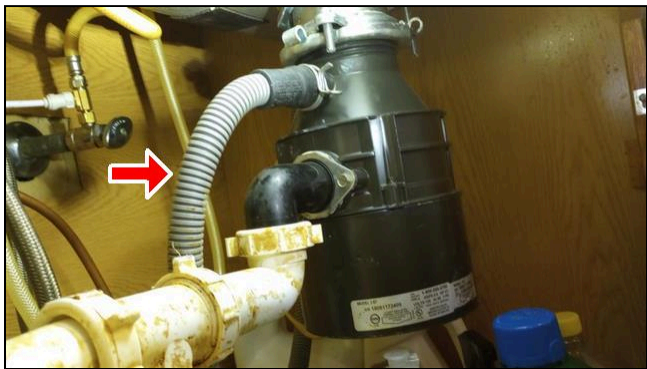
10.0 Item 1 (Picture)

10.0 The dishwasher drain line does not appear to perform a 'high-loop' which helps prevent accidental sewage back-up from entering the unit. Correction is recommended.

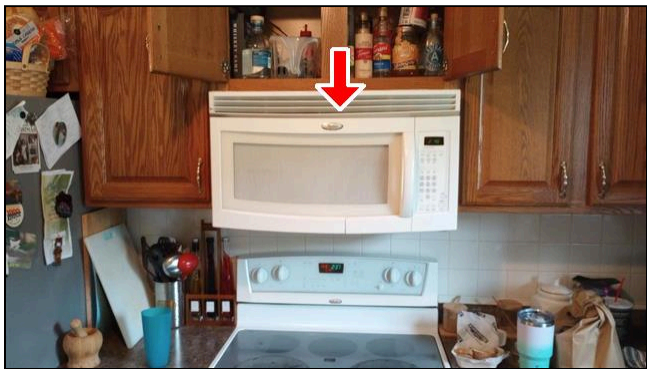
10.1 Item 1 (Picture)

10.1 The range hood re-circulates into the living space. Termination at the exterior as desired by a qualified person is recommended for improved ventilation.

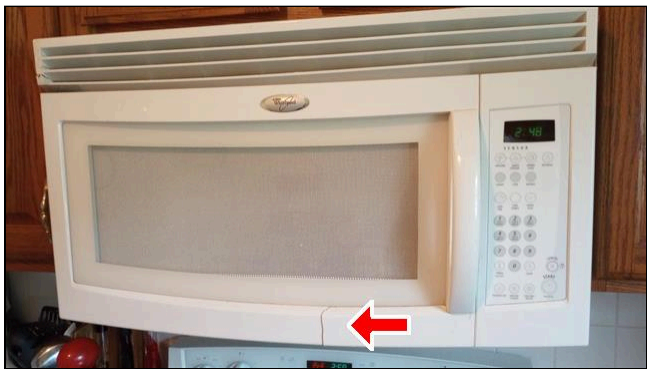
10.4 Item 1 (Picture)

10.4 Minor damage was located to the microwave door and grille. Repair or replacement as desired by a qualified person is recommended.

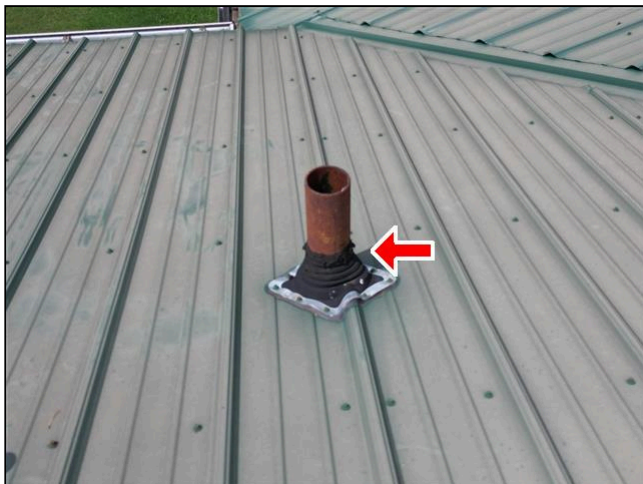
1.2 Item 1 (Picture)

Failed seals were located at some of the roof penetrations which may allow water intrusion. Repair as needed by a licensed roofer is recommended.

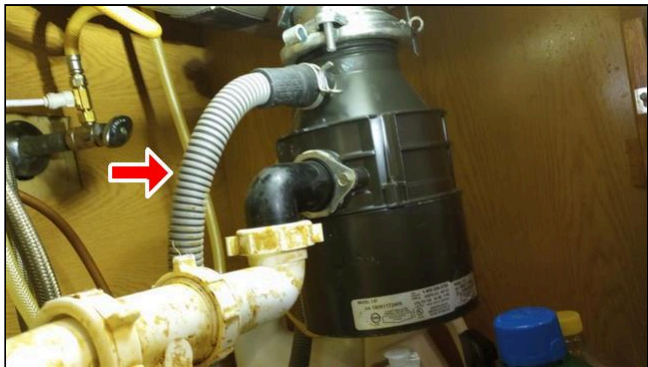
10.0 Item 1 (Picture)

The dishwasher drain line does not appear to perform a 'high-loop' which helps prevent accidental sewage back-up from entering the unit. Correction is recommended.
