ACE HOME INSPECTION

INSPECTION REPORT
124 Main Street
Knoxville Tennessee 37918

INSPECTED BY
Dave Ellis,
License No. 2885
Ace Home
Inspection

INSPECTION DATE
📅 3/6/2024
🕒 12:30 PM

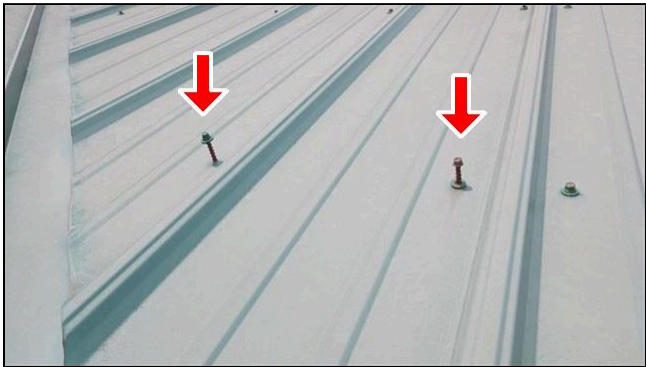
1.0 Item 1 (Picture)

1.0 (1) Loose screws and minor separation was located in various areas which can allow water intrusion. Further evaluation and repair by a licensed roofer is recommended.

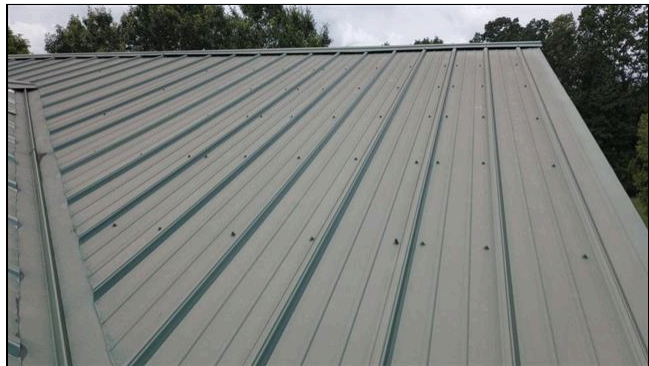
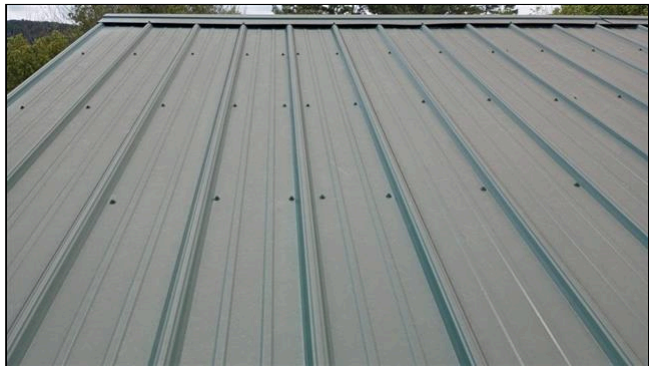
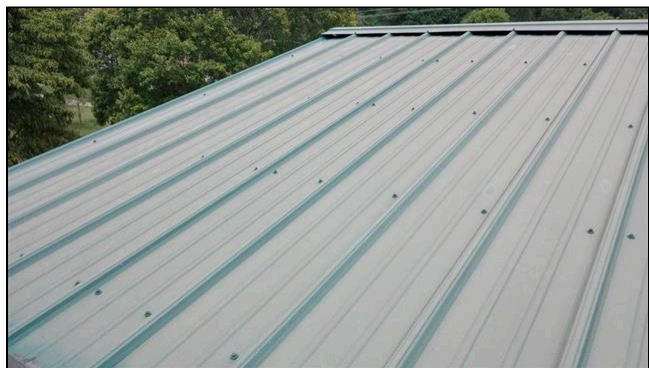
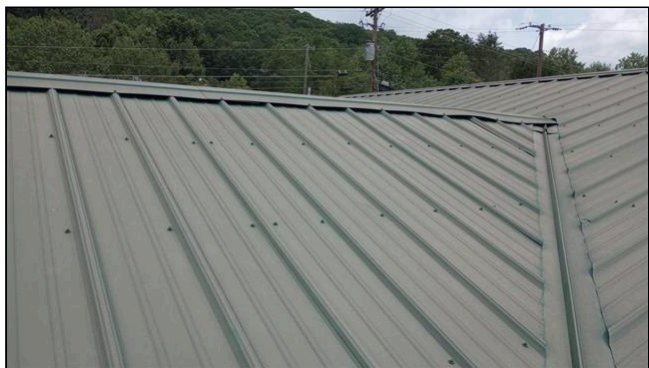
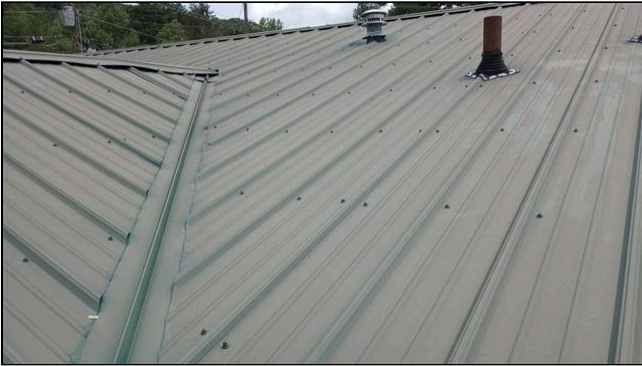
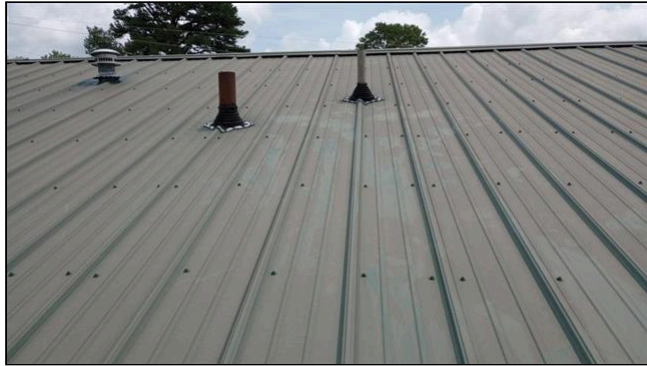
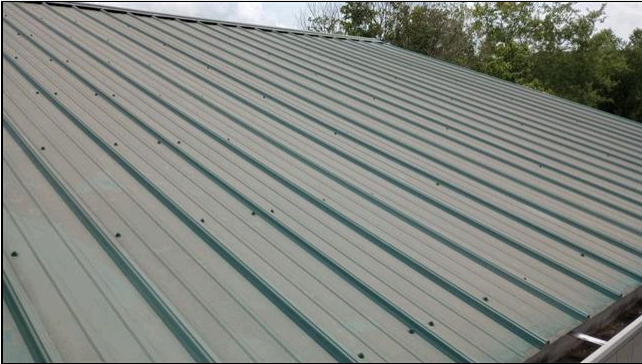
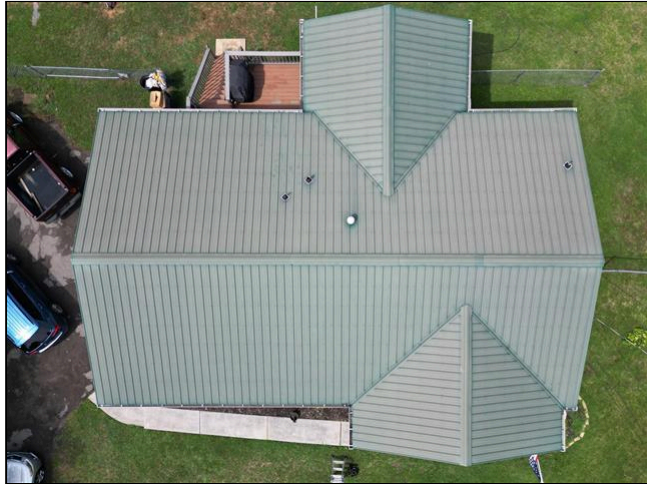
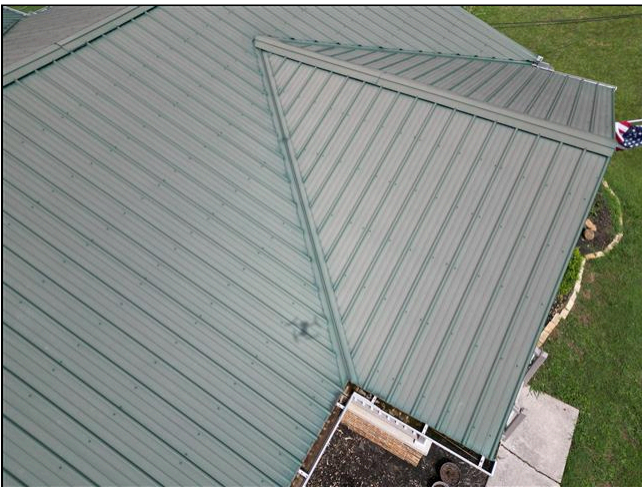
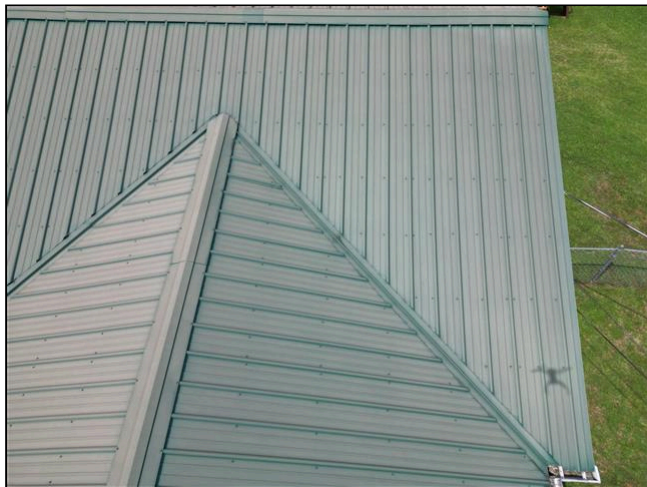
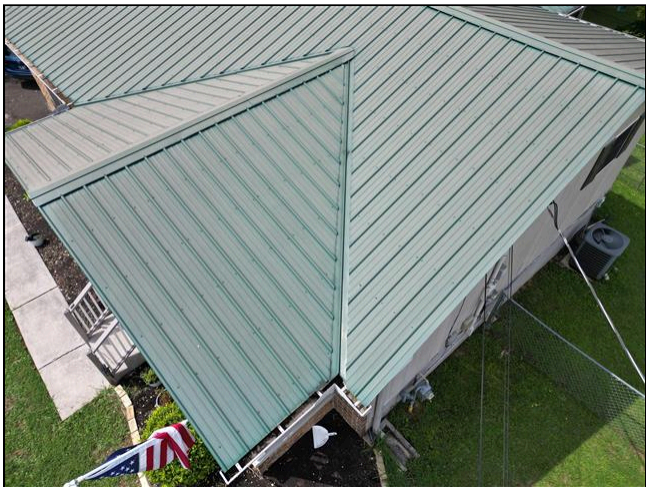
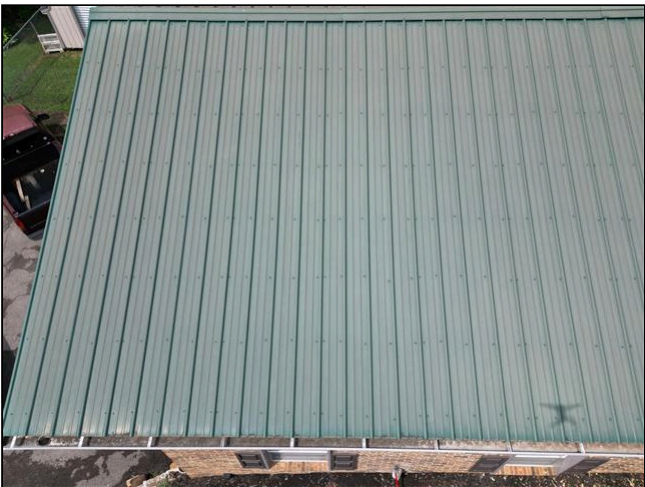
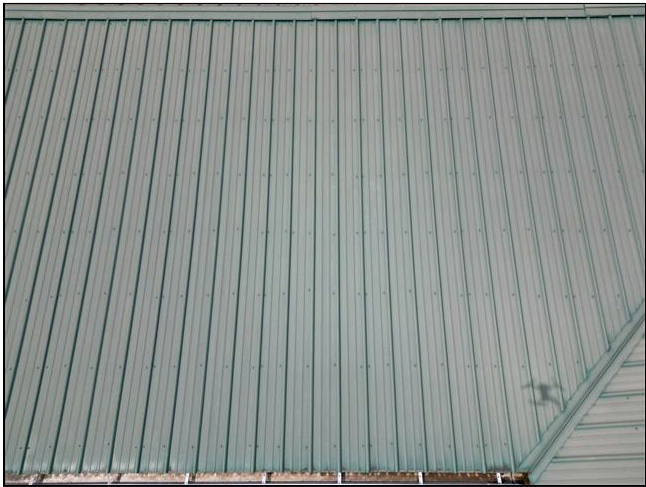
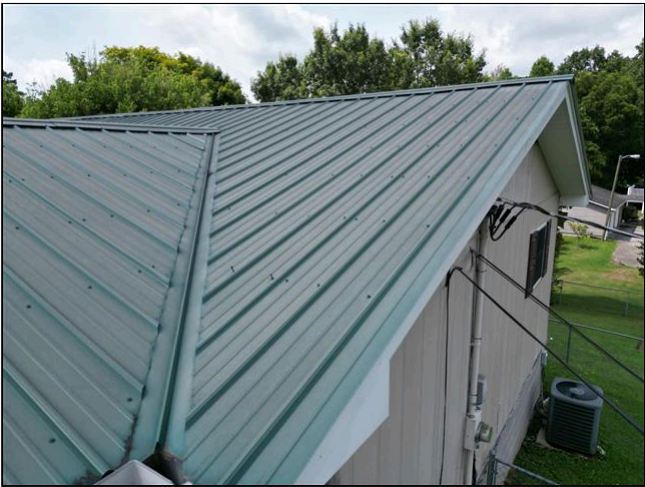
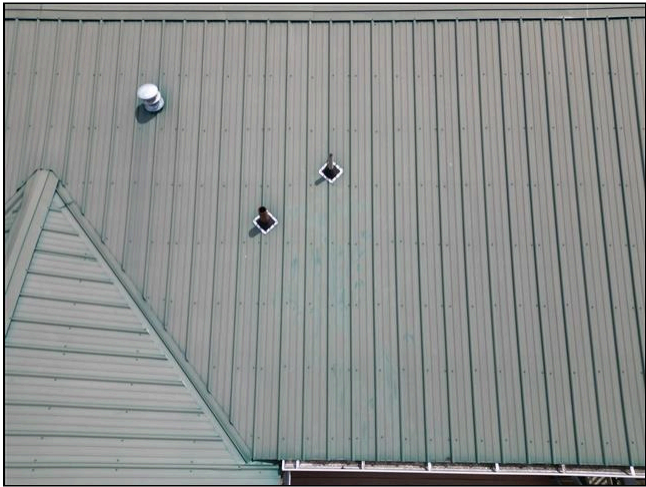
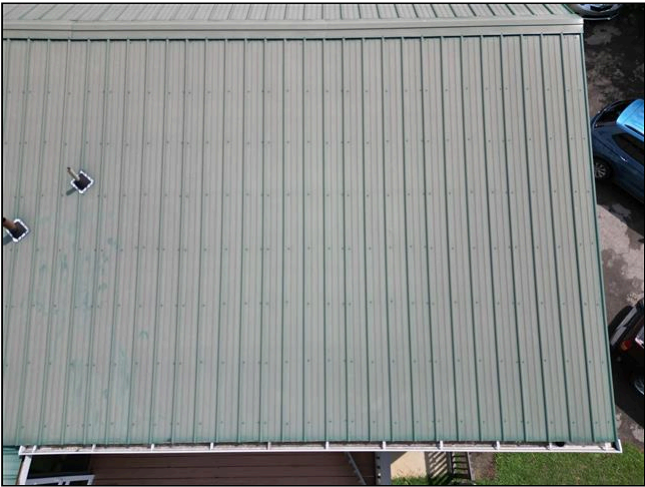
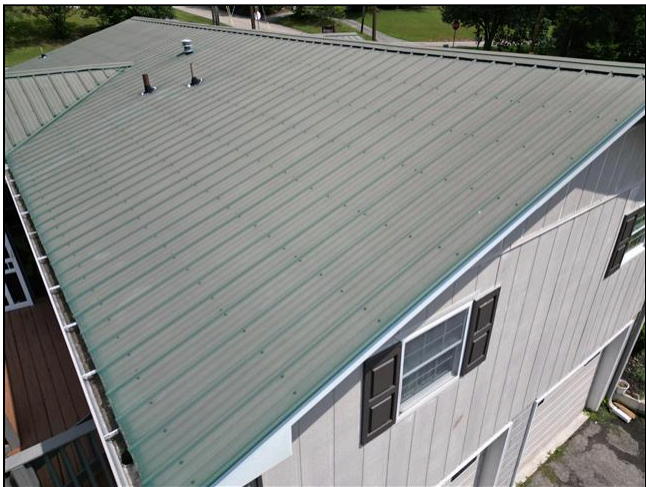
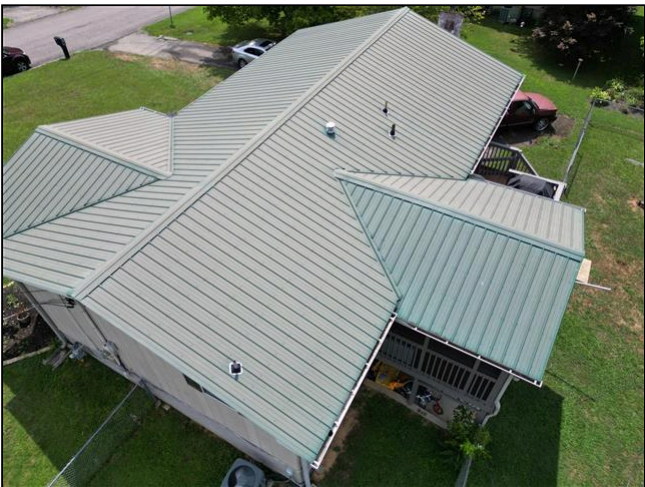
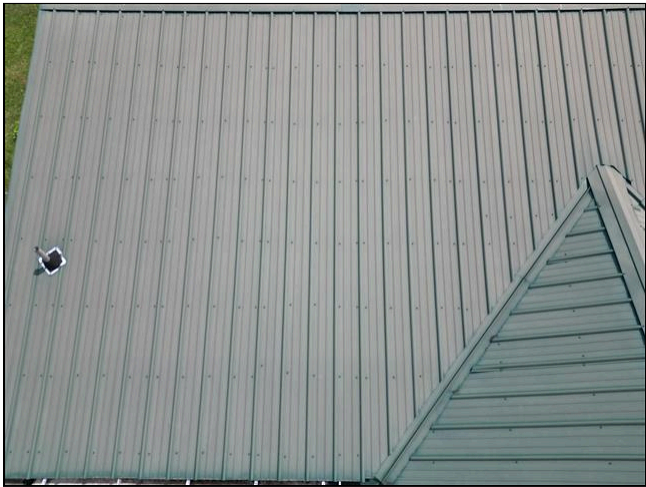
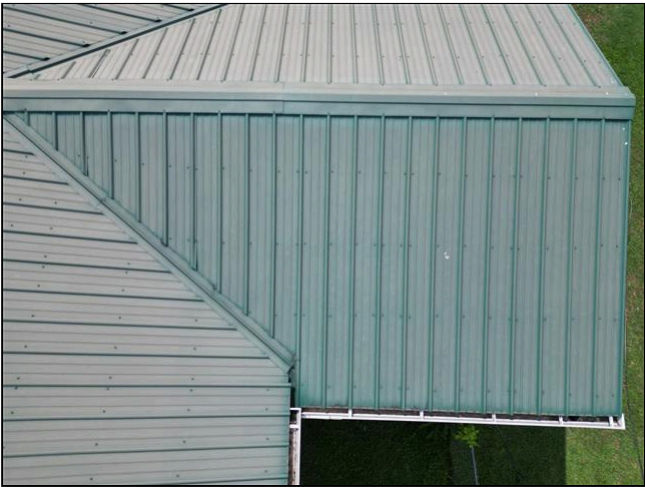
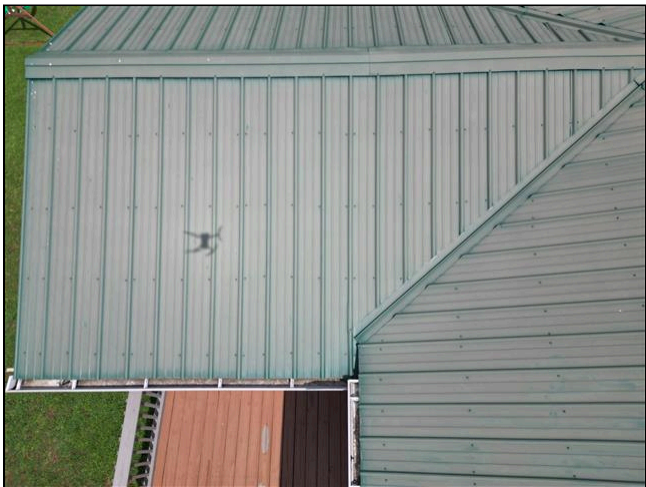
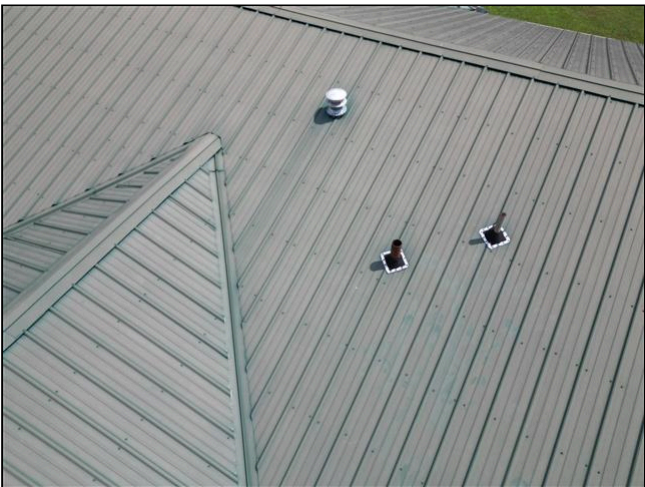
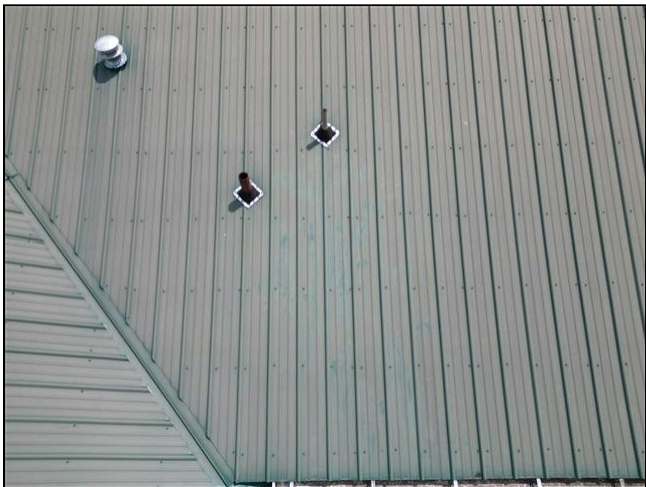
(3) Due to the metal surface, the roof was viewed from the ground using binoculars, eaves and aerial drone, and some areas were not fully visible. Further evaluation as desired by a licensed roofing company who can safely access the roof is recommended.

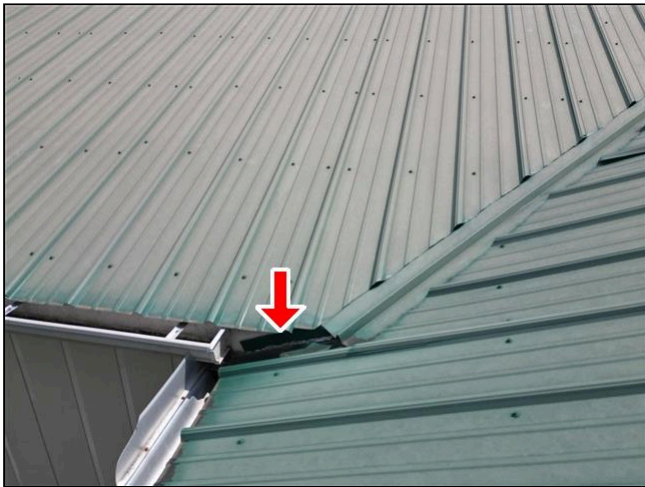
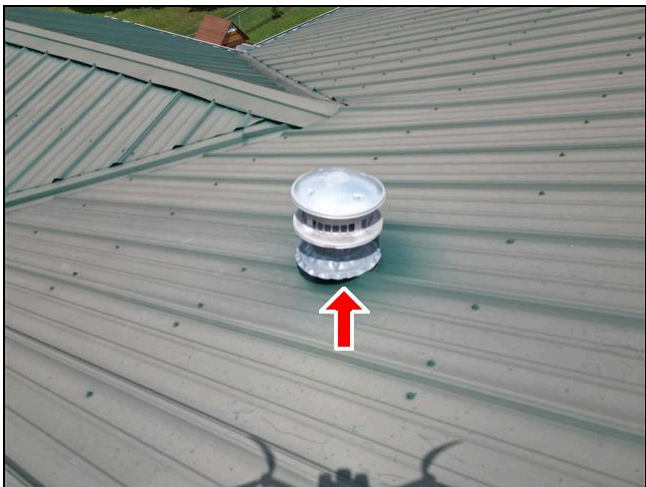
(4) Sealant is being used in various areas which has a tendency to fail. Continued monitoring of these areas and below for any changes is recommended.

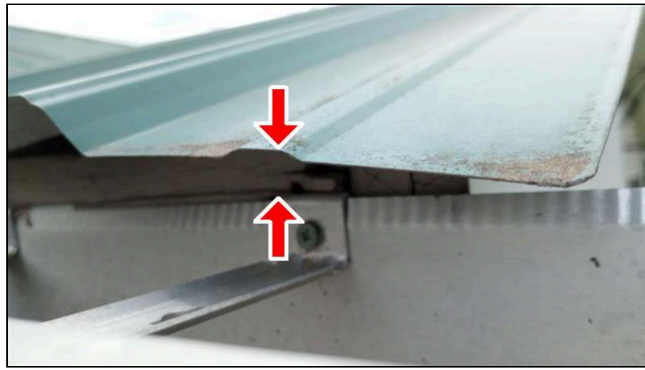
1.1 Item 2 (Picture)

1.1 (1) Drip edge flashing is missing at the eaves which may allow water penetration and contribute to

deterioration. Correction by a qualified person is recommended.

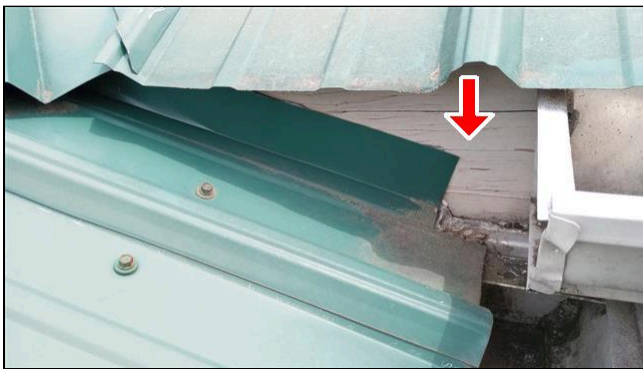
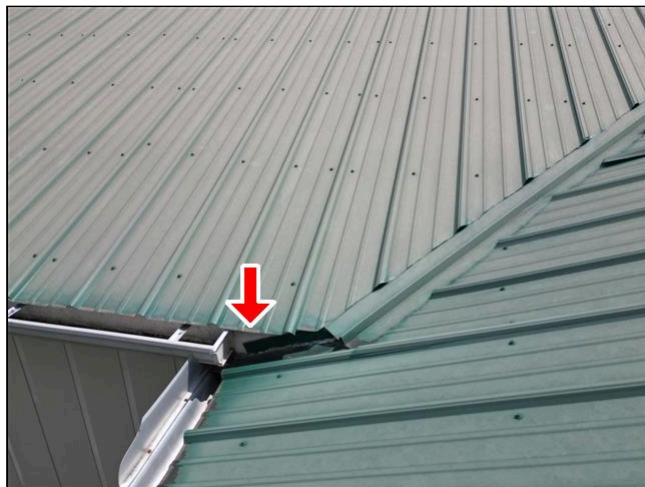
(2) Installation of kick out flashing as desired by a licensed roofer is recommended for improved drainage into the gutters.

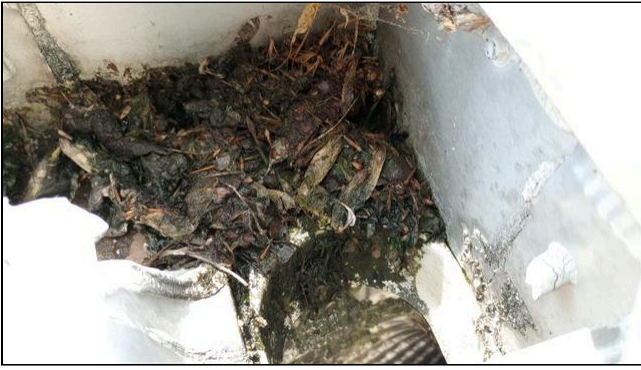
1.3 Item 1 (Picture)

1.3 (1) Cleaning the gutters and drainage system is recommended per regular maintenance for improved

drainage and to prevent damage to the eaves.

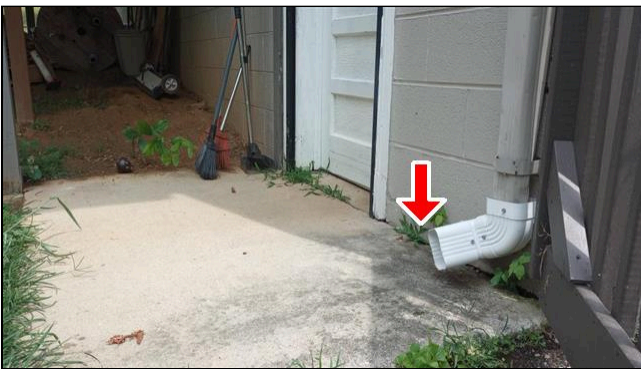
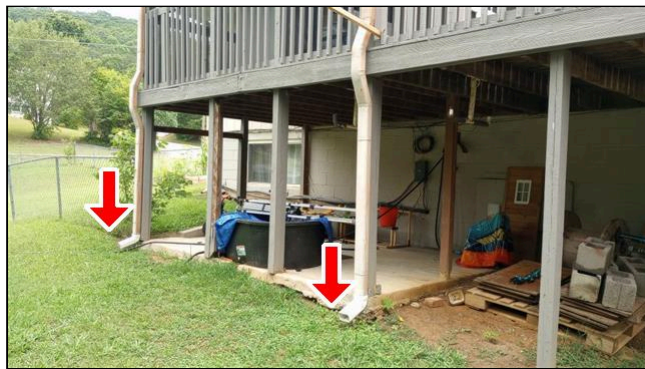
(2) Installation of downspouts extensions as desired where none currently exist and or reattachment/repair where needed is recommended for improved drainage away from the house.

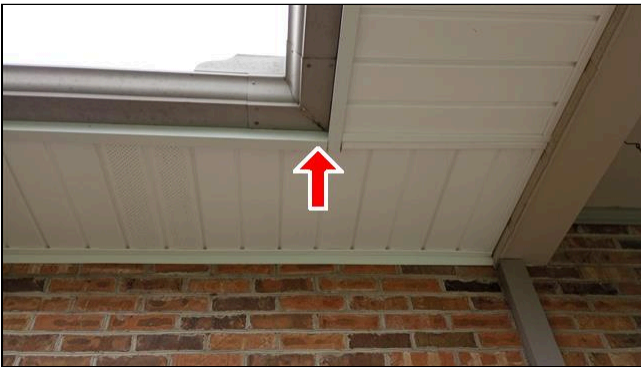
1.3 Item 4 (Picture)

(3) Evidence of minor leaks were located at some of the gutter seams. Resealing as desired is recommended for improved drainage.

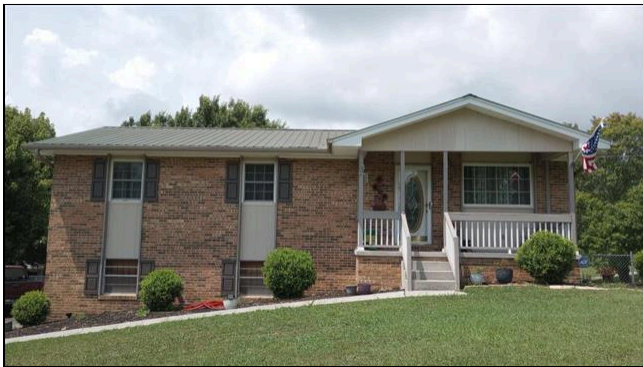
2.0 Item 1 (Picture)

2.0 (1) Front exterior overview.

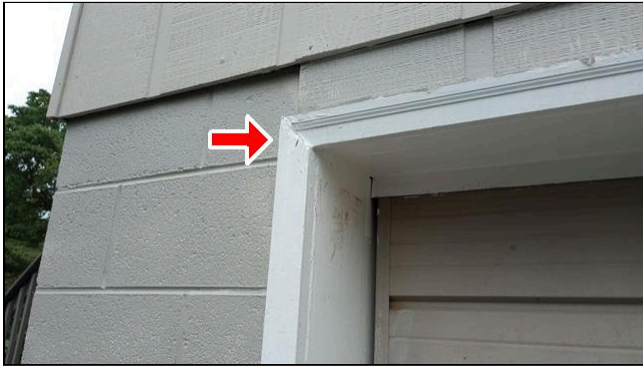
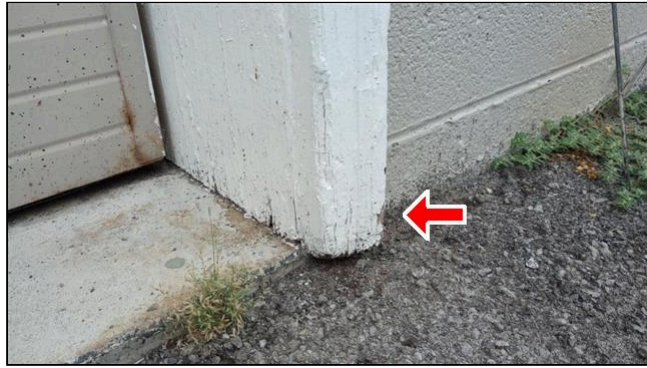
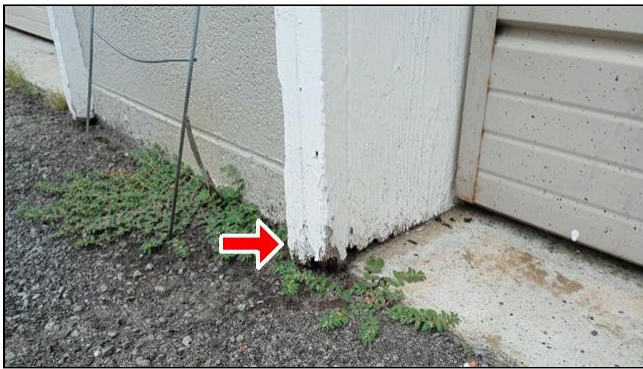
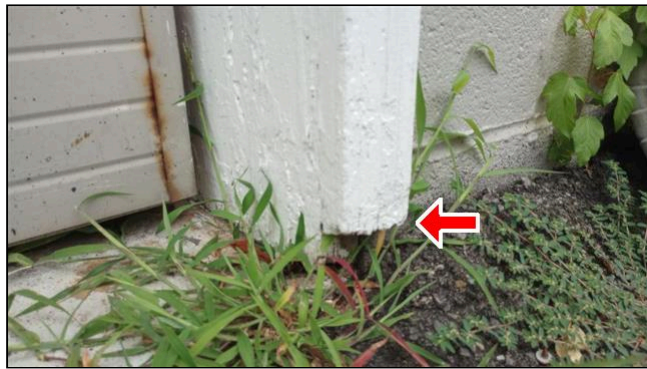
(2) Moisture damage is located to trim at the southern and rear exterior. Repair by a qualified person is recommended.

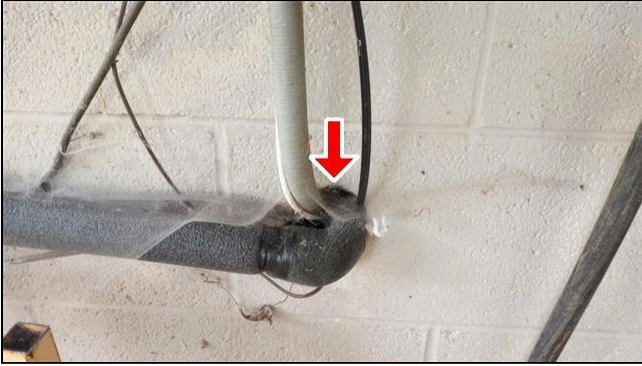
2.0 Item 9 (Picture)

(3) A gap is located in the annular space where the refrigerant lineset enters the building which may allow pest intrusion. Correction by a qualified person is recommended.

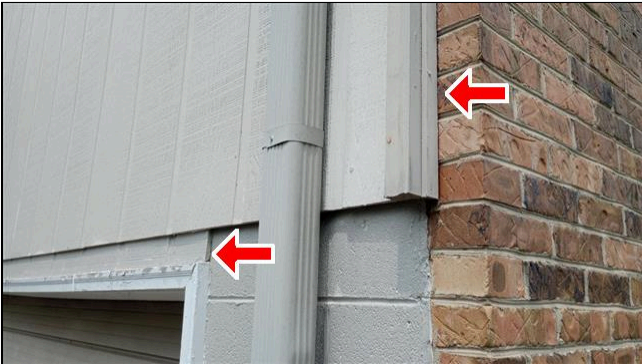
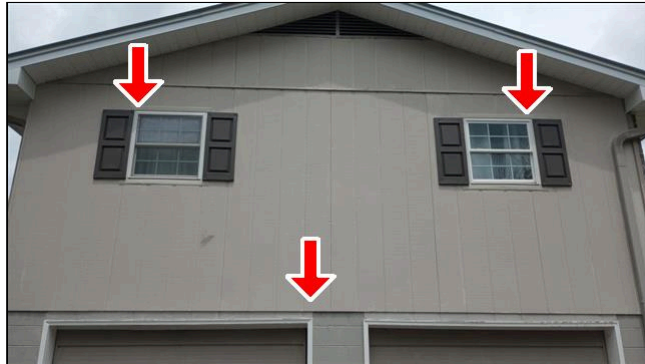
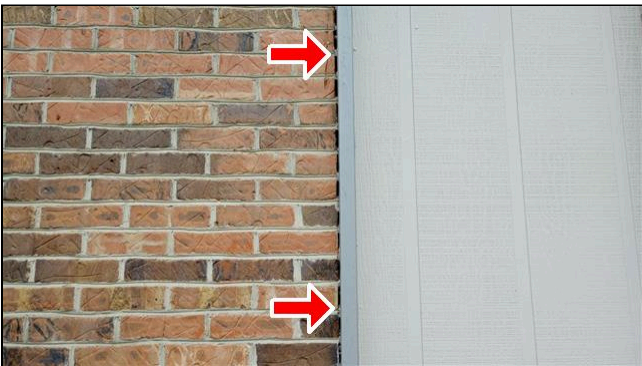
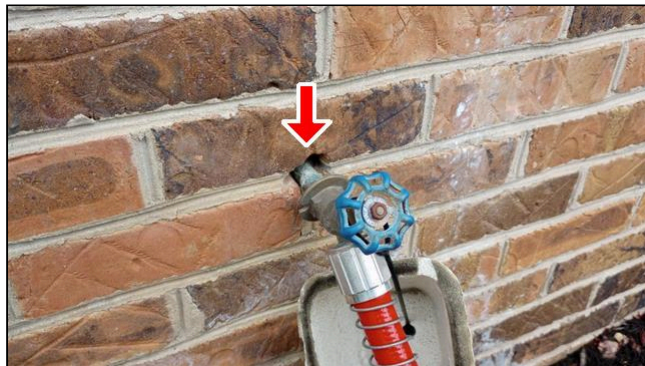
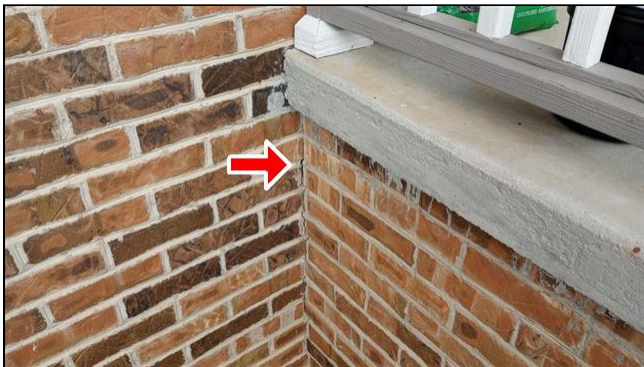
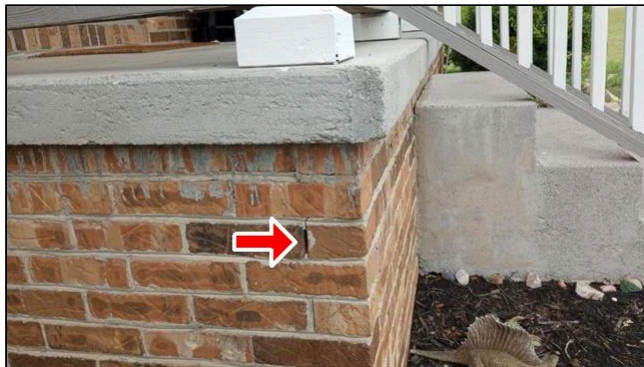
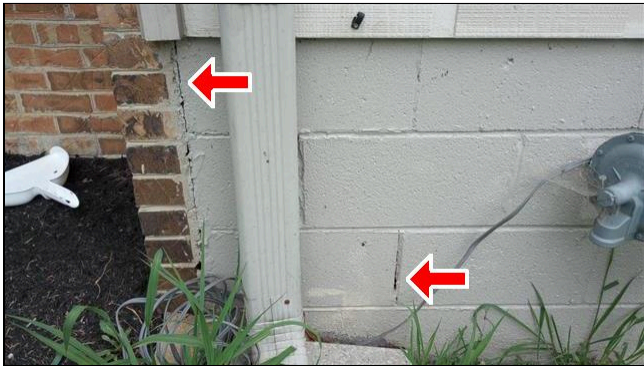
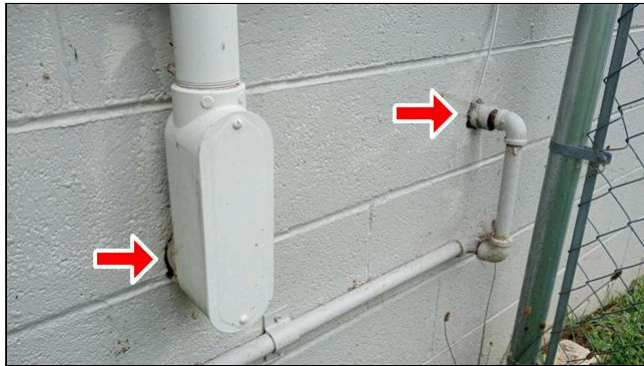
(4) Failed and missing seals were located to the siding, trim and building components around the exterior which may allow water penetration. Resealing these areas is recommended.

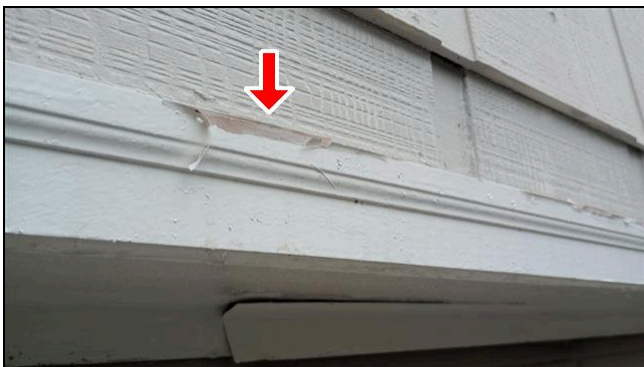
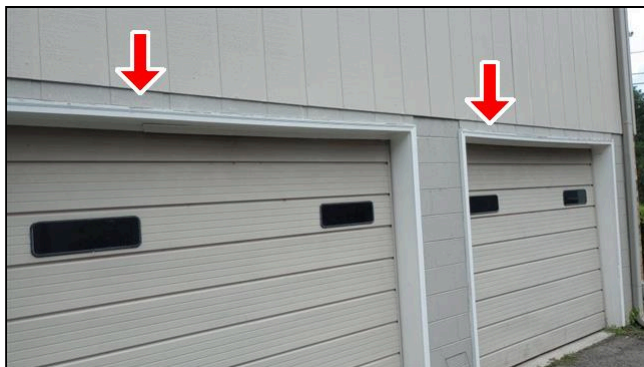
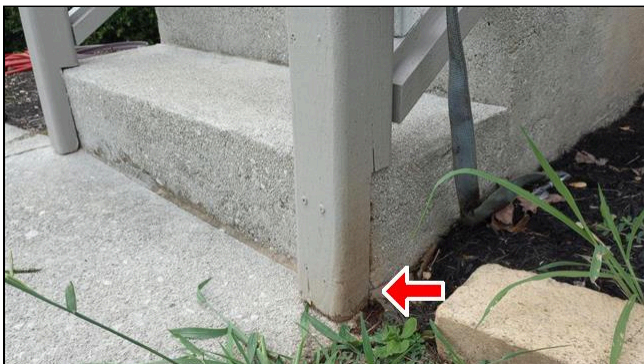
(5) Failed and missing paint was located to building components around the exterior. Repainting as desired is recommended to prolong the lifespan of the building materials.

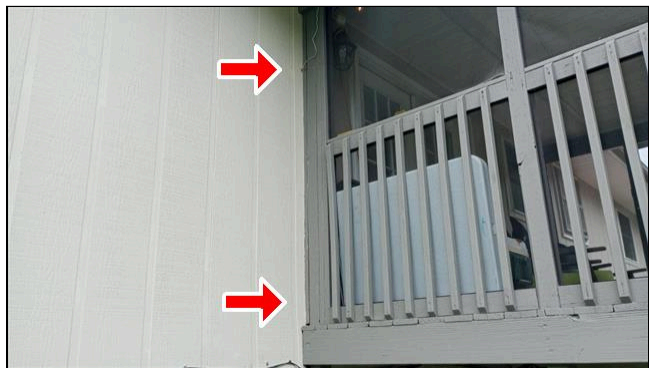
2.0 Item 21 (Picture)

(6) Installation of flashing between the deck post and siding as desired by a qualified person is recommended to help prevent possible pest intrusion.

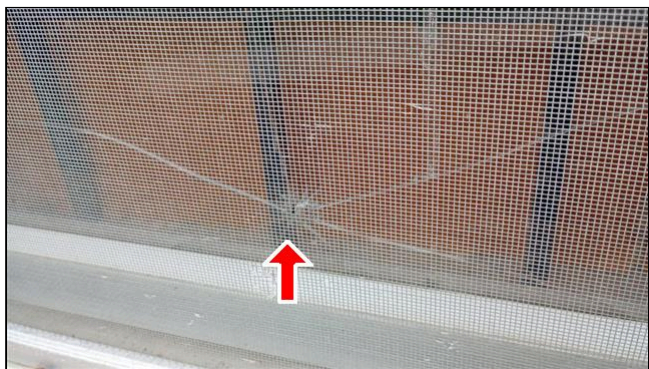
2.2 Item 2 (Picture)

2.2 (1) A broken window pane was located at the front exterior. Repair by a qualified person is recommended.

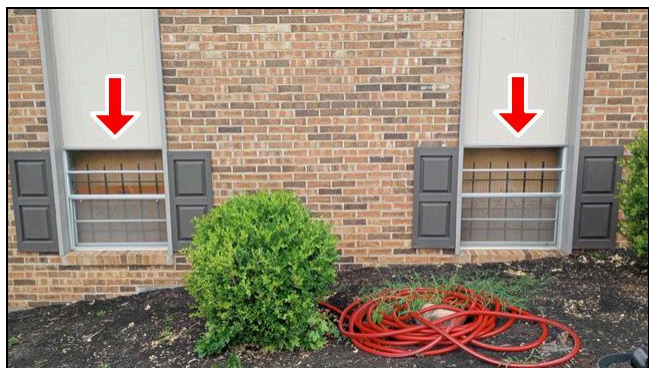
2.2 Item 3 (Picture)

(2) Windows at the lower level do not appear to have tempered safety glass. Replacement as desired by a window specialist is recommended for improved safety.

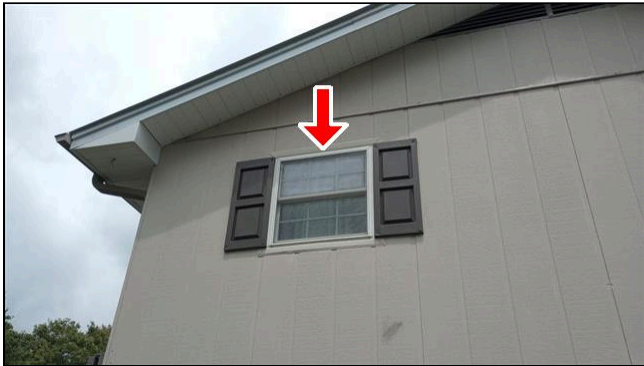
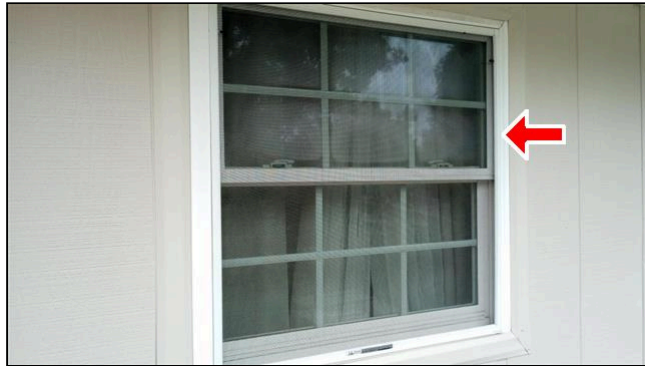
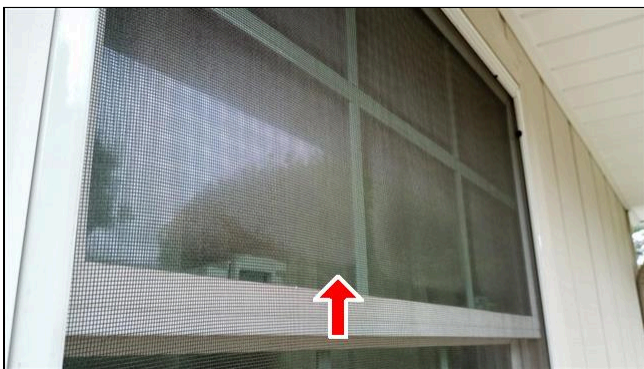
(3) Windows at the southern and rear exterior appear to have a failed factory seal which can allow condensation buildup and haziness between the panes, and it is possible that other windows also exist in this condition that went undetected. Further evaluation and repair as desired by a qualified person is recommended.

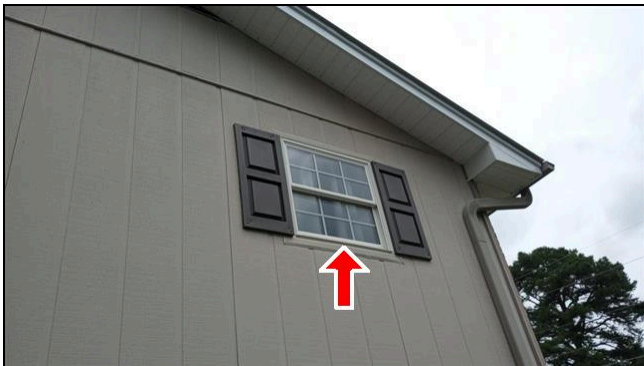
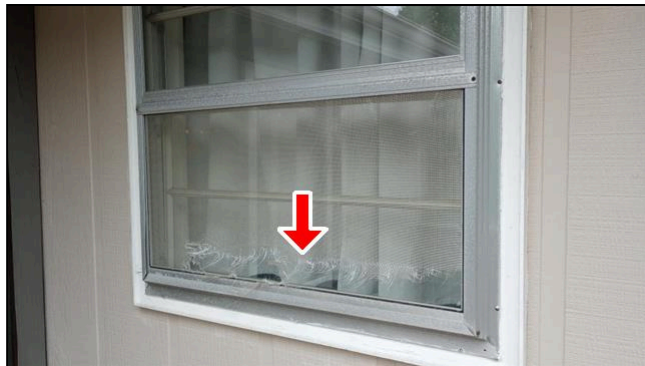
(4) Repair or replacement of any damaged or missing screens as desired is recommended to help prevent pest intrusion or further damage.

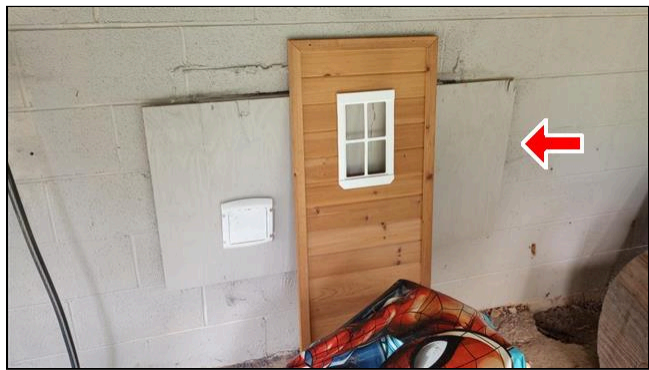
2.2 Item 9 (Picture)

(5) A window at the rear exterior and garage appears to have been covered and or removed. This is for your information only.

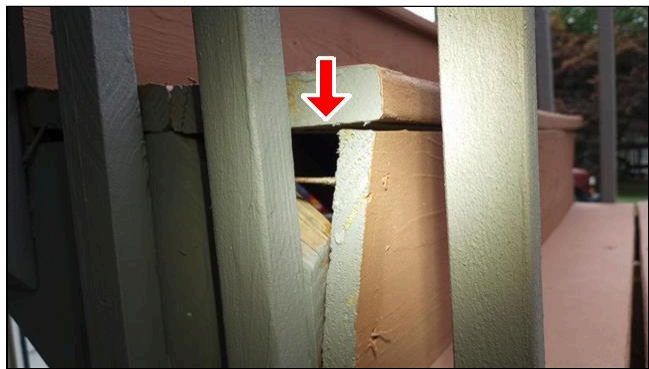
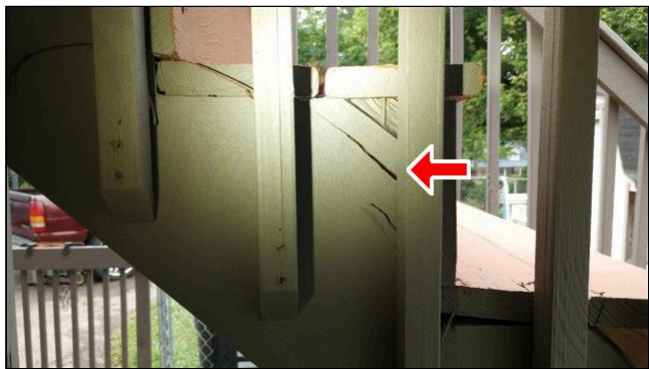
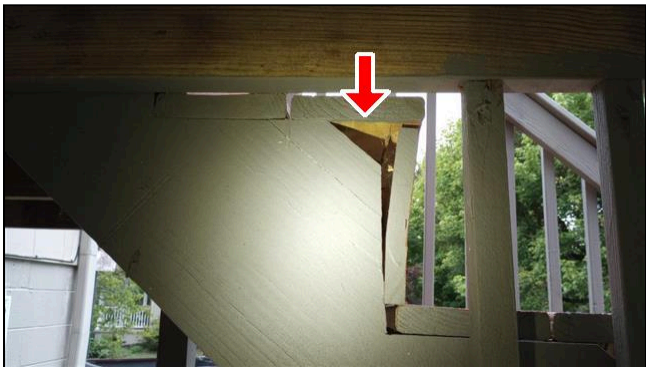
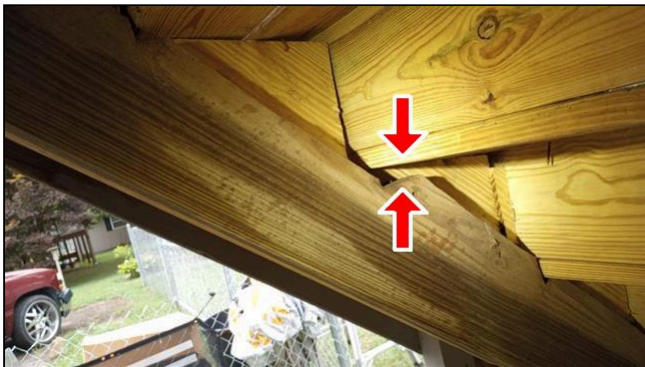
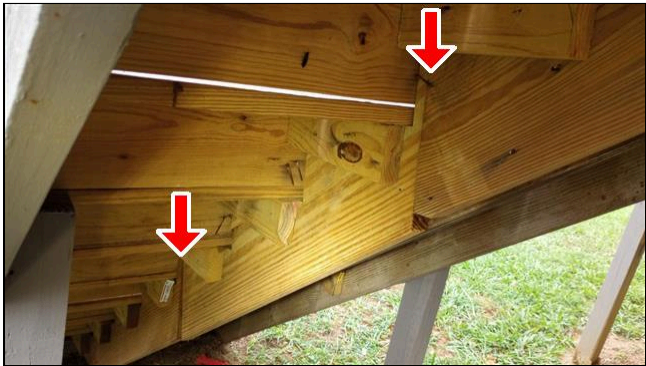
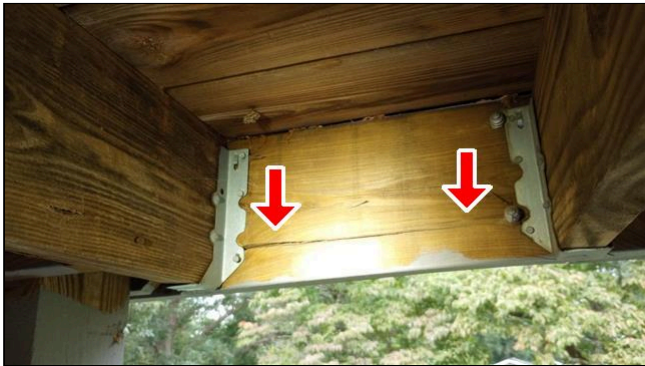
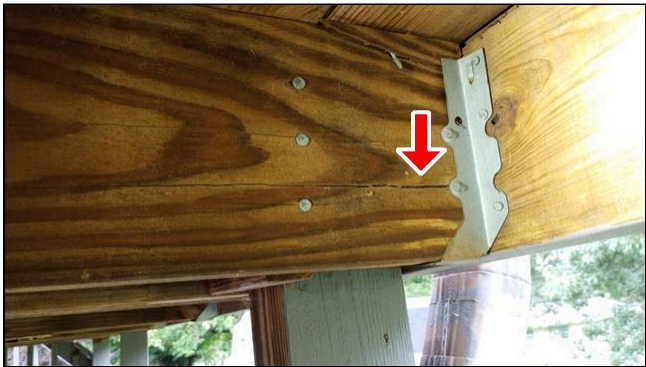
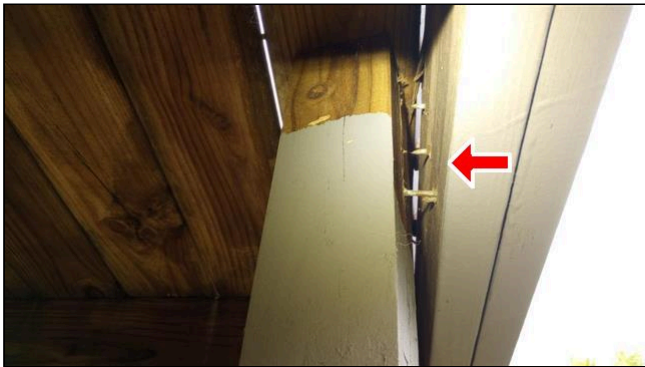
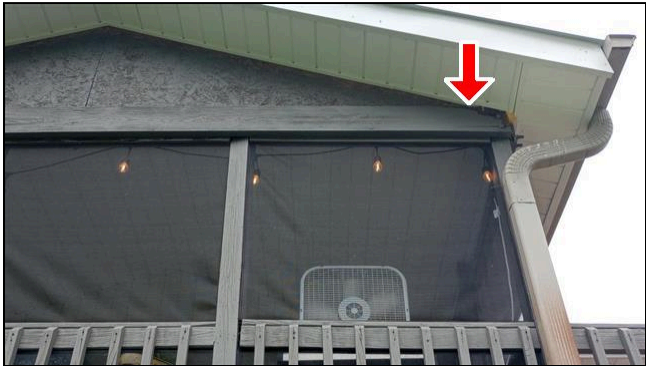
(2) General damage and loose components were located to the deck and stair structure. Further evaluation and repair as needed by a qualified person is recommended for improved safety.

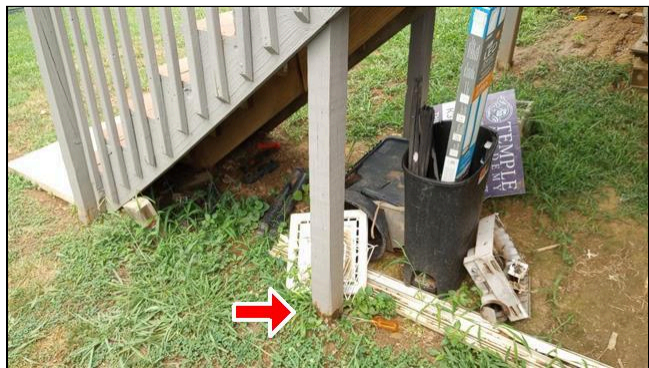
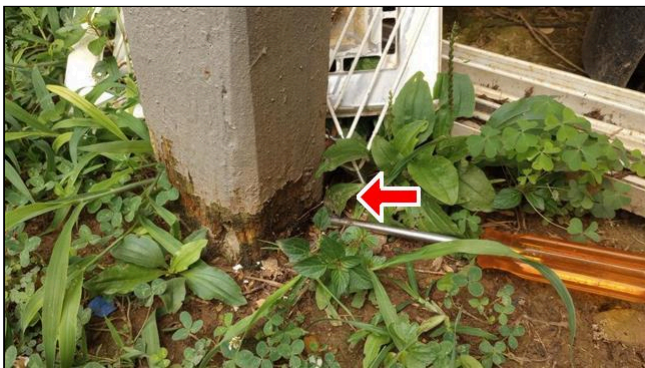
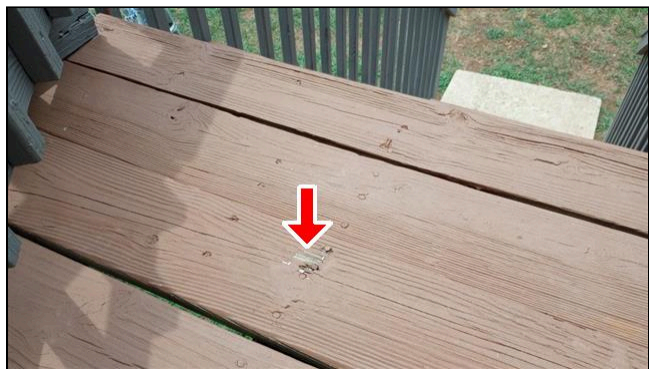
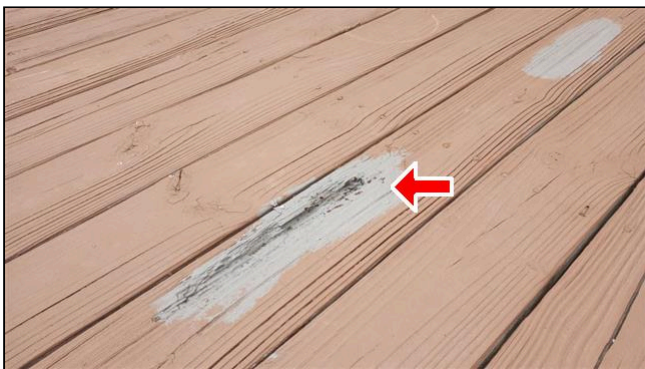
(3) Moisture damage is located to various deck components. Further evaluation and repair by a qualified person is recommended.

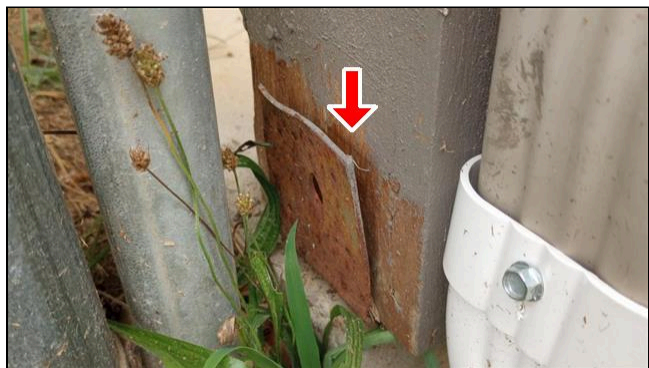
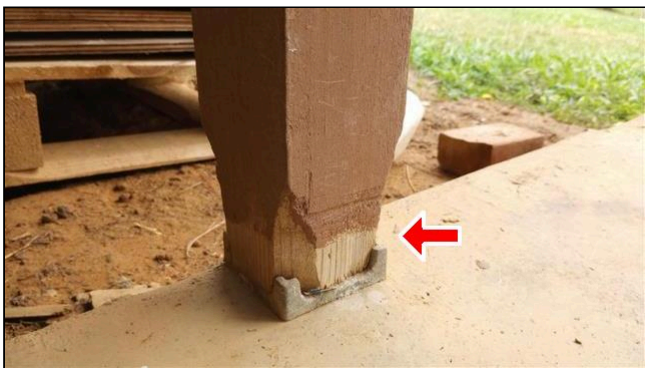
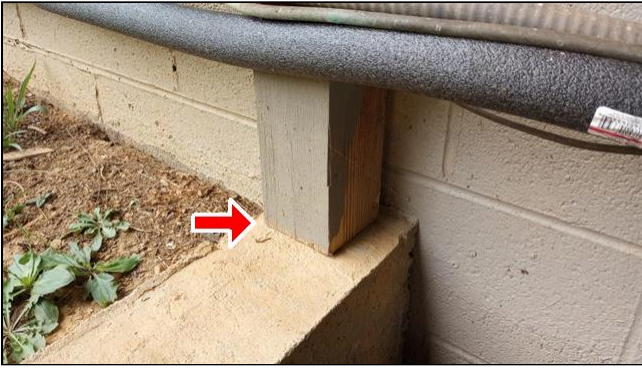
(4) Posts at the rear deck do not appear to be properly fastened to their brackets. Repair by a qualified person is recommended to help prevent damage or movement.

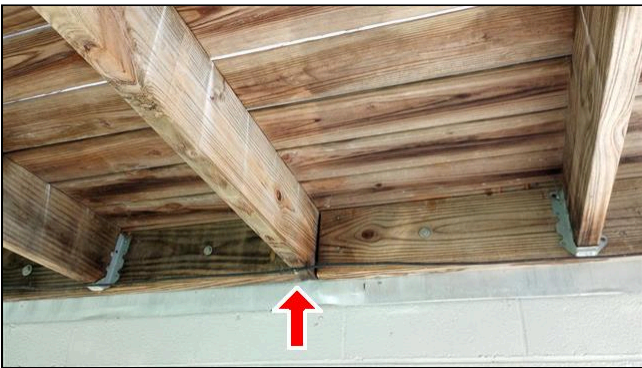
2.3 Item 19 (Picture)

(5) Installation of joist hangers as desired where none currently exist by a qualified person is recommended for improved structural support.

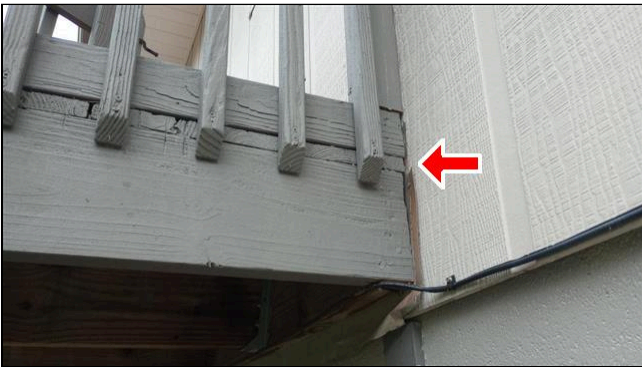
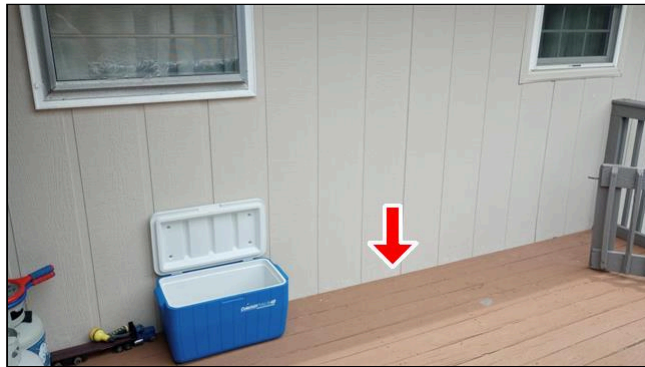
(6) Z-bar flashing was not located at the deck which can facilitate leaks, however this area was not fully visible due to the installed components. Further evaluation and repair as desired by a qualified person is recommended to ensure no leaks.

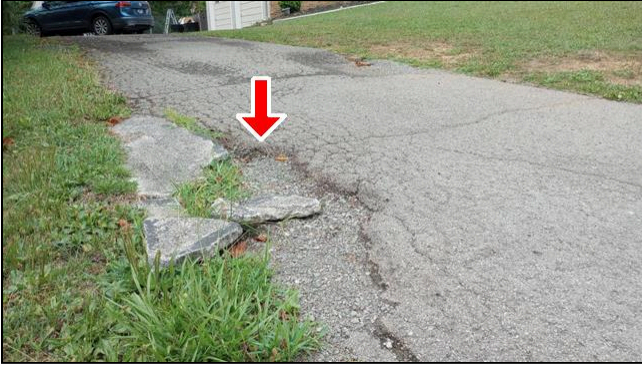
2.4 Item 1 (Picture)

2.4 (1) Differences in elevation are located to the walkway(s) which is a tripping hazard. Repair as needed by a qualified person is recommended.

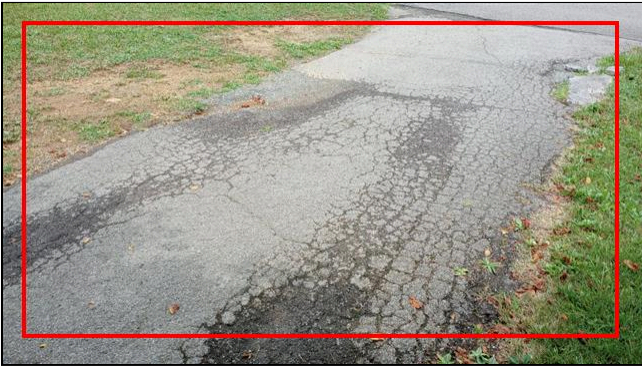
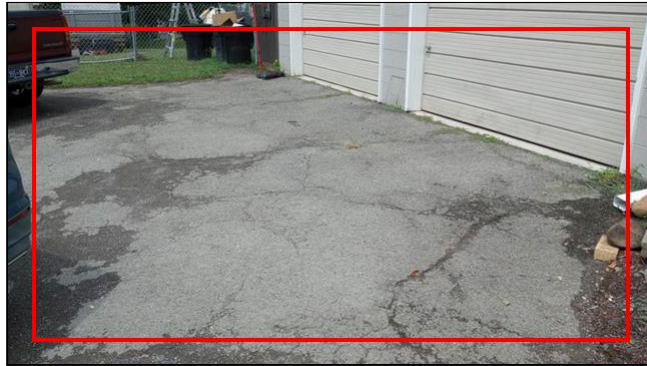
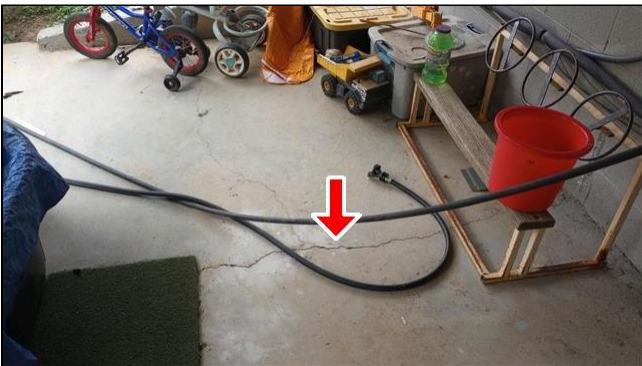
(2) Minor cracks were located to the flatwork around the exterior. Resealing these areas as desired by a qualified person is recommended to prevent further damage.

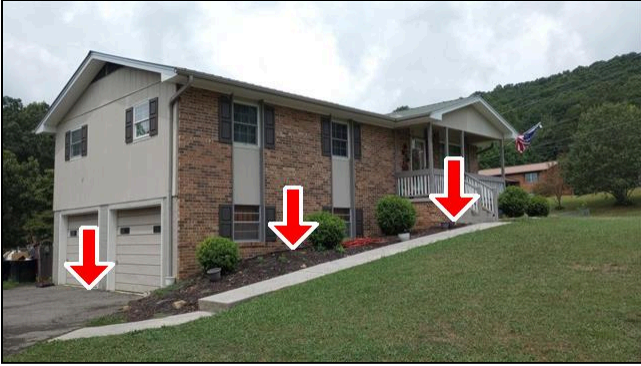
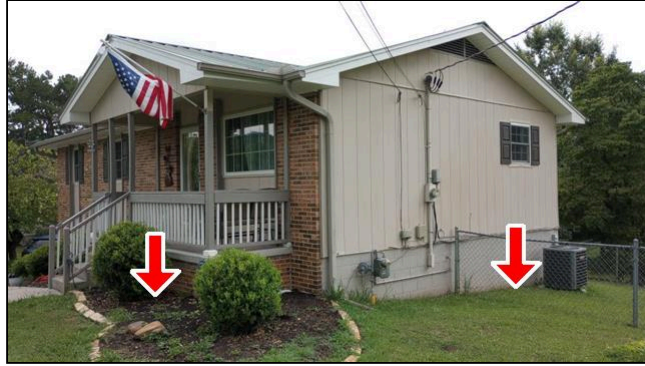
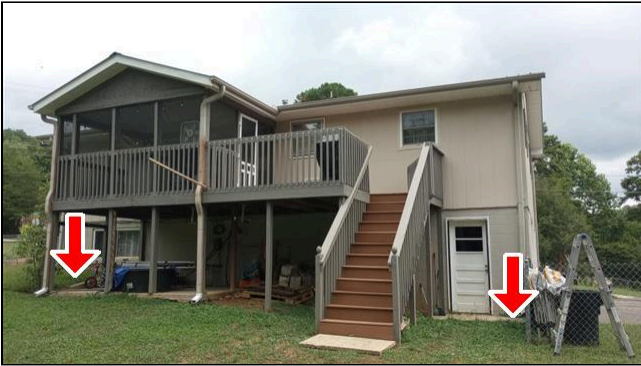
(3) Unable to determine if the grading and flatwork around the exterior sufficiently drains water away from the house during heavy rainfall. Recommend monitoring and making corrections as needed.

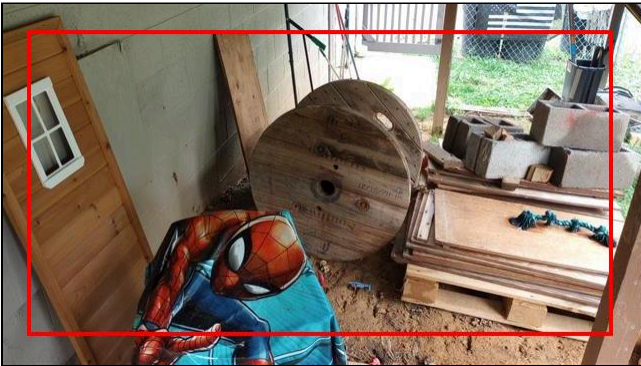
2.4 Item 8 (Picture)

(4) Removal of any cellulose debris and or dead vegetation adjacent to the home as desired is recommended to help deter wood destroying organisms.
