ACE HOME INSPECTION

INSPECTION REPORT
124 Main Street
Knoxville Tennessee 37918

INSPECTED BY
Dave Ellis,
License No. 2885
Ace Home
Inspection

INSPECTION DATE
📅 3/6/2024
🕒 12:30 PM

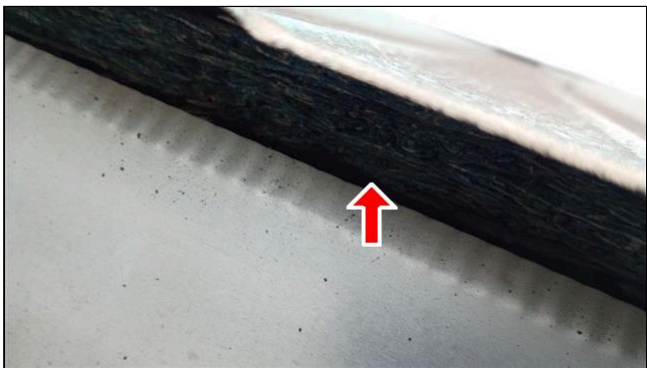
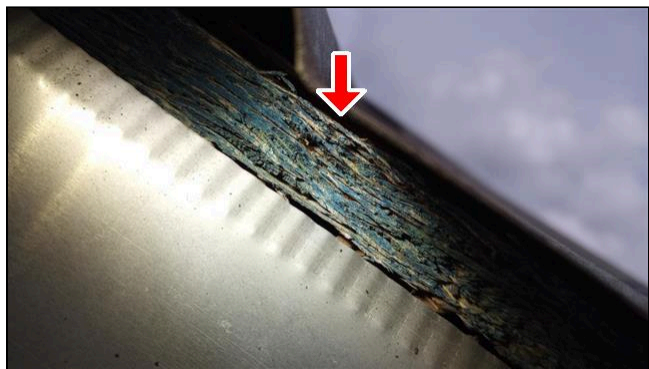
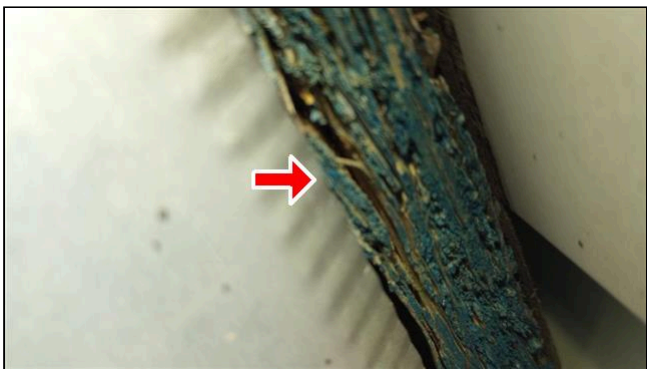
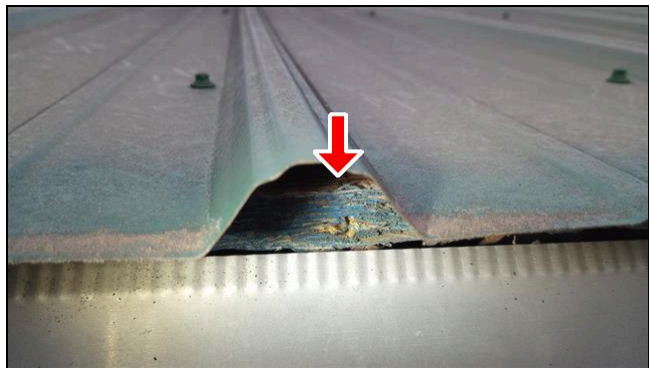
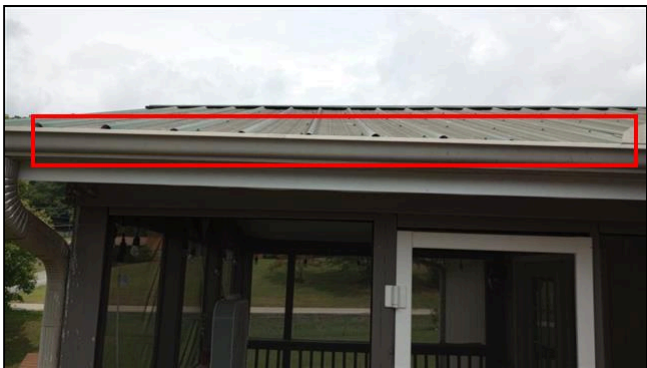
2.5 (1) Moisture damage is located to roof sheathing at the rear exterior and many areas were not visible. Further evaluation and repair by a qualified person is recommended.

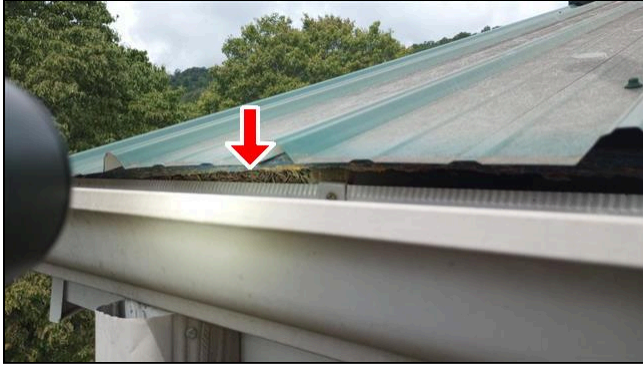
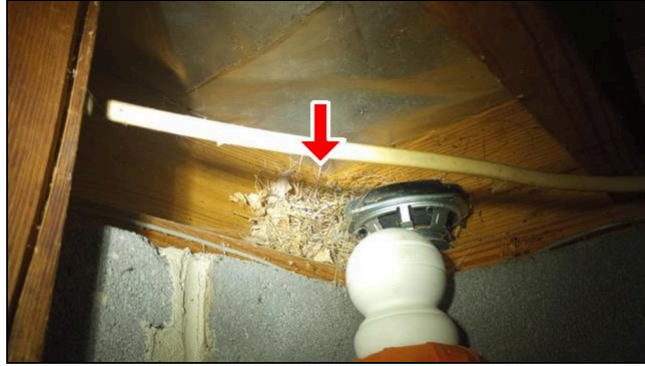
(2) Evidence of pest activity, possibly wasps and birds, was located in the rear soffit and garage. Careful removal of these nests as desired is recommended for improved safety.

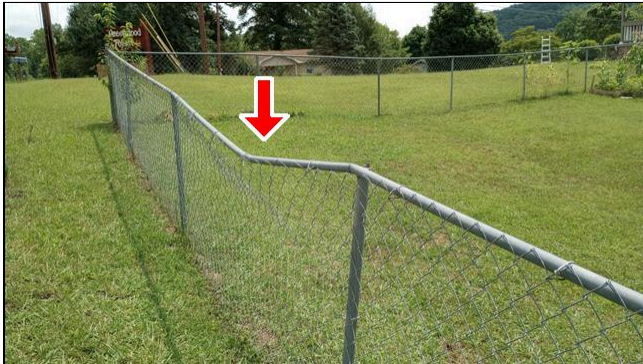
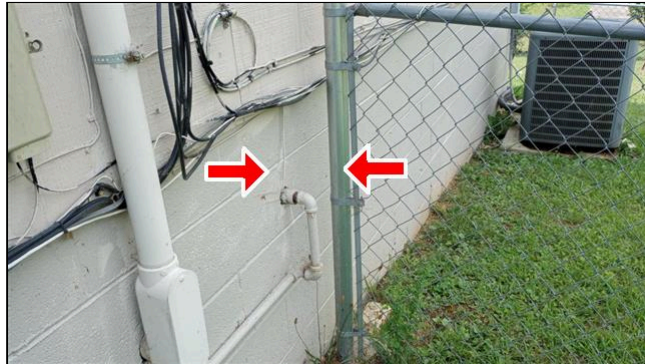
2.6 General damage and gaps are located to the fence which may allow pets out. Repair as desired by a qualified person is recommended.

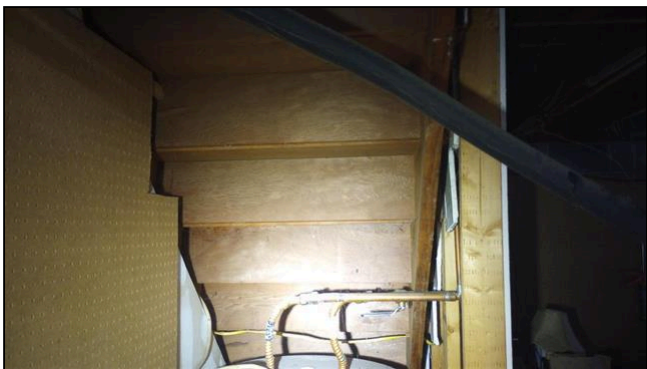
3.1 Item 2 (Picture)

3.1 (1) Gaps (exposed floor structure) were located to the fire separation wall/ceiling between the garage and dwelling. Repair by a qualified person is recommended for improved fire protection.

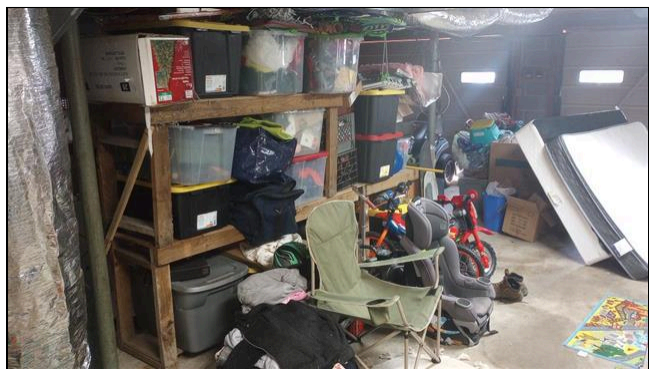
3.1 Item 3 (Picture)

(2) Portions of the garage were not visible due to the occupant's belongings.

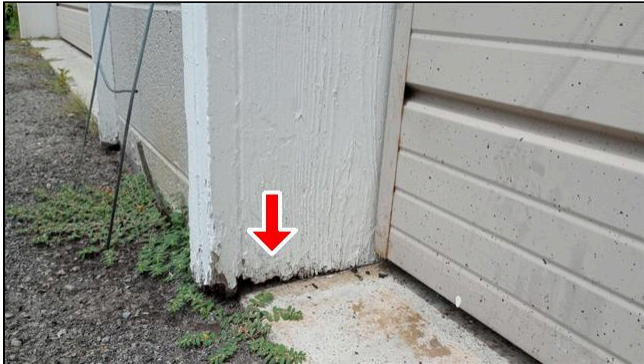
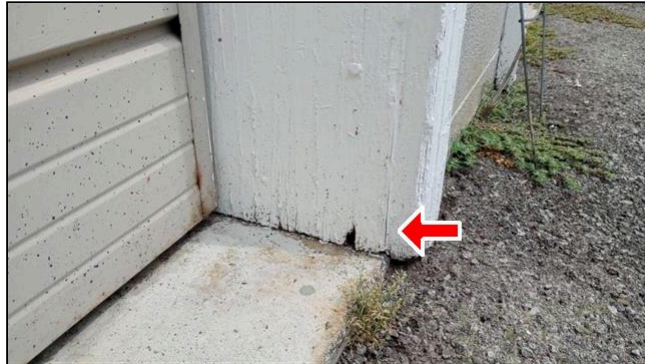
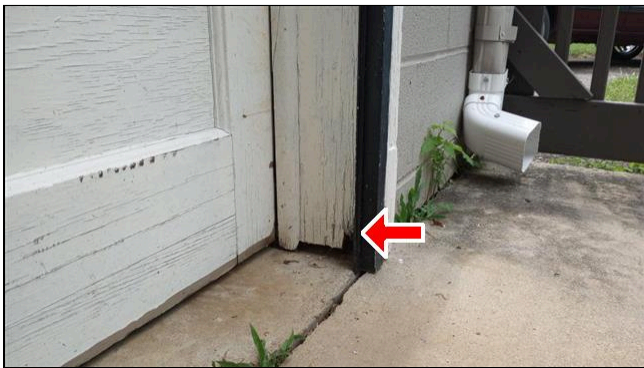
3.3 (1) Moisture damage is located to the garage door / casing. Repair by a qualified person is recommended.

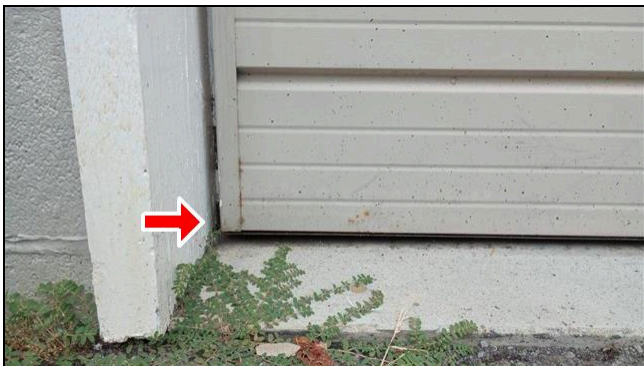
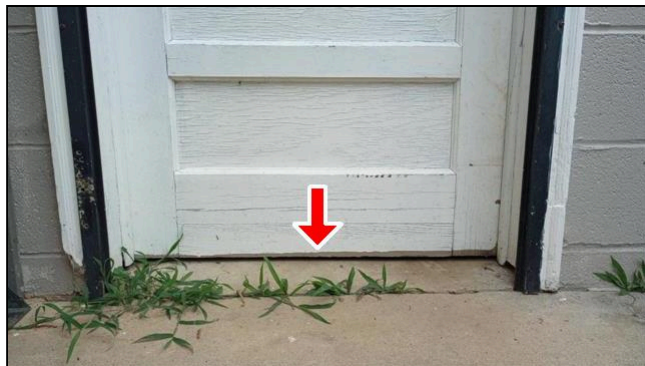
(2) Gaps are located at the garage door(s) which may allow water and pest intrusion. Correction is recommended.

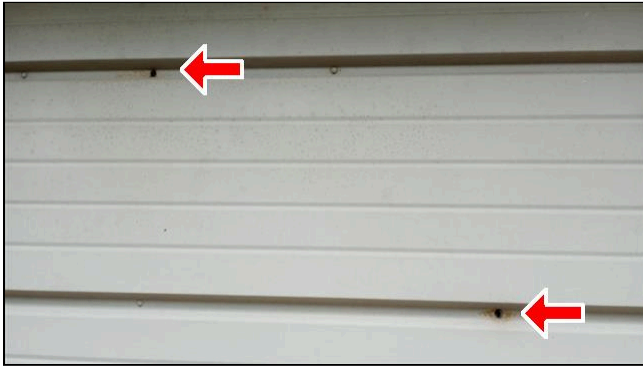
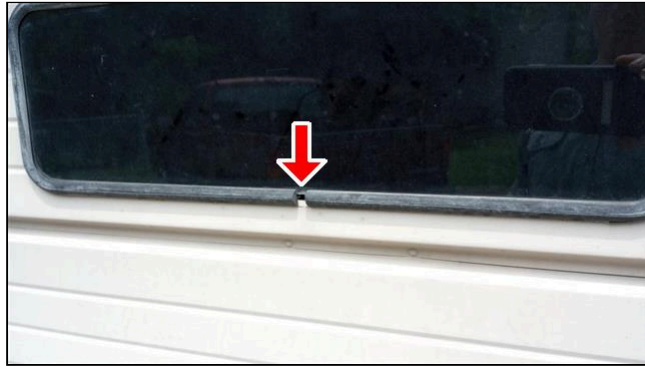
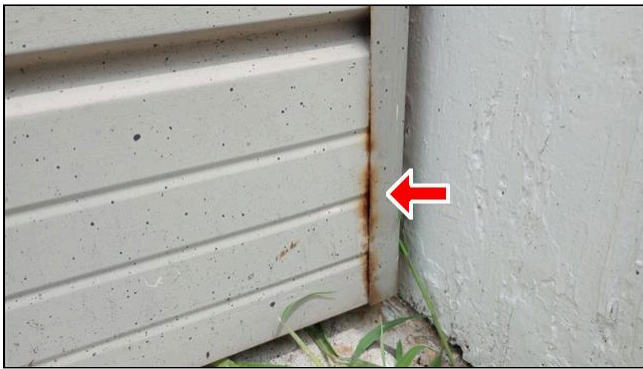
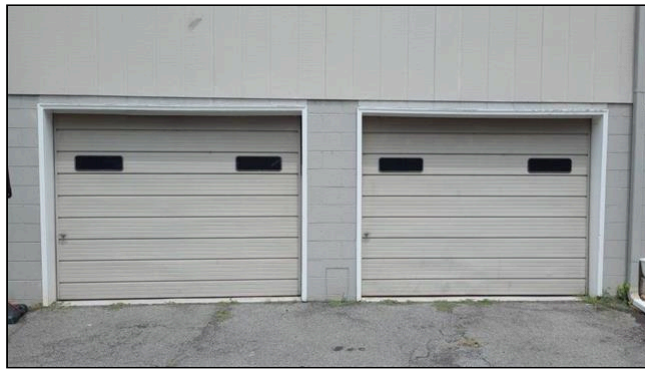
(3) Minor imperfections and rust were located to the garage doors. Repair as desired by a qualified person is recommended.

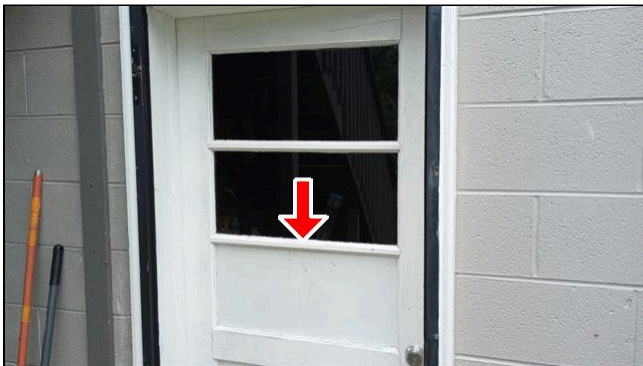
3.3 Item 10 (Picture)

(4) One of the window panes at the side garage door is missing and has been replaced with a non-conforming item. Repair by a qualified person is recommended.

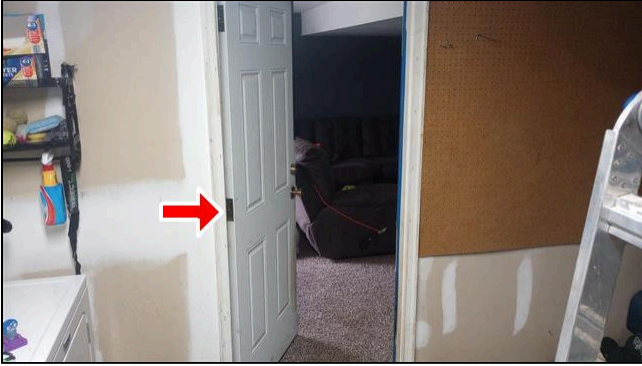
3.4 Item 1 (Picture)

3.4 The door between the garage and dwelling does not close without manual assistance. Installation of a self-closing hinge(s) is recommended for improved fire protection.

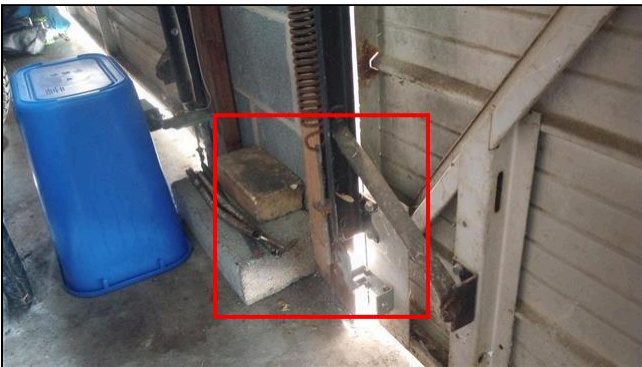
3.5 Item 1 (Picture)

3.5 (1) The garage door does not have safety reverse sensors and did not reverse when pressure was manually applied. Installation of sensors and or readjustment of the door opener is recommended for improved safety.

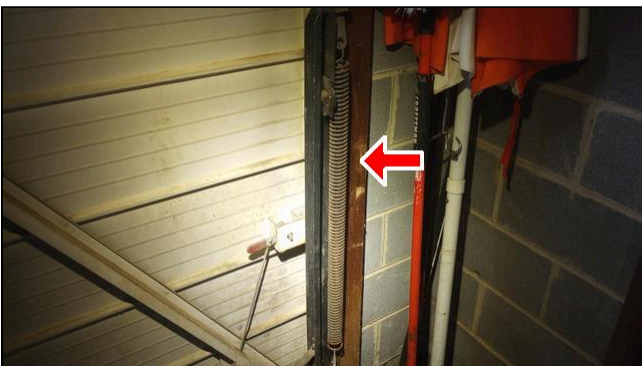
3.5 Item 2 (Picture)

(2) Installation of a safety cable at the garage door springs as desired by a qualified person is recommended for improved safety.

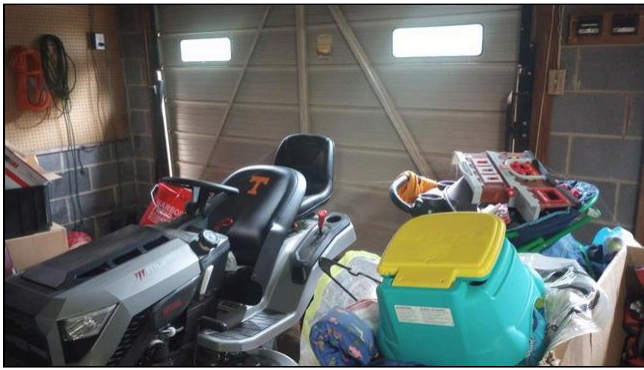
3.5 Item 3 (Picture)

(3) The front garage door was not tested due to the occupant's belongings.

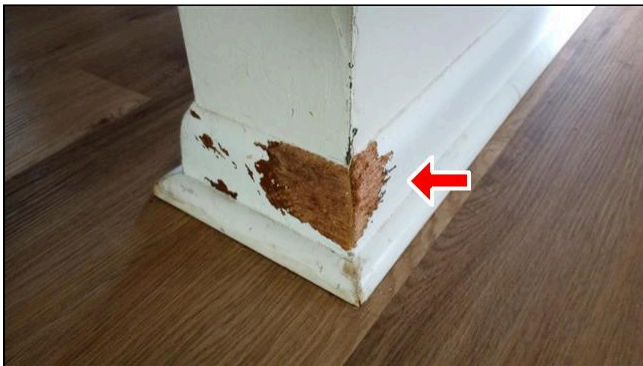
4.1 Item 1 (Picture)

4.1 (1) Minor damage and imperfections were located to the walls and ceiling throughout the interior. Repair as desired by a qualified person and continued monitoring for any changes is recommended.

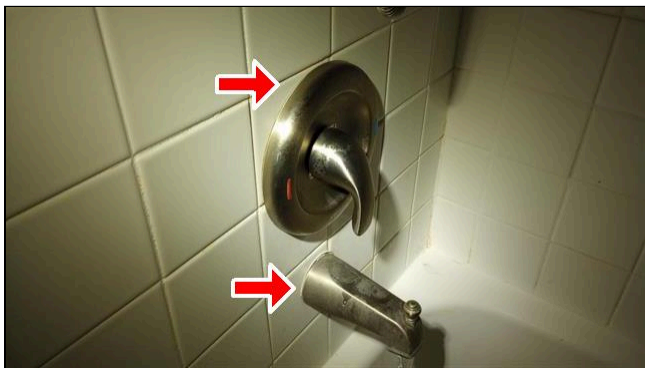
4.1 Item 4 (Picture)

(2) Failed seals were located to the shower walls which can allow water penetration. Resealing these areas is recommended.

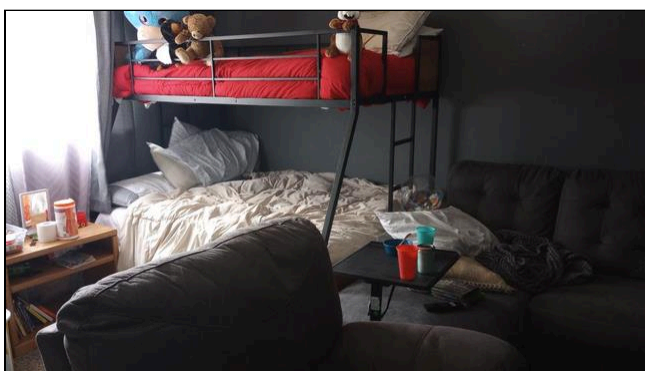
4.1 Item 6 (Picture)

(3) Portions of the interior were not visible and inaccessible due to the occupant's belongings.

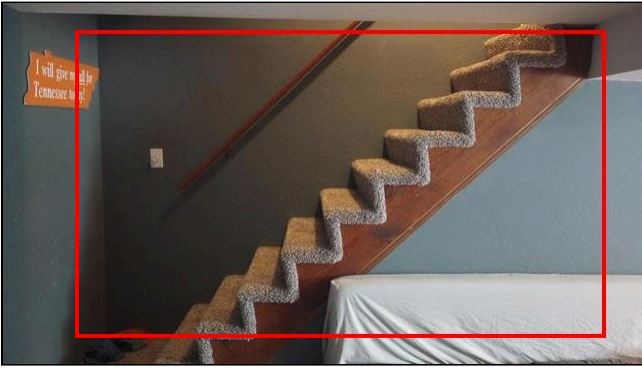
4.3 Item 1 (Picture)

4.3 Installation of a railing with balusters at the steps as desired is recommended for improved safety.

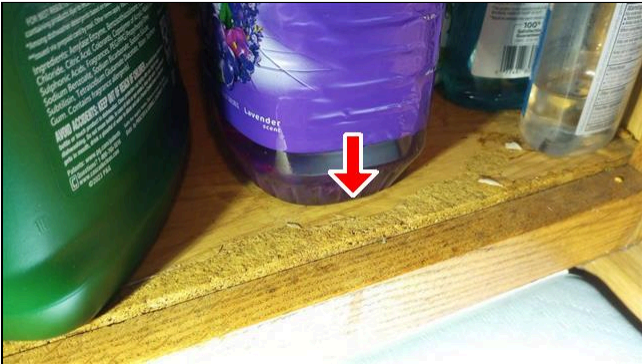
4.4 Item 1 (Picture)

4.4 (1) Minor warping, staining and damage was located in the cabinet below the kitchen sink which indicates a possible / previous leak or spill, however no current moisture was detected when tested. Cleaning and further monitoring for any changes is recommended.

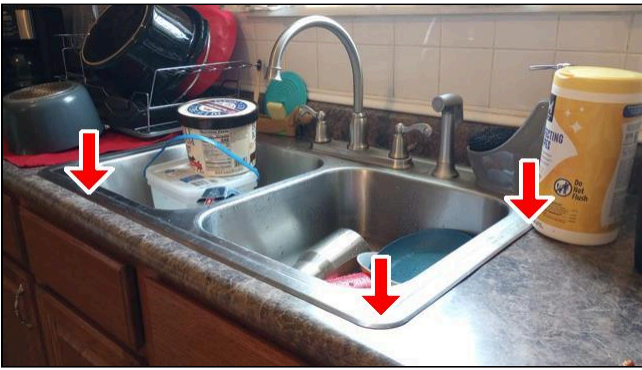
4.4 Item 4 (Picture)

(2) Resealing the counters as needed is recommended to help prevent water penetration.

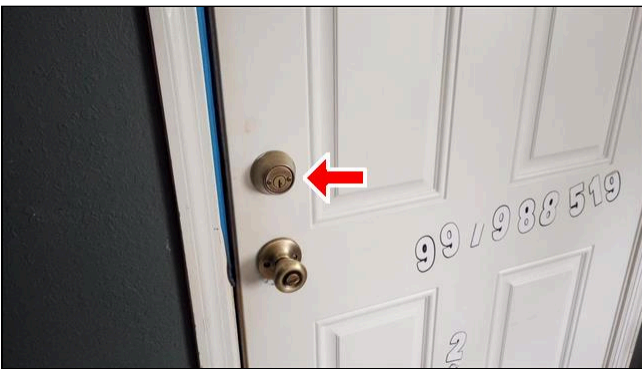
4.5 Item 1 (Picture)

4.5 (1) Installation of thumb-latch style locks wherever keyed interior locks are present is recommended to allow for proper emergency egress.

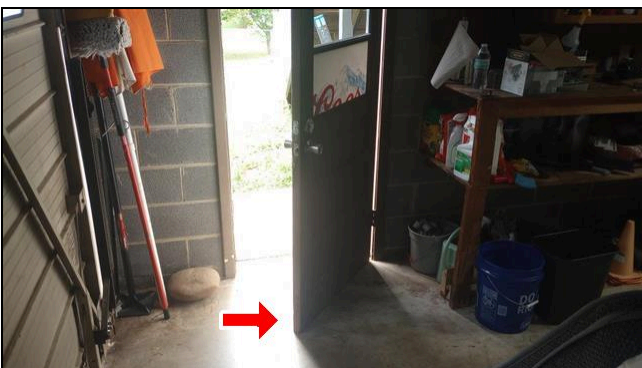
4.5 Item 2 (Picture)

(2) Readjustment of any doors that make contact with their frame/floor or do not latch as desired is recommended. Continued monitoring for any changes is also recommended, as sometimes this can indicate movement.

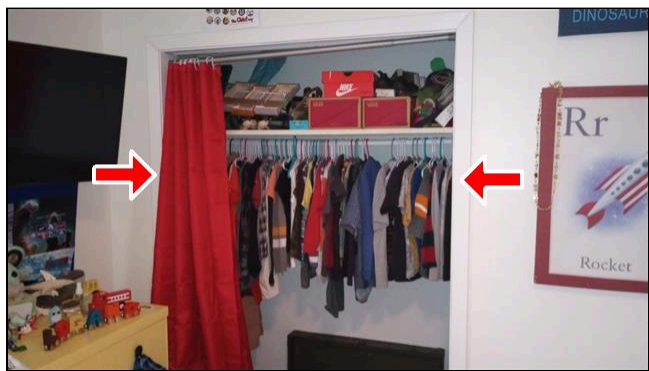
4.5 Item 3 (Picture)

(3) Replacement of any missing doors as desired is recommended.

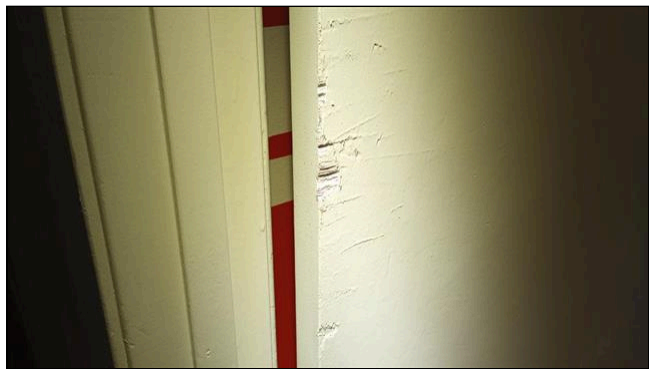
4.5 Item 4 (Picture)

(4) Minor damage was located to some of the doors. Repair or replacement as desired by a qualified person is recommended.

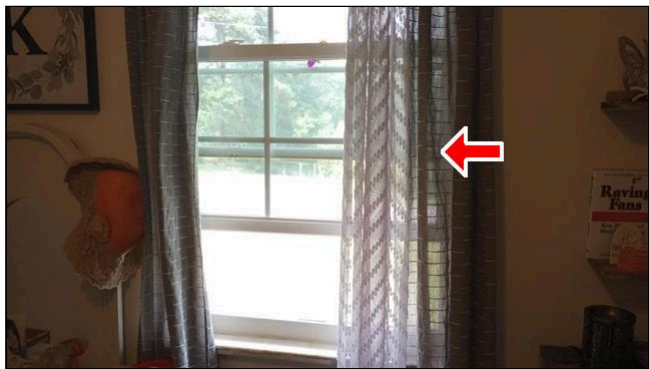
4.6 Item 2 (Picture)

4.6 Windows in the guest bedrooms appear to have a sprung rod which may make operation difficult. Further evaluation and repair as desired by a qualified person is recommended.

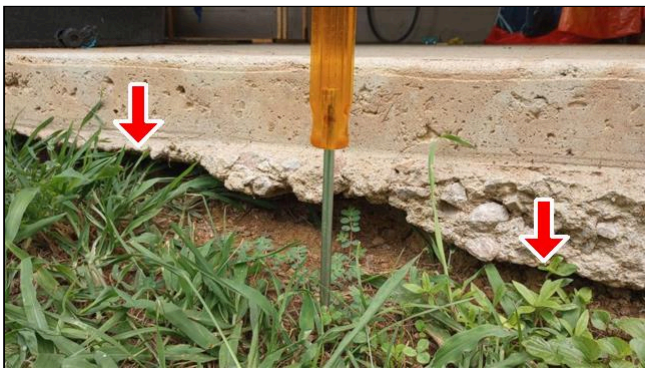
5.0 Item 4 (Picture)

(2) Soil erosion was located below the rear patio and deck footing. Correction is recommended to help prevent future damage.

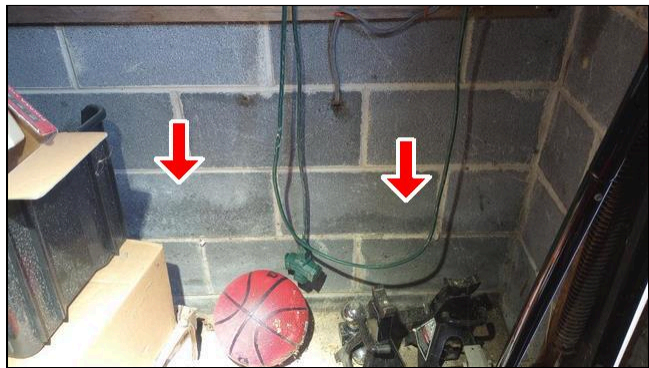
5.0 Item 5 (Picture)

(3) White efflorescence (powder substance) on the front foundation wall indicates that moisture is in contact with the masonry, and moisture was present. I recommend checking the gutters and downspout drain lines for proper operation and making sure all exterior soil slopes away from the house. A water proofing paint could be applied to the the concrete if necessary. Efflorescence is found on many homes without water intrusion occurring inside the home, but, it should alert you to the possibility that future steps may be needed.

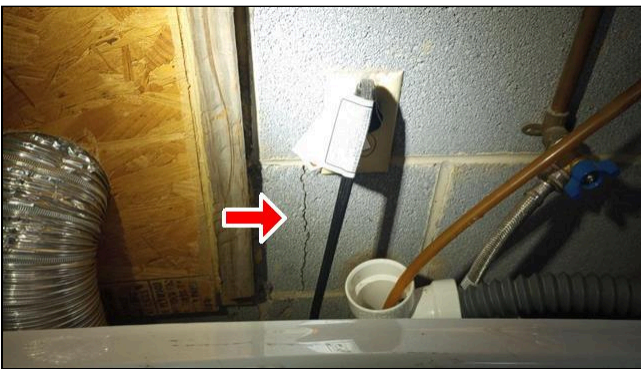
5.1 Item 1 (Picture)

5.1 A broken block was located to the structural wall located behind the washing machine (garage) which indicates possible or previous movement. Resealing and continued monitoring for any changes is recommended.

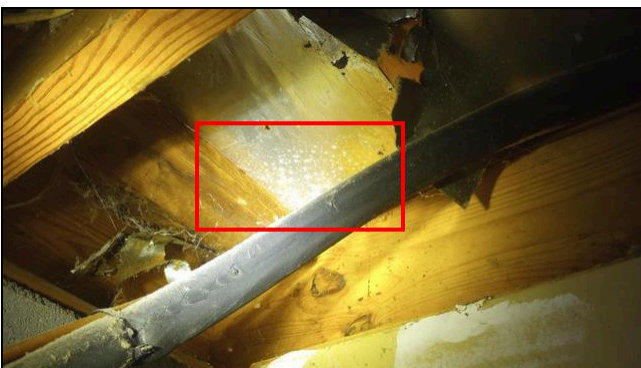
5.2 Item 1 (Picture)

5.2 (1) Light and dark-colored staining was located to the floor structure in various areas of the garage. Further evaluation and cleaning/removal if needed by a qualified person is recommended to prevent possible deterioration and possible mold growth.

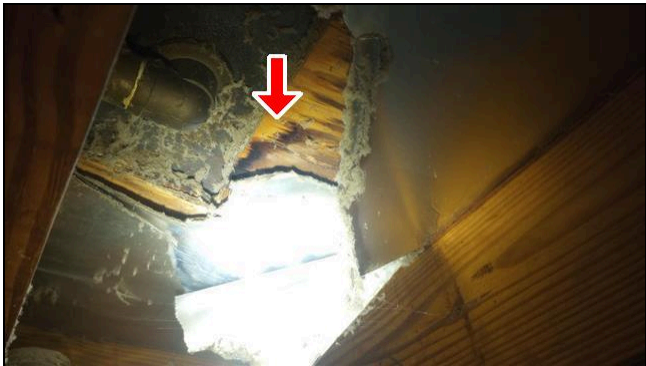
5.2 Item 7 (Picture)

(2) Staining and moisture was located to the subfloor below the guest bathtub which indicates a possible leak. Further evaluation and repair as needed by a licensed plumber is recommended.

(4) No active leaks were detected to the plumbing drainage below the sinks. Continued monitoring of any staining for any changes is recommended. Also see 5.2 regarding a stain with moisture below the bathtub. Installation of rigid style drain lines as desired is also recommended for improved drainage.

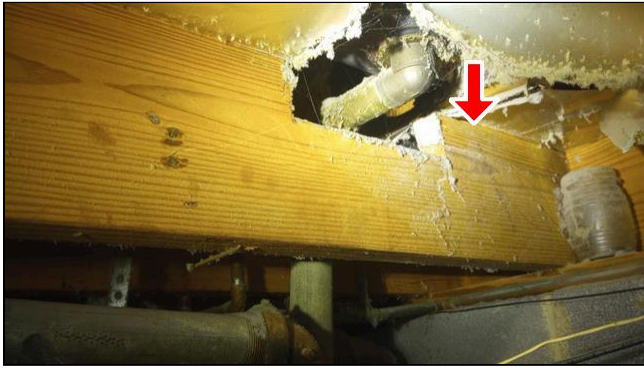
5.2 Item 9 (Picture)

(3) A broken floor joist was located adjacent to a notch below the guest bathroom. Further evaluation and repair as needed by a qualified carpenter is recommended to ensure proper structural support.

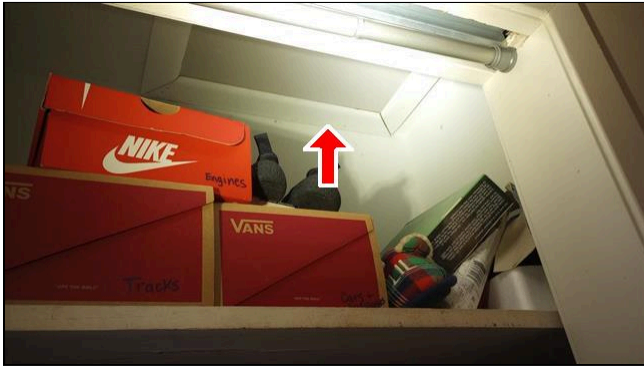
5.4 Item 1 (Picture)

5.4 The attic was inaccessible due to the installed shelf and therefore the roof structure could not be evaluated. Further evaluation as desired by a qualified person is recommended.

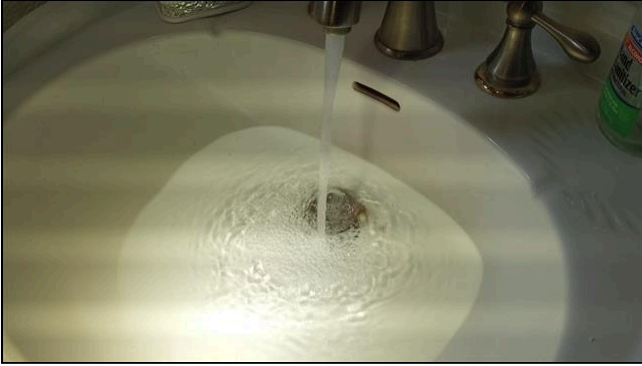
6.0 Item 1 (Picture)

6.0 (1) The sink in the master bedroom drained slowly when tested which indicates a possible clog in the drain line. Further evaluation and correction by a licensed plumber is recommended.

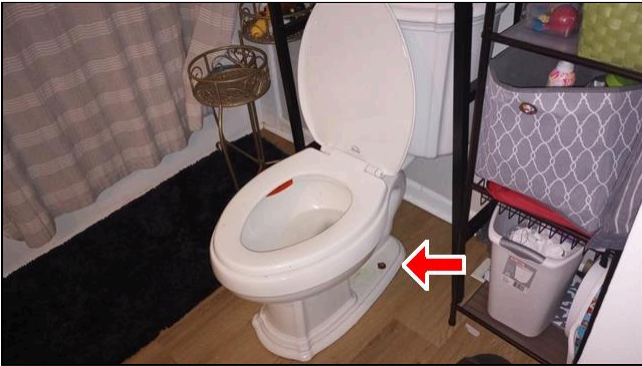
6.0 Item 2 (Picture)

(2) The toilet in the guest bathroom is loose at the floor. Repairs may involve re-setting the toilet on a new wax seal. I recommend a qualified licensed plumber repair or correct as needed.

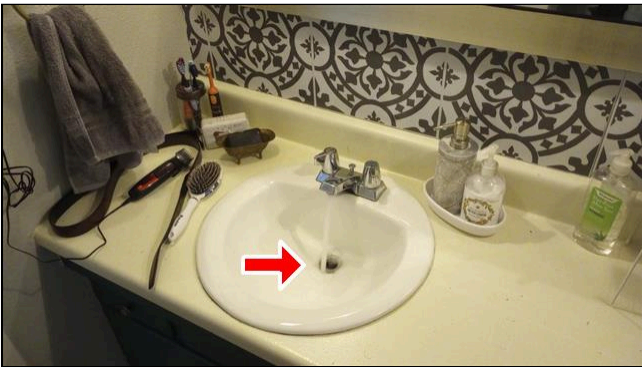
6.0 Item 3 (Picture)

(3) Replacement of any missing drain stops as desired is recommended.

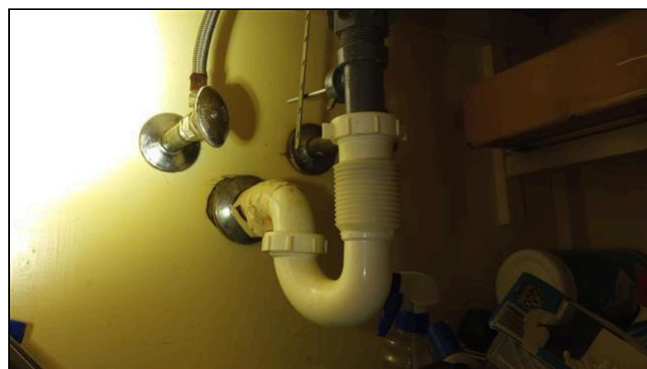
6.0 Item 13 (Picture)

(5) A drain line below the guest bathroom sink has been taped for an unknown reason. Continued monitoring for any changes is recommended. This area was not fully visible.

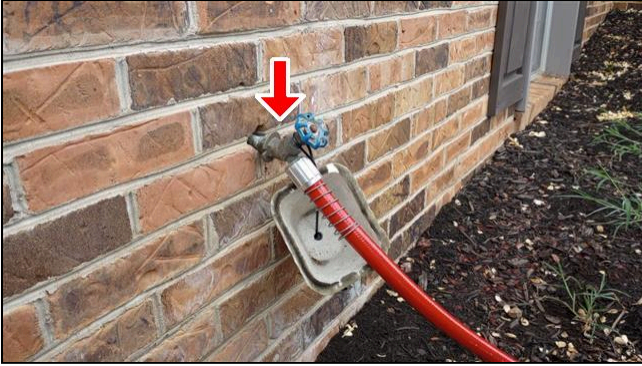
6.1 Item 3 (Picture)

(2) Re-securing any loose water supply lines as desired by a qualified person is recommended to help prevent leaks.

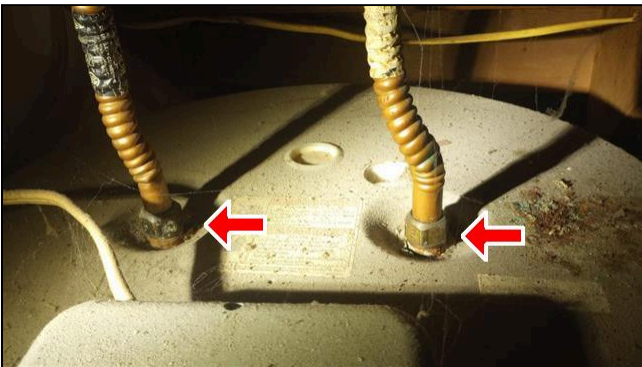
6.1 Item 4 (Picture)

(3) Dissimilar metals appear to be in contact at the water heater which can facilitate corrosion and leaks, and minor corrosion was located. Installation of dielectric unions as desired by a licensed plumber is recommended.

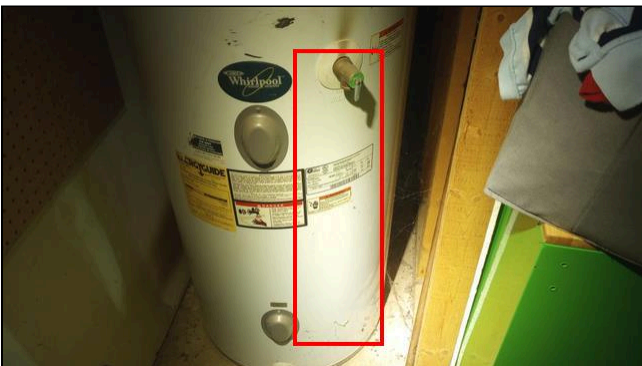
6.2 Item 1 (Picture)

6.2 (1) The TPR valve on water heater needs a 3/4" rigid pipe (not flex) to extend to the exterior and not run uphill for safety. (PVC must be rated for approved hot water use). I recommend repairs by a licensed plumbing contractor.

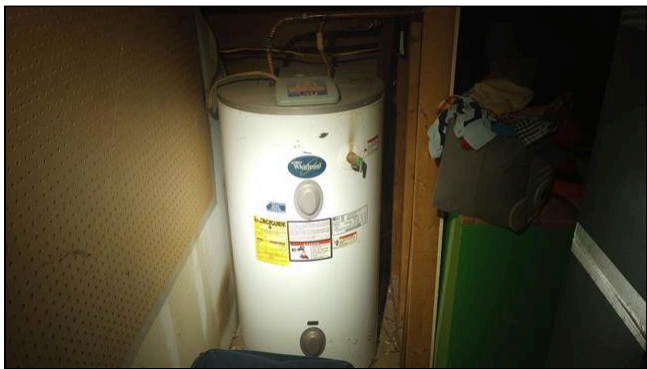
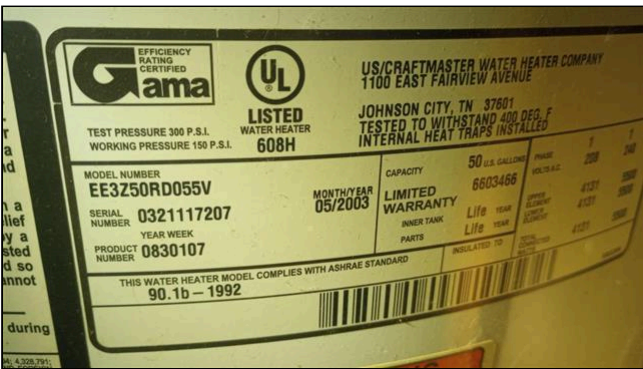
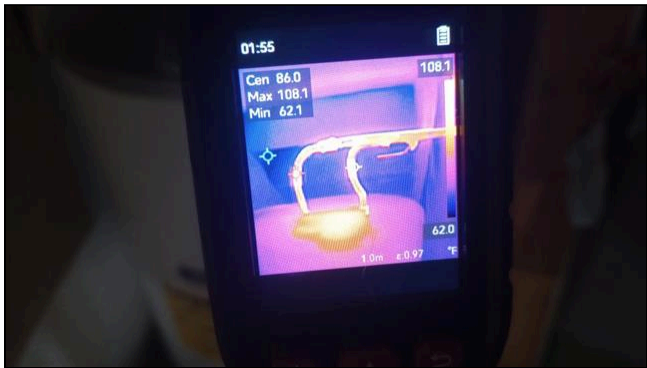
(2) The water heater is located in the garage and appears operational.

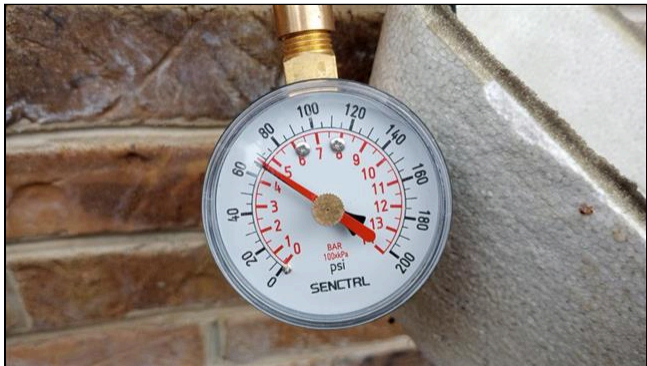
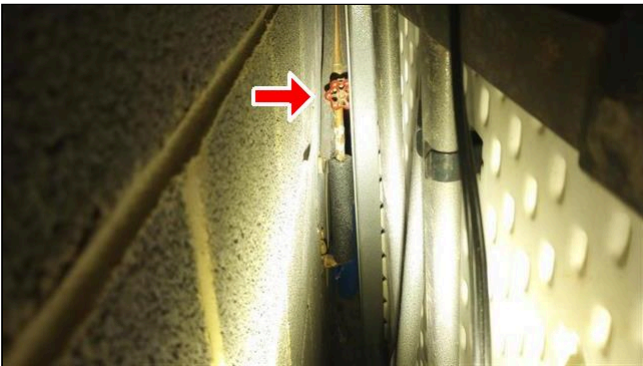
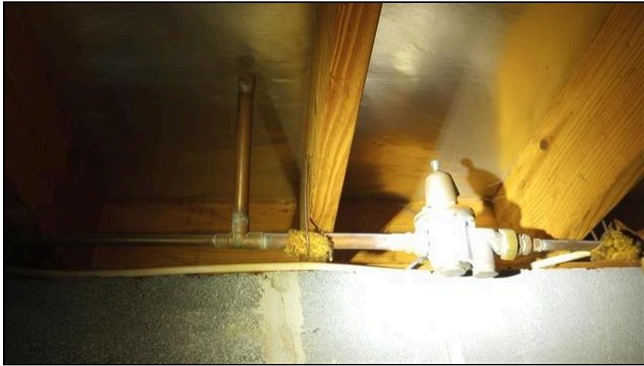
6.3 The main water shut off appears to be the red knob at the front wall of the garage interior, however it was not accessible due to the occupants belongings (65 PSI tested at the front hose bib). A nearby water pressure regulator was also discovered - this is for your information only. Insulating any exposed water lines in the garage as desired is also recommended to help prevent freezing.

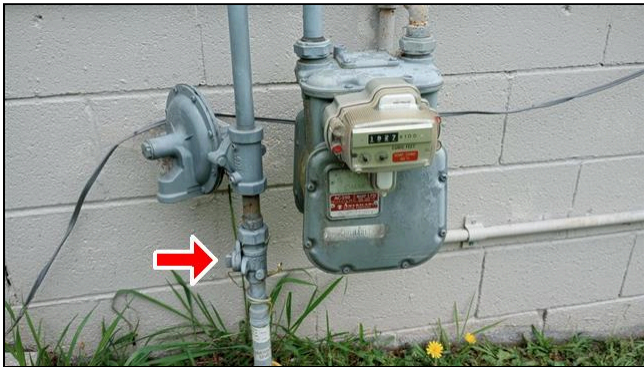
6.5 Item 1 (Picture)

6.5 The main gas shutoff is located at the meter on the northern exterior.

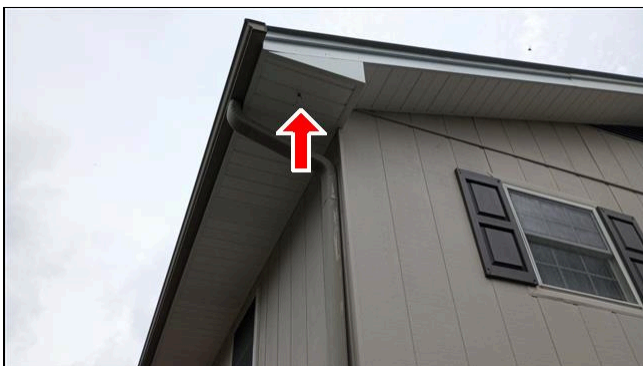
7.2 Item 1 (Picture)

7.2 (1) Exposed wires were located at the rear soffit which is a possible shock and fire hazard, however they could not be tested for power due to the location. Further evaluation and repair as needed by a licensed electrician is recommended.

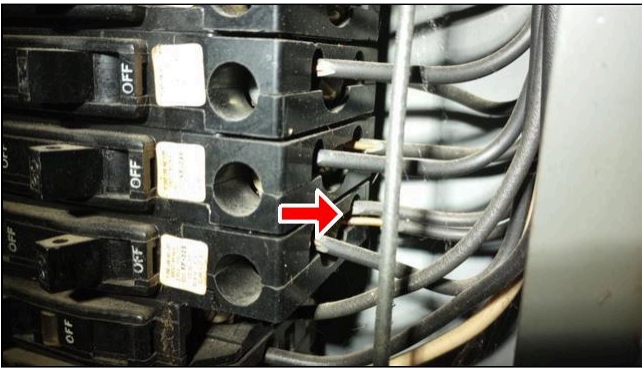
7.2 Item 2 (Picture)

(2) A double-tapped breaker was located in the electrical panel which may loosen connections and cause

overheating. Further evaluation and repair by a licensed electrician is recommended.

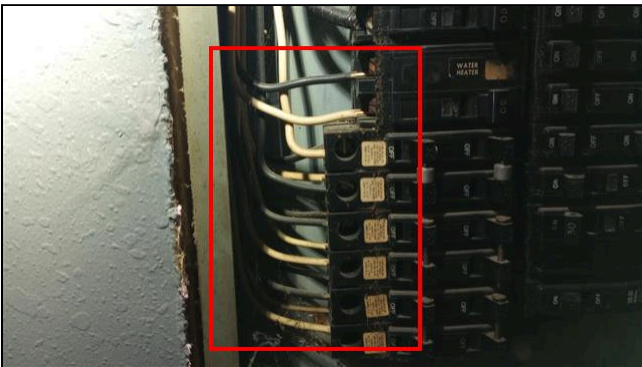
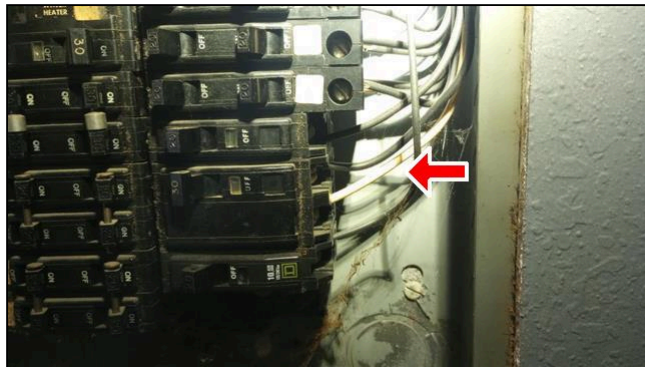
(3) Unmarked white wires, which are normally reserved for neutral conductors, were located going to breakers. Sometimes (but not always) the electrician fails to re-identify the wires with black tape or a marker. Although this is not necessarily a hazardous condition further evaluation by a licensed electrician is recommended.

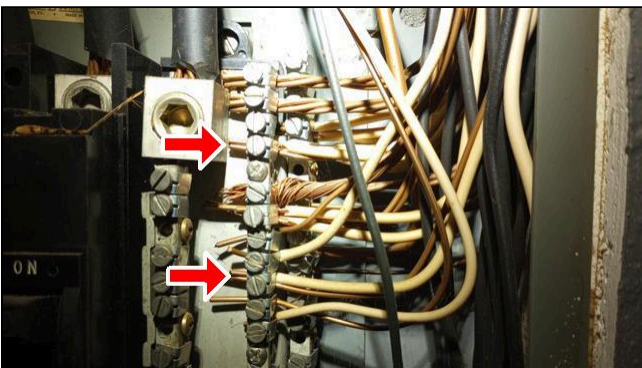
7.2 Item 5 (Picture)

(4) A double-tapped bus bar was located in the electrical panel which may loosen connections. Further evaluation and repair by a licensed electrician is recommended for improved safety.

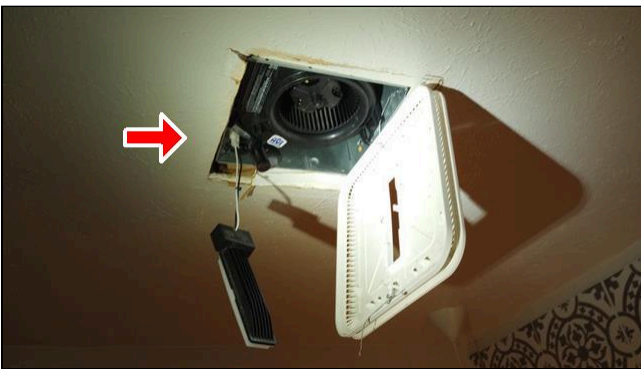
7.3 Item 1 (Picture)

7.3 (1) The bathroom light and vent fan was disconnected upon arrival and did not operate when using the adjacent switches. Further evaluation and repair as needed by a licensed electrician is recommended.

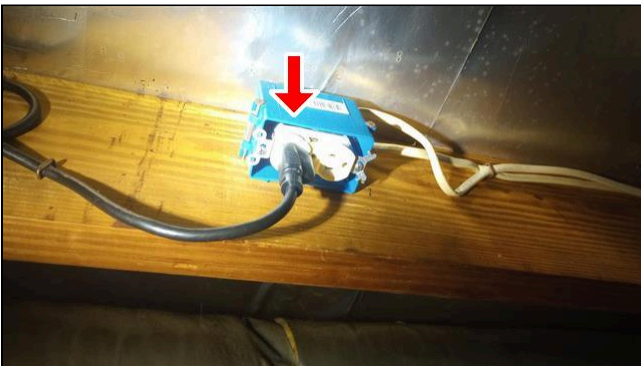
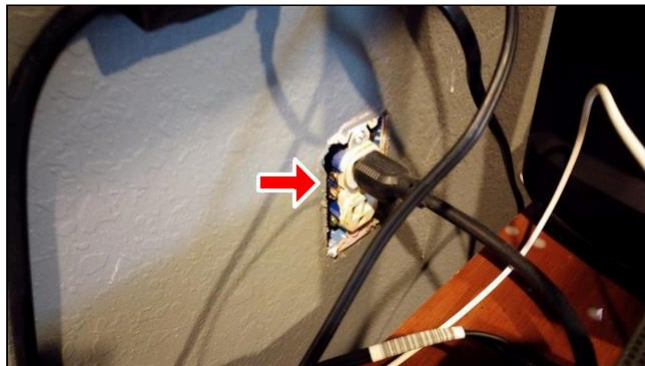
(2) Repair or replacement of any damaged or missing cover plates is recommended for improved safety.

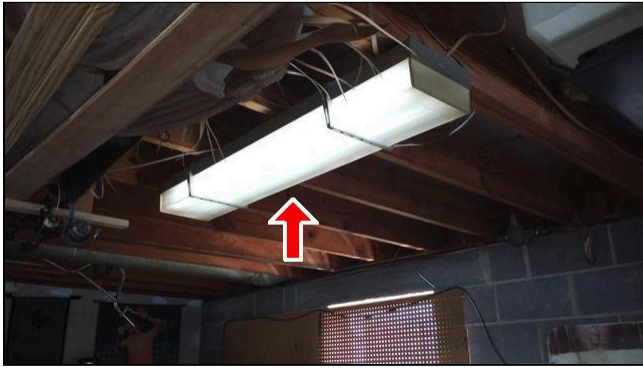
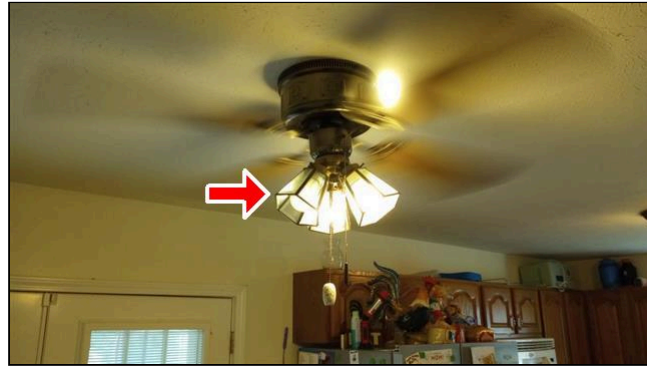
(3) Some light fixtures did not fully illuminate when tested. Bulb replacement is recommended before further evaluation is needed.

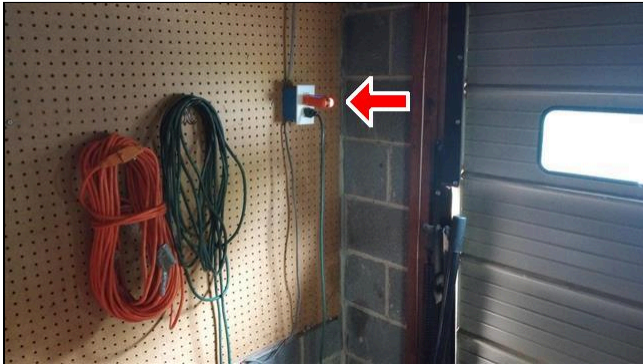
7.4 Item 1 (Picture)

7.4 A receptacle at the garage has reverse polarity which is a shock hazard. Further evaluation and repair by a licensed electrician is recommended.

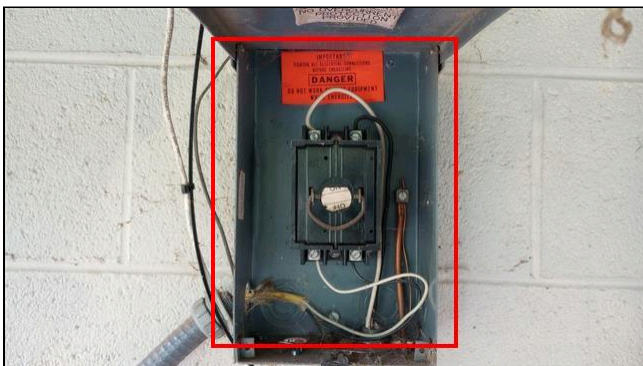
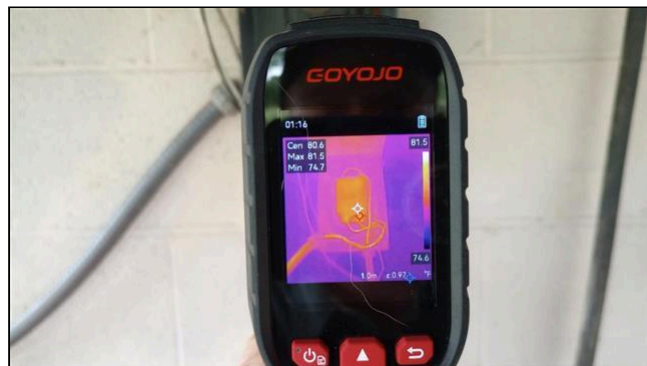
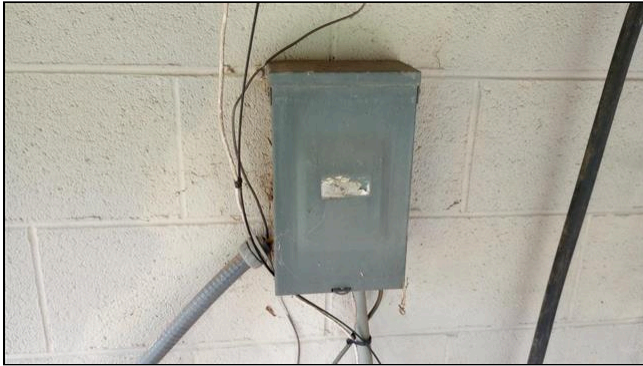
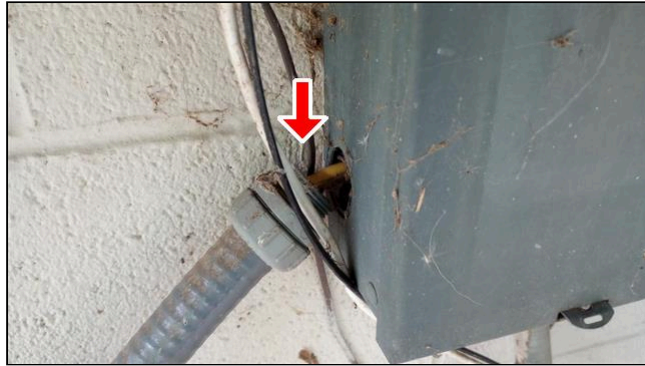
7.6 (1) A fused sub-panel was located at the rear exterior below the deck. Installation of knock-out filler plates and resealing the loose conduit by a licensed electrician is recommended for improved safety.

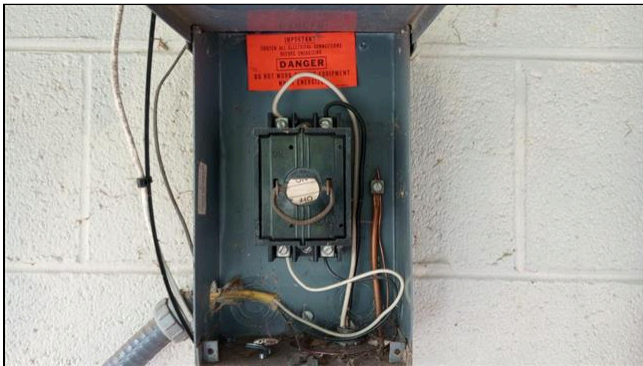
7.6 Item 6 (Picture)

(2) Installation of a dead front cover at the rear electrical panel is recommended for improved safety.

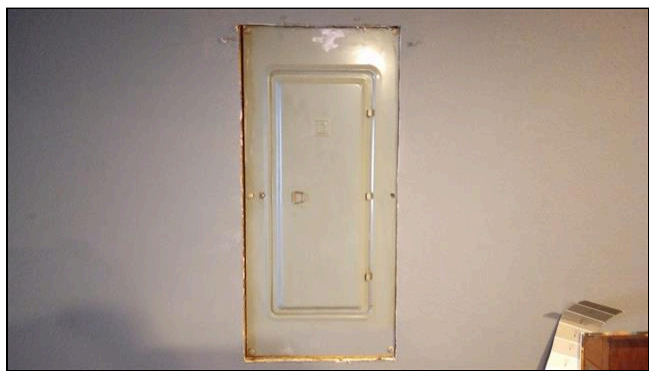
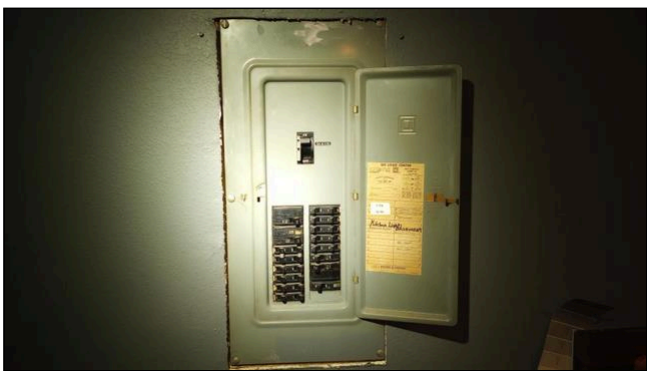
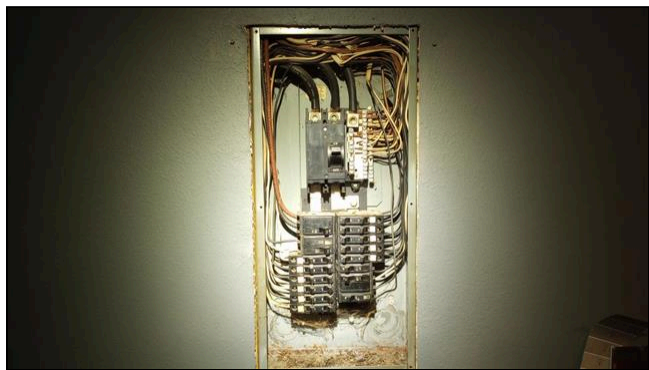
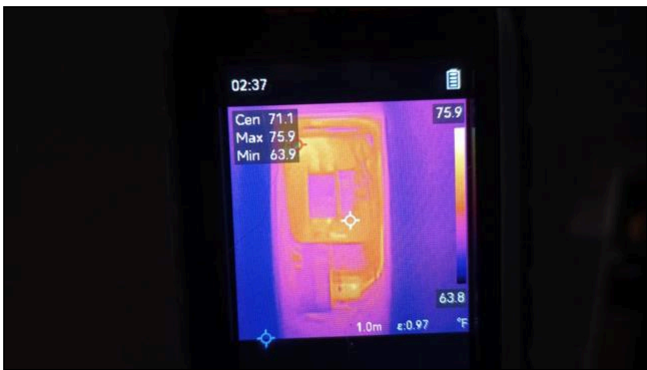
(3) The main electrical panel is located at the downstairs living space.

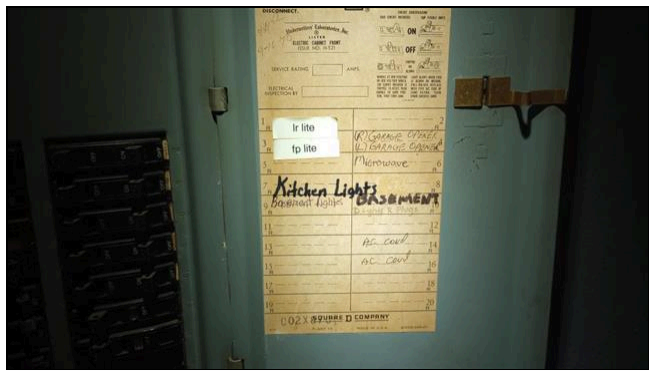
7.6 Item 11 (Picture)

(4) Labeling each breaker per room or appliance is recommended for improved safety.

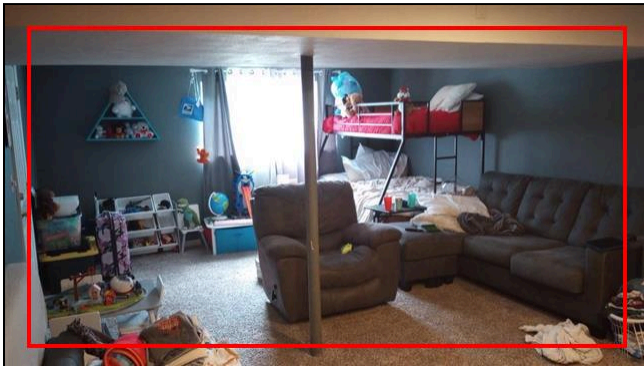
7.7 Item 1 (Picture)

7.7 (1) A smoke alarm was not located downstairs. Recommend installing according to the manufacturer's instructions. Inquiring with the State Fire Marshall's office is also recommended to see about receiving a 'free' alarm (the State made me include that last part).

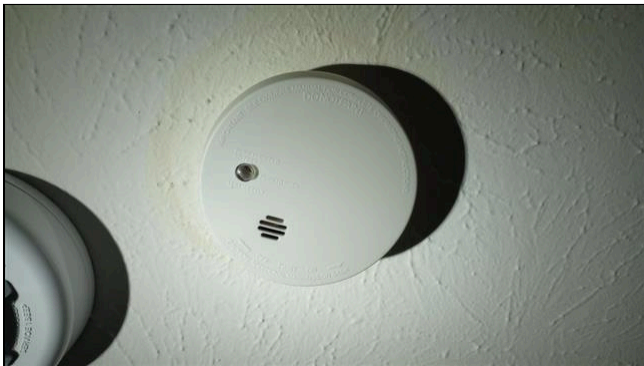
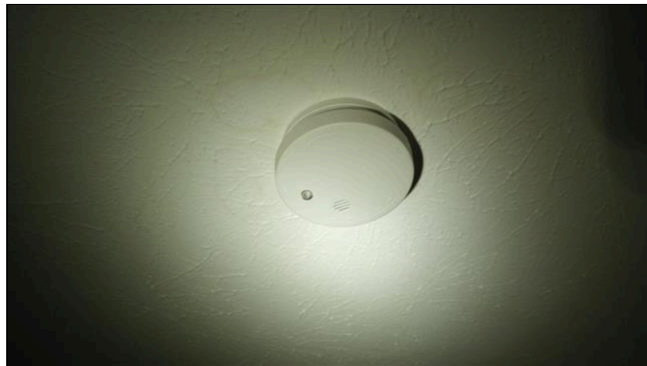
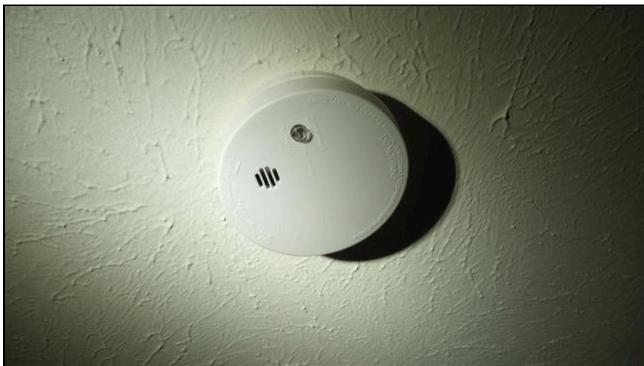
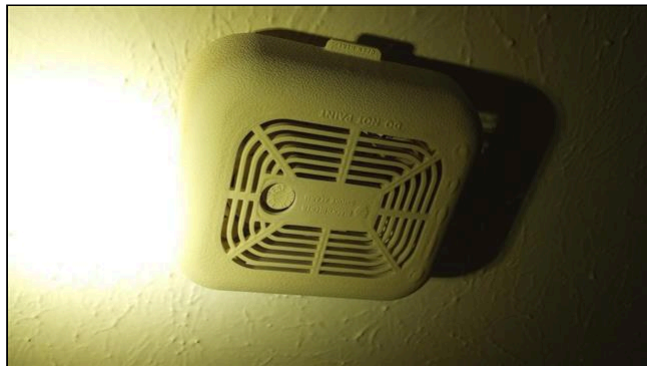
(2) Battery replacement in all alarms is recommended upon obtaining occupancy.

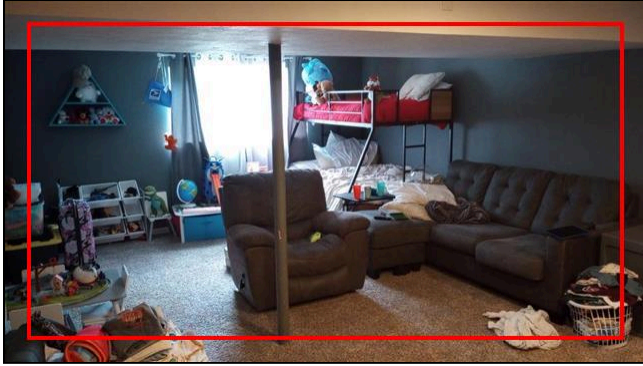
7.8 Item 1 (Picture)

7.8 (1) A carbon monoxide detector was not located downstairs. Recommend installing according to the manufacturer's instructions.
