ACE HOME INSPECTION

INSPECTION REPORT
124 Main Street
Knoxville Tennessee 37918

INSPECTED BY
Dave Ellis,
License No. 2885
Ace Home
Inspection

INSPECTION DATE
📅 3/6/2024
🕒 12:30 PM

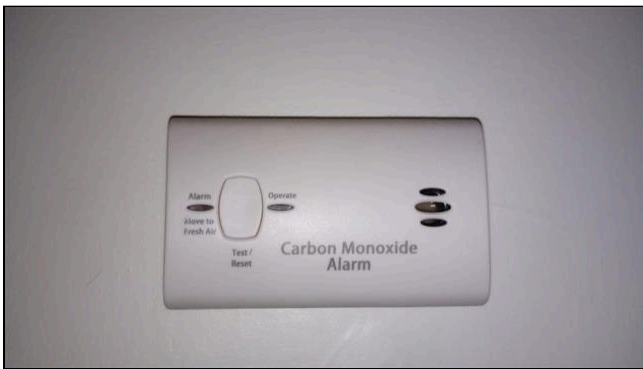
7.8 Item 2 (Picture)

(2) Battery replacement in all alarms is recommended upon obtaining occupancy.

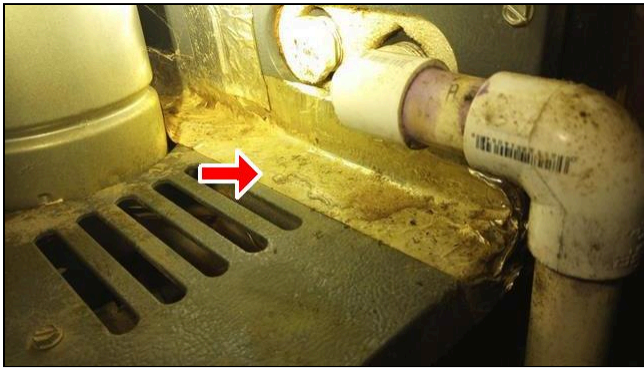
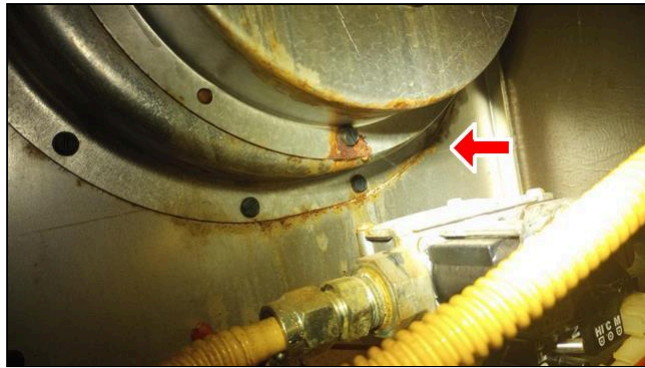
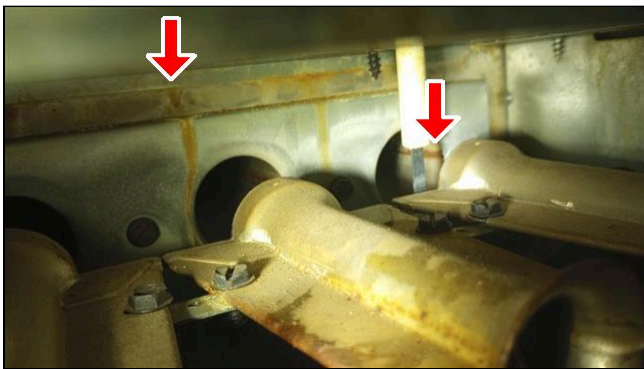
8.0 (1) Dripping water and minor rust was located on and in the furnace (including the burn chamber) which indicates a possible leak. Further evaluation, repair and regular servicing by a licensed HVAC technician is recommended.

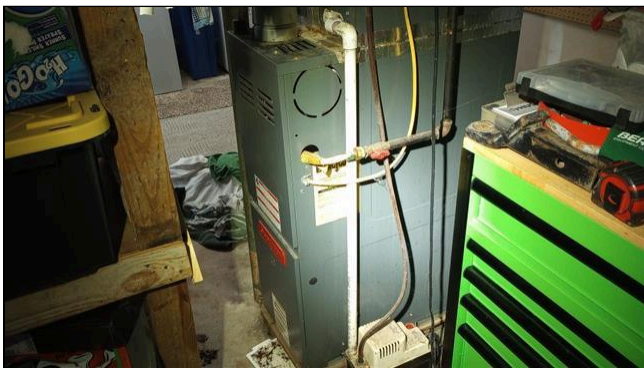
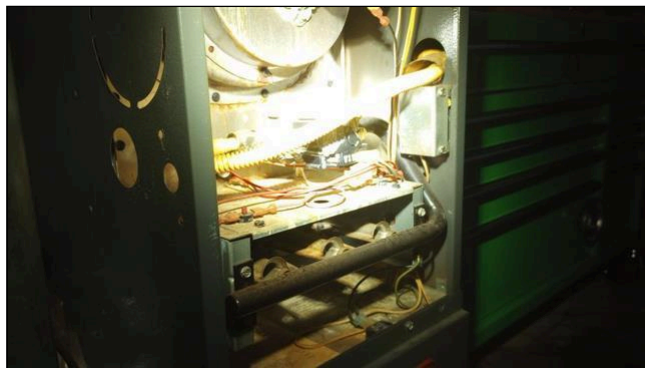
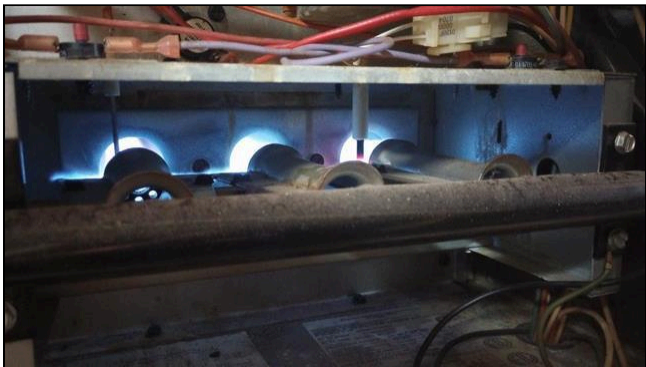
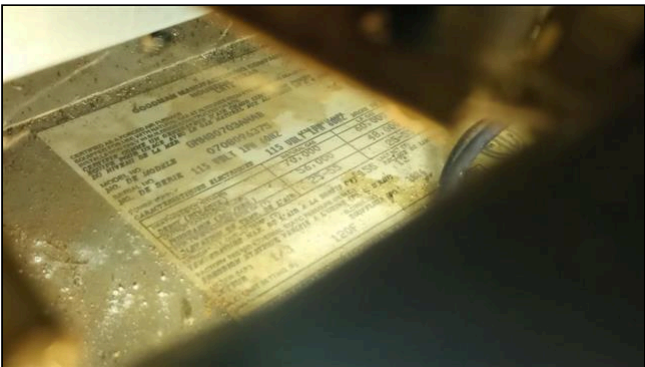
(2) The furnace is located in the garage and appears operational. Providing proper clearance in front of the unit is recommended to allow for servicing as needed.

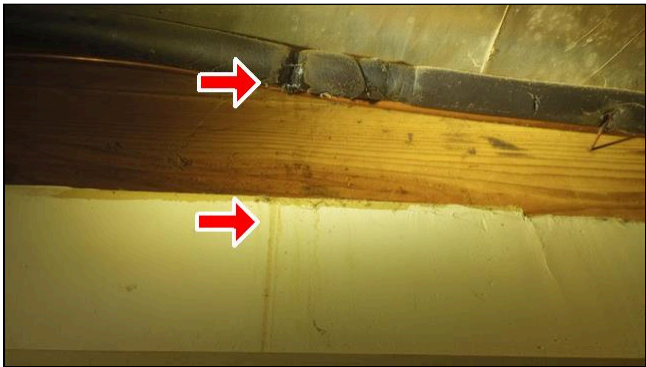
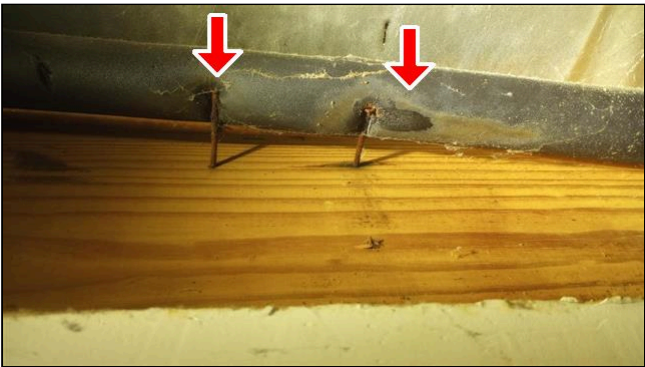
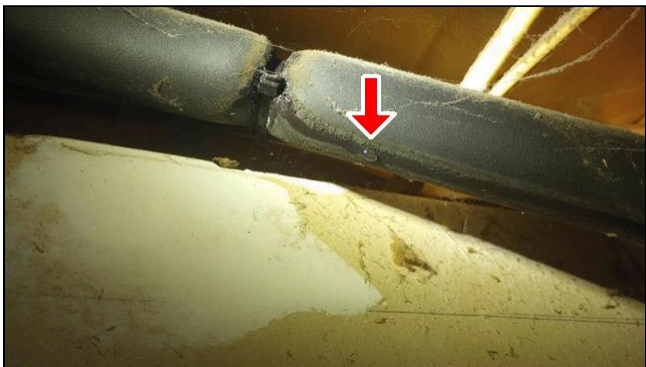
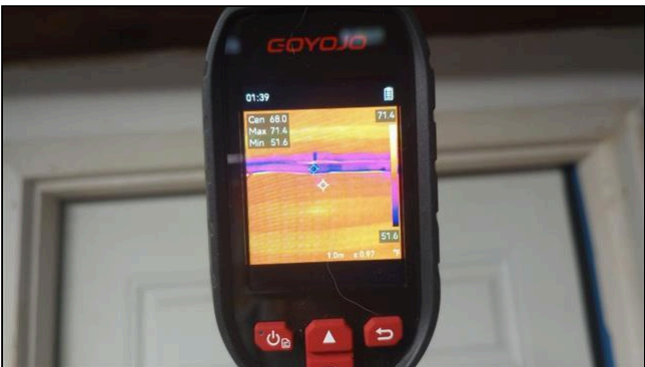
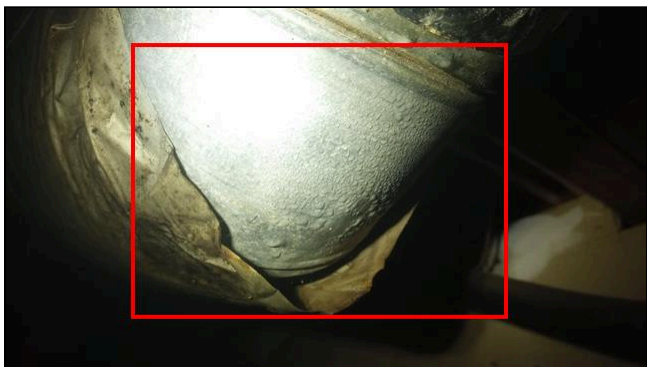
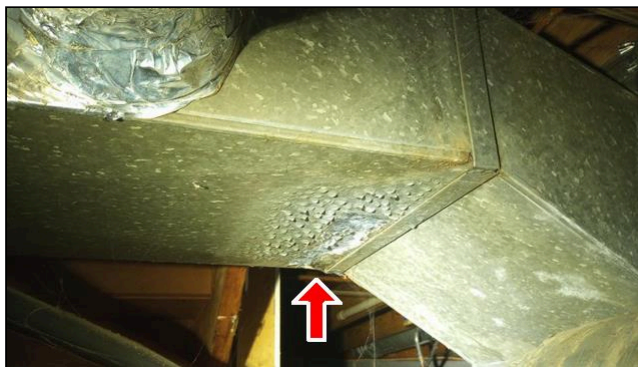
8.2 (1) Significant condensation buildup and dripping water was located along the refrigerant line set and ductwork in various areas. Further evaluation and repair as needed by a licensed HVAC technician is recommended.

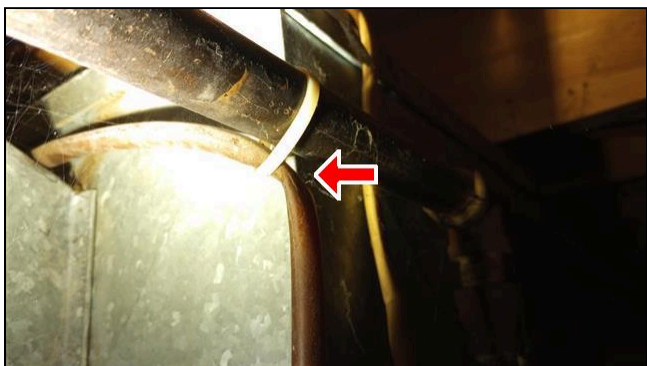
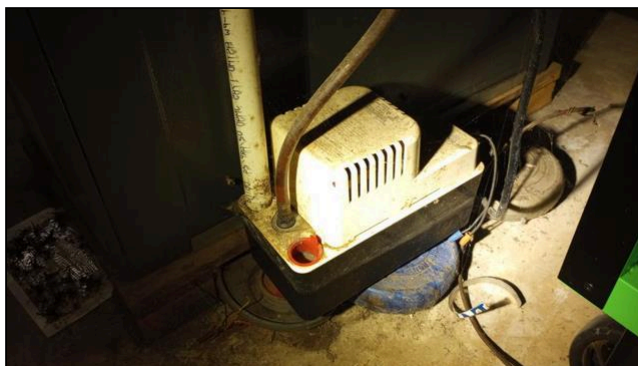
(2) The condensate drain line appears to be kinked. Correction is recommended to allow for proper drainage.

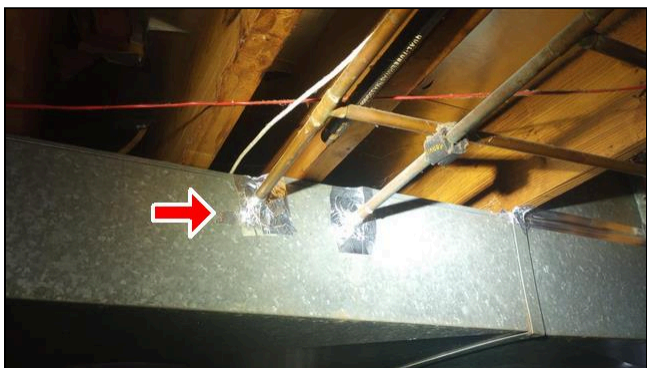
8.2 Item 9 (Picture)

(3) A section of ductwork appears to have been compromised to allow water lines to go through. Further evaluation and repair as desired by a licensed HVAC contractor is recommended.

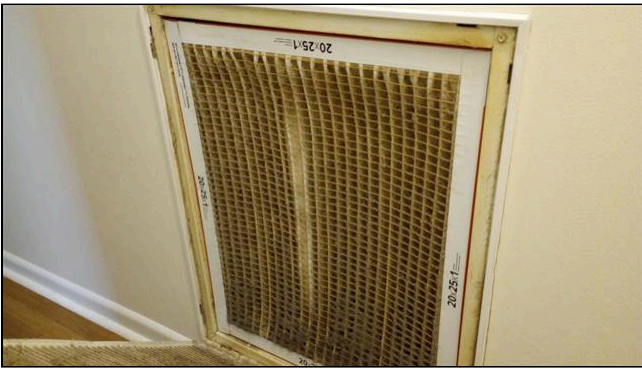
8.2 Item 10 (Picture)

(4) Replacement of the dirty filter at the return is recommended per regular maintenance.

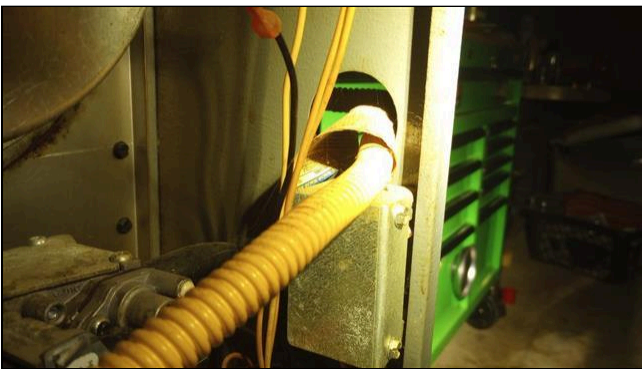
8.2 Item 11 (Picture)

(5) Installation of a rigid gas line where it currently penetrates the furnace jacket by a licensed HVAC technician is recommended for improved safety.

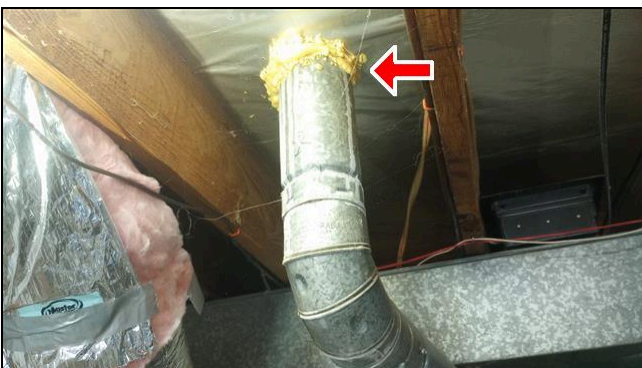
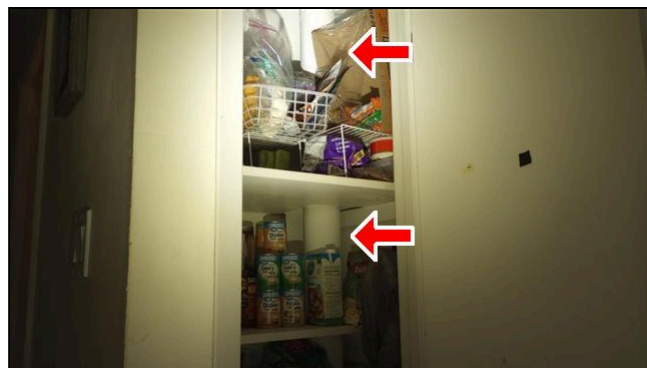
8.4 The furnace flue does not appear to have proper clearance from combustibles and may be in contact with stored items in the kitchen pantry. Providing proper clearance as needed by a qualified person is recommended.

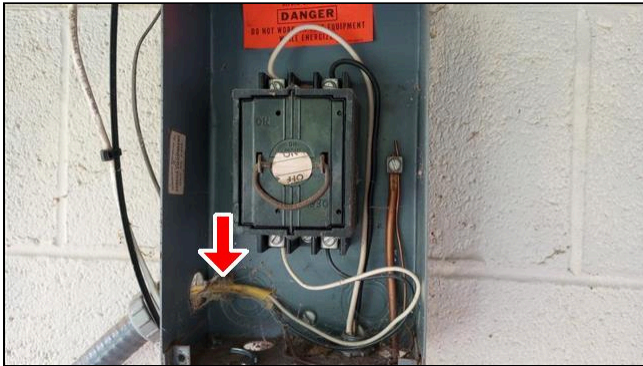
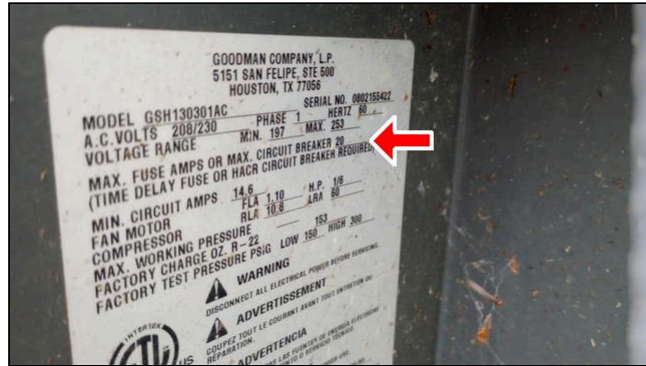
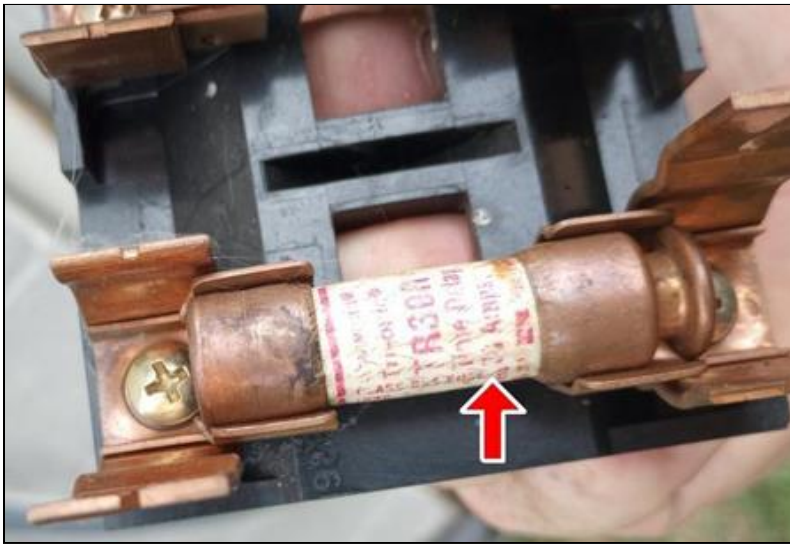
(5) Also see 8.2 regarding improper fuse size at the HVAC disconnect.

8.6 (1) Wires going to a 30 amp fuse (at the HVAC disconnect) do not appear large enough to blow the fuse if needed which can cause overheating, and the fuse appears to be oversized for the condenser which can prevent proper operation. Further evaluation and repair as needed by a licensed electrician or HVAC technician is recommended.

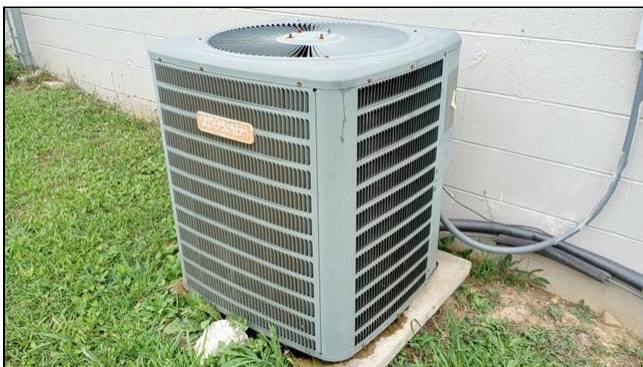
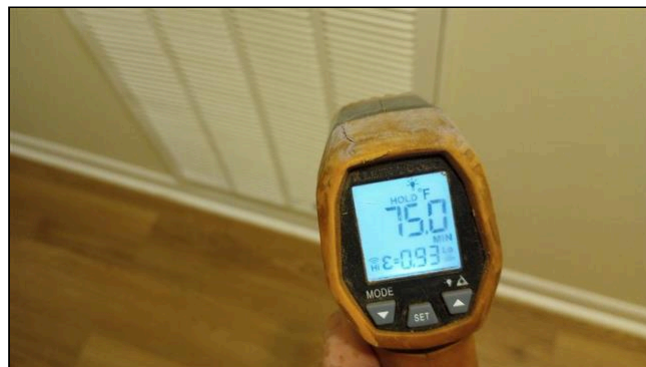
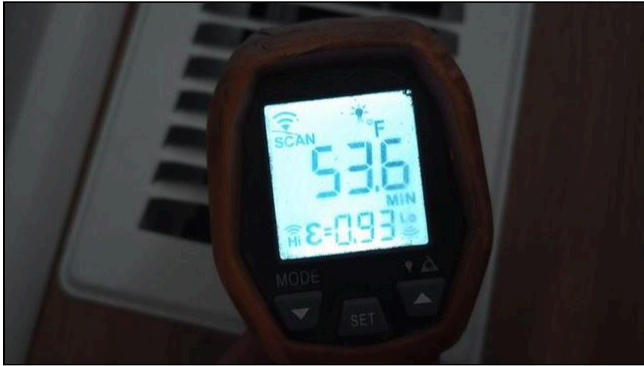
(2) The ambient air test was performed by using thermometers on the air handler of the air conditioner to determine if the difference in temperatures of the supply and return air are at least 20 degrees which indicates that the unit is cooling as intended. The supply air temperature on your system read 53 degrees, and the return air temperature was 75 degrees. This indicates the range in temperature drop is normal.

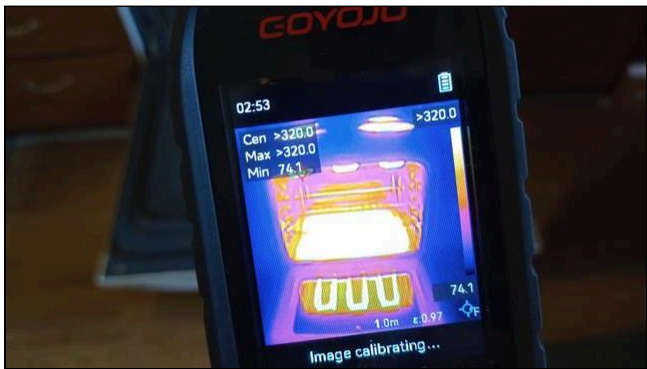
10.2 Item 1 (Picture)

10.2 The oven and cooktop appear operational.

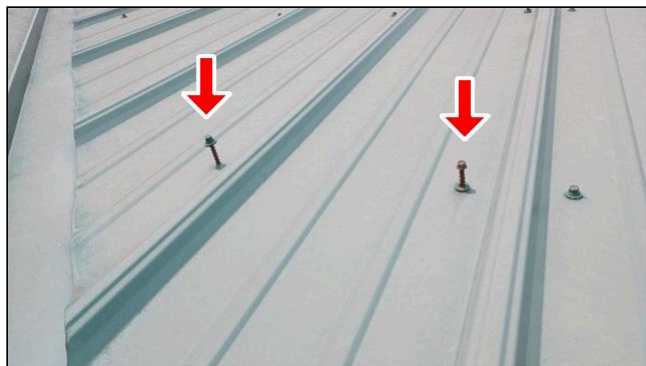
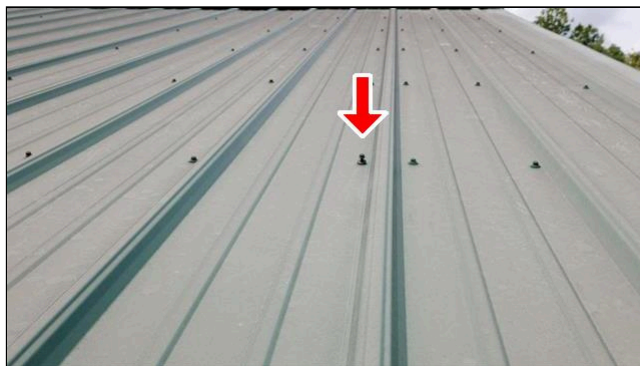
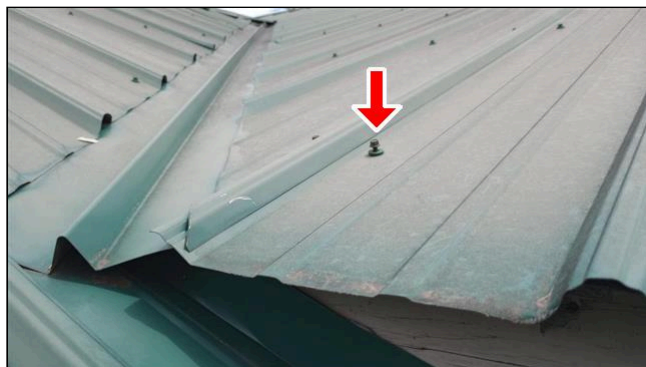
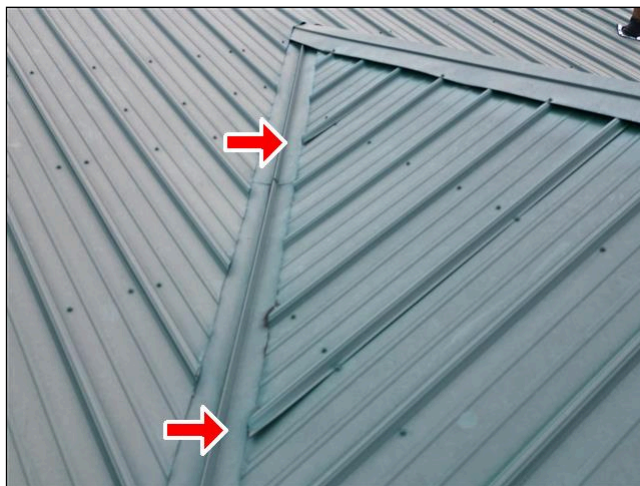
(1) Loose screws and minor separation was located in various areas which can allow water intrusion. Further evaluation and repair by a licensed roofer is recommended.

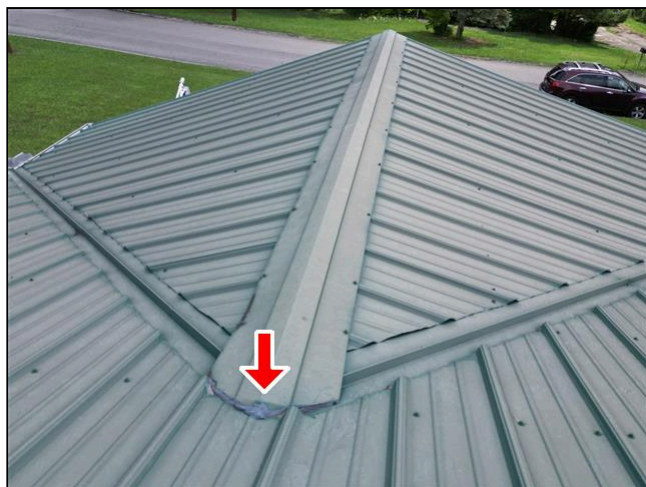
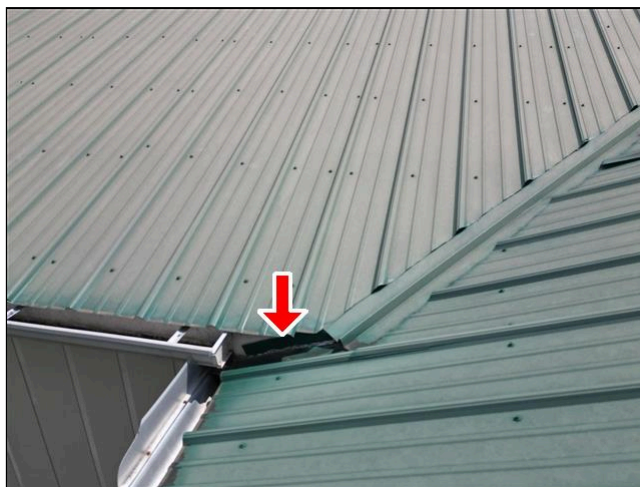
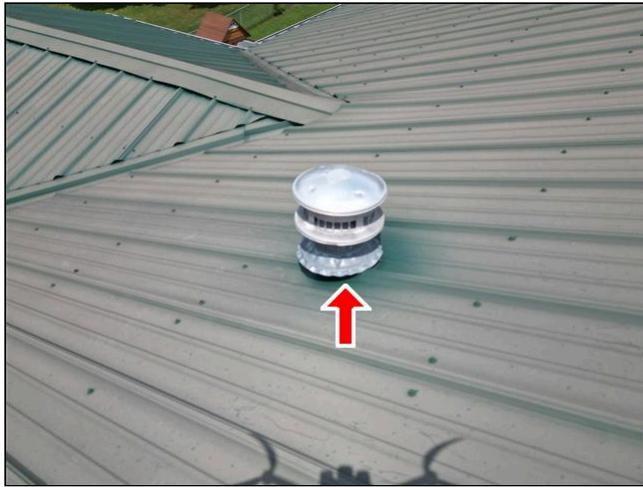
(4) Sealant is being used in various areas which has a tendency to fail. Continued monitoring of these areas and below for any changes is recommended.

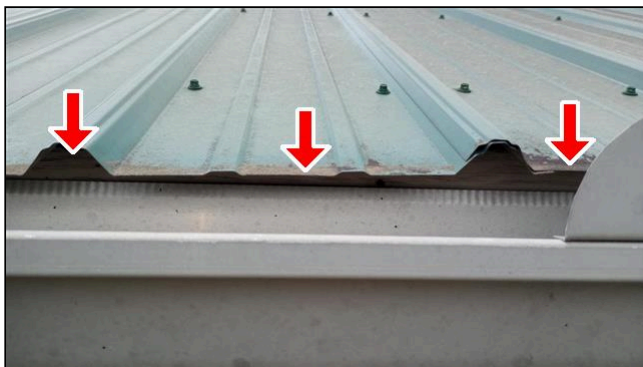
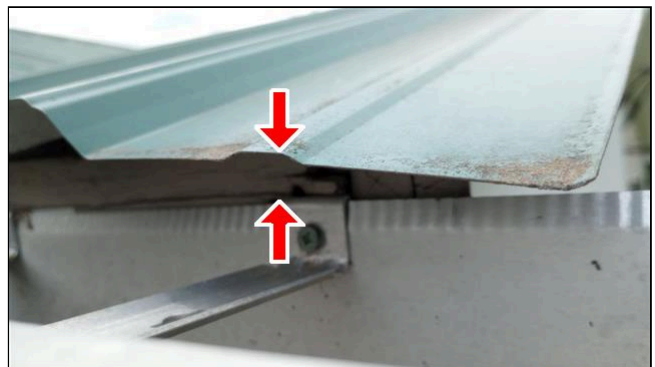
(1) Drip edge flashing is missing at the eaves which may allow water penetration and contribute to deterioration. Correction by a qualified person is recommended.

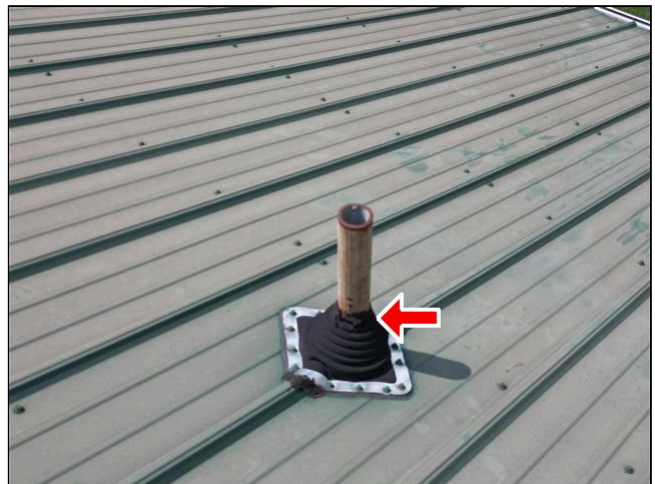
1.2 Item 2 (Picture)

Failed seals were located at some of the roof penetrations which may allow water intrusion. Repair as needed by a licensed roofer is recommended.

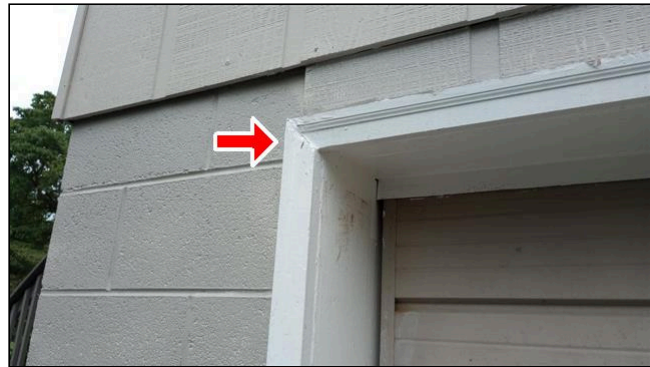
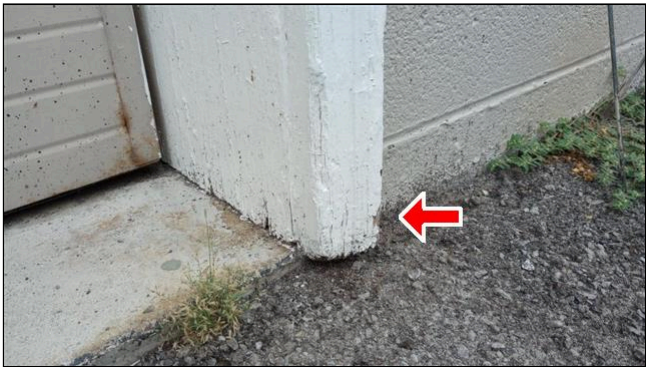
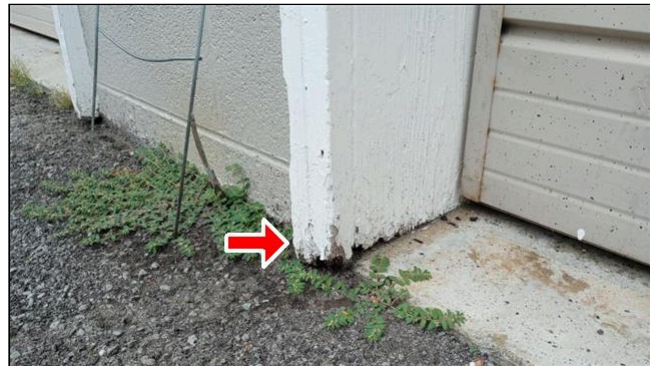
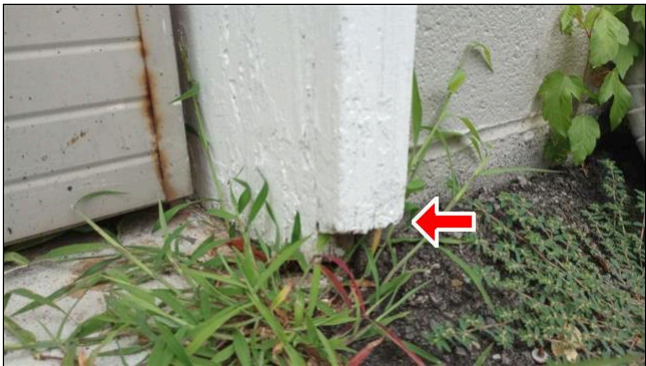
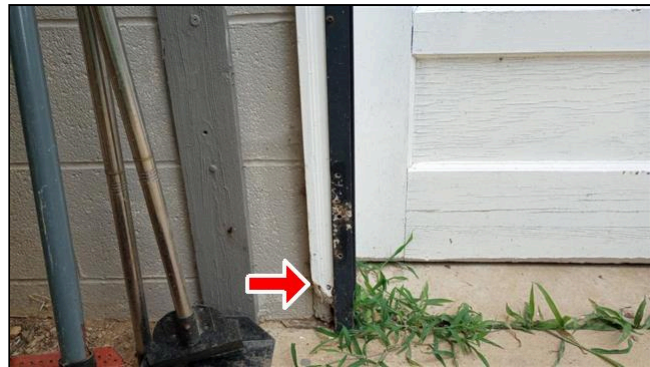
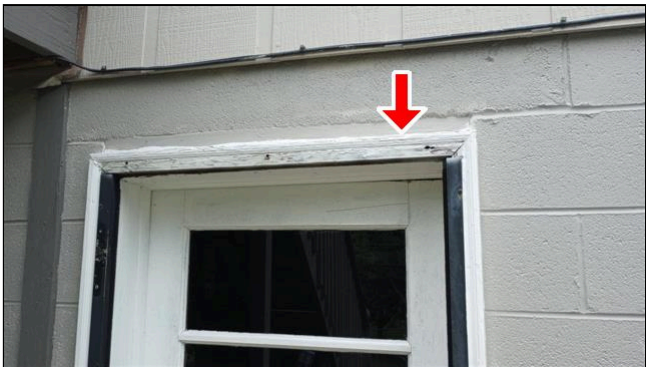
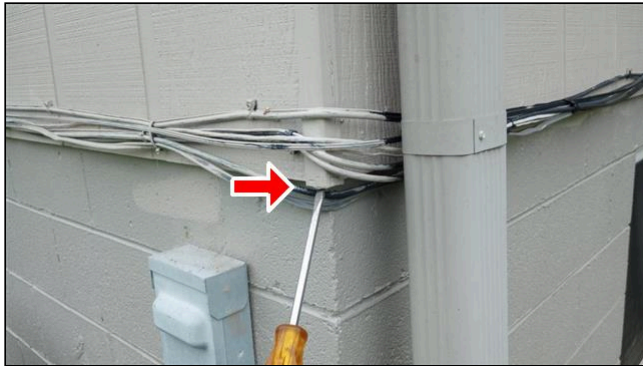
(2) Moisture damage is located to trim at the southern and rear exterior. Repair by a qualified person is recommended.

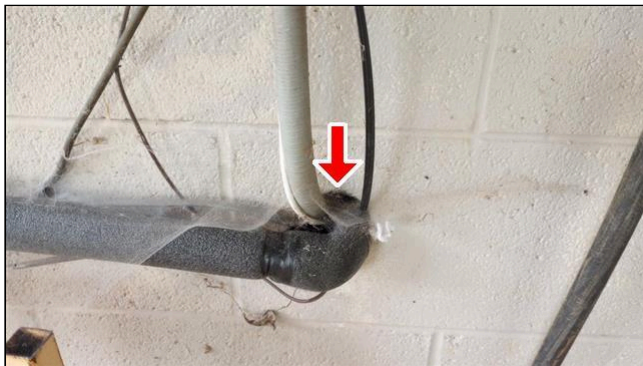
2.0 Item 9 (Picture)

(3) A gap is located in the annular space where the refrigerant lineset enters the building which may allow pest intrusion. Correction by a qualified person is recommended.

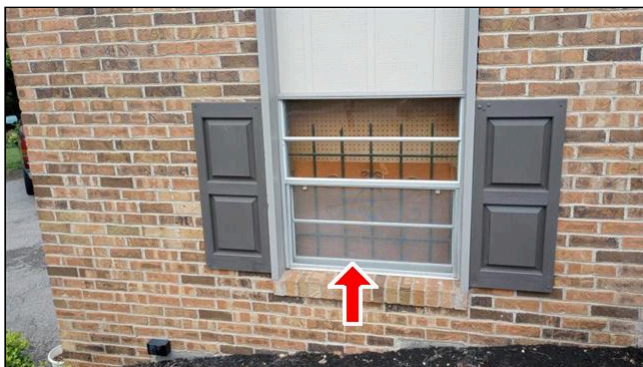
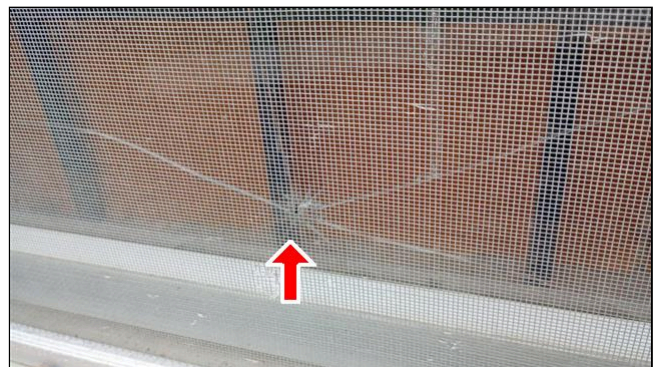
(1) A broken window pane was located at the front exterior. Repair by a qualified person is recommended.

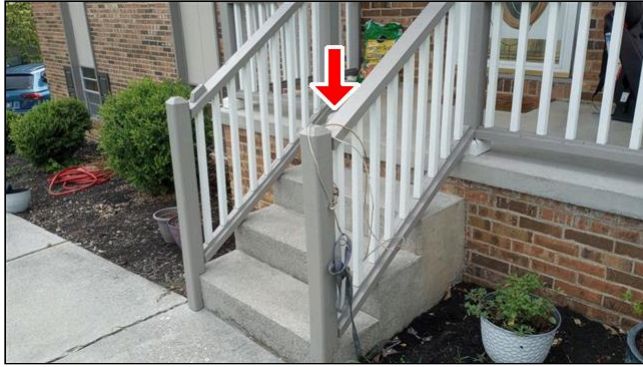
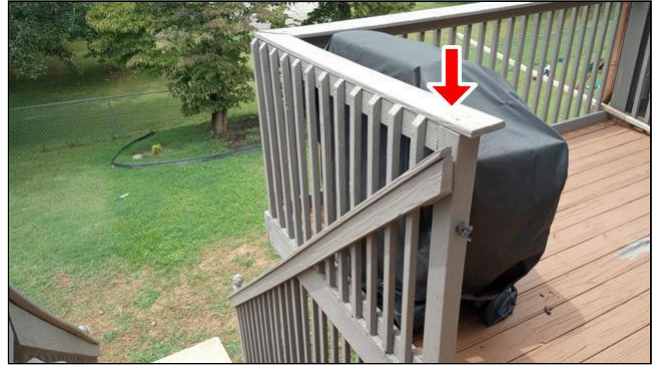
(1) Re-securing the loose handrails by a qualified person is recommended for improved safety.

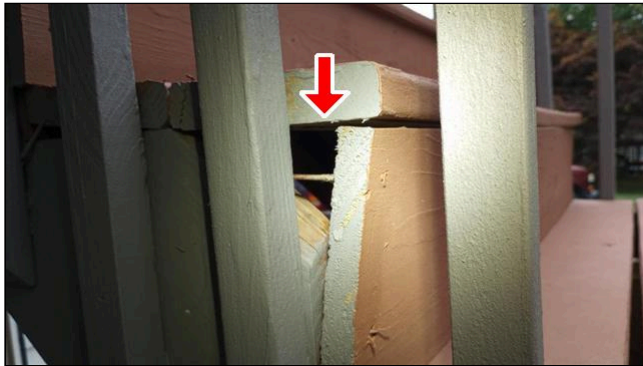
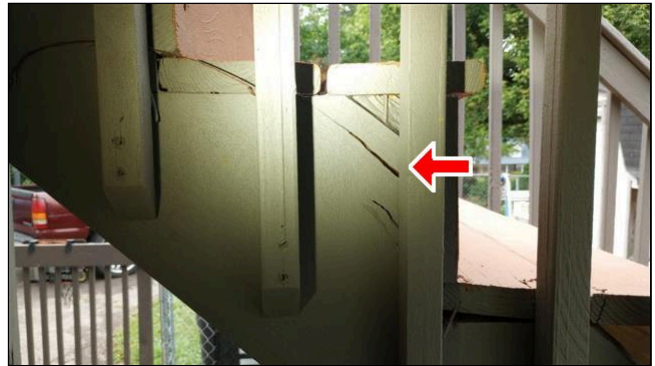
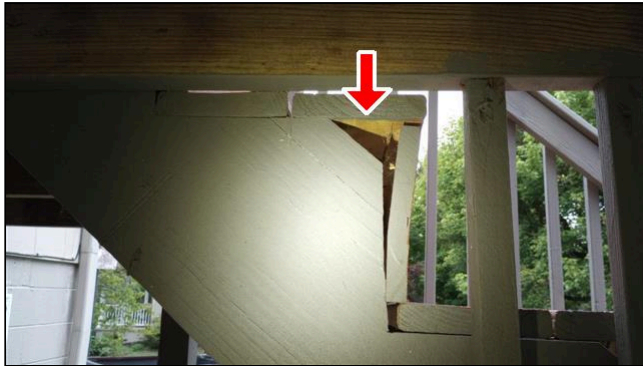
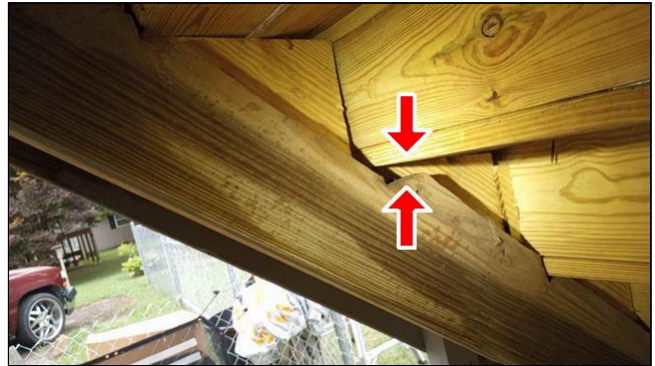
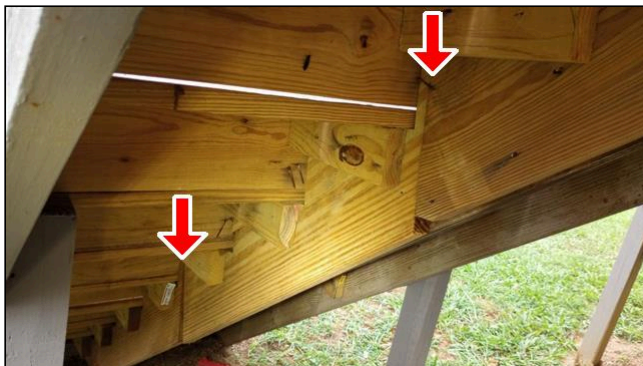
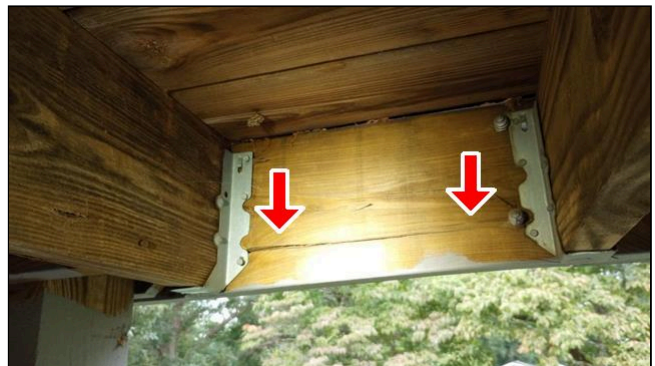
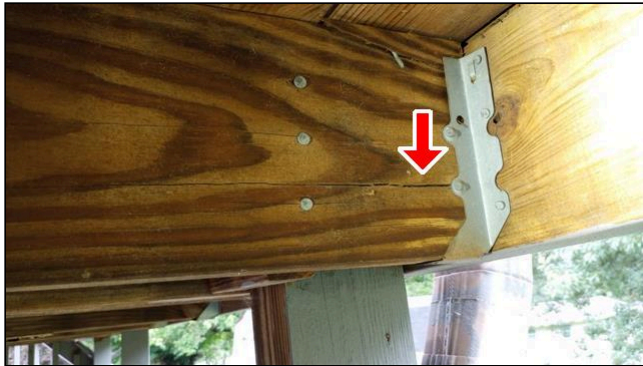
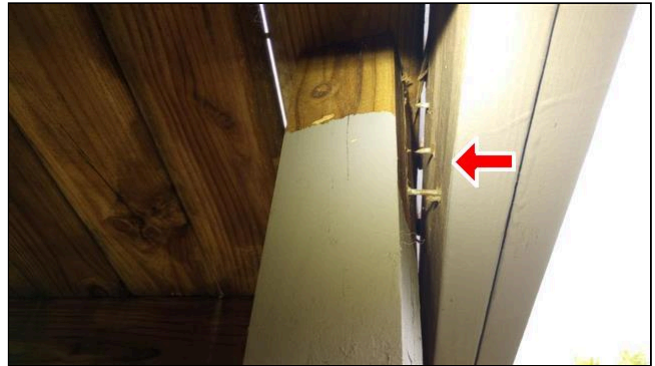
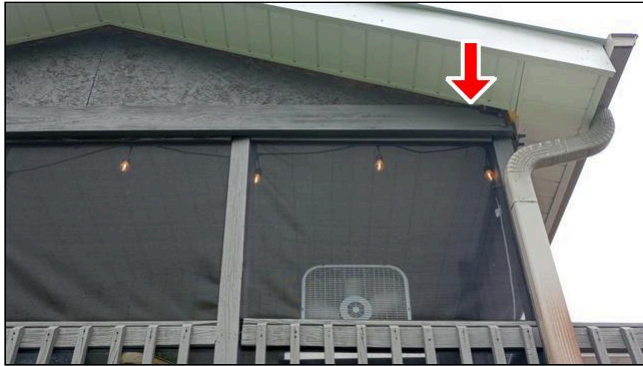
(2) General damage and loose components were located to the deck and stair structure. Further evaluation and repair as needed by a qualified person is recommended for improved safety.

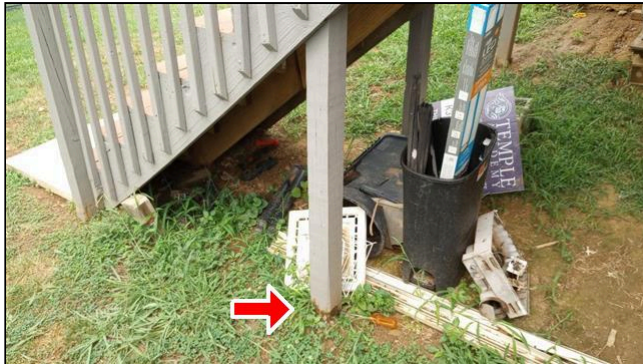
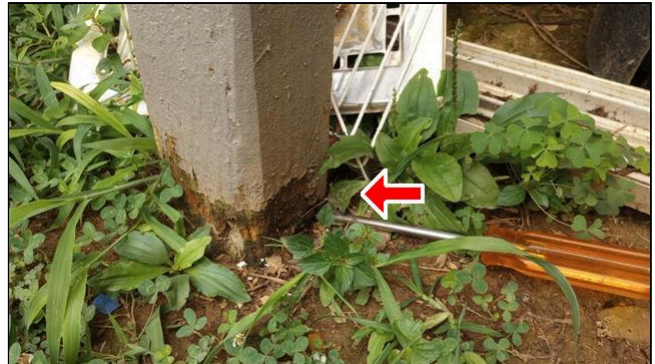
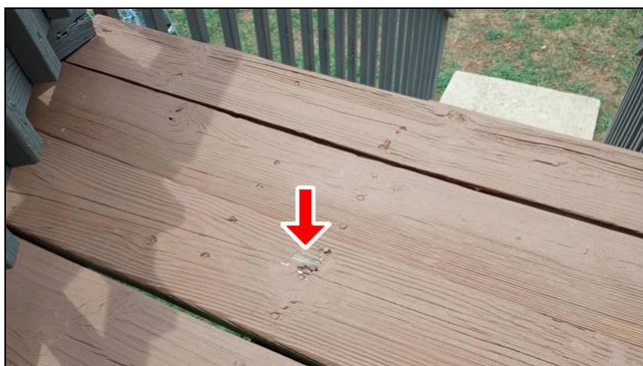
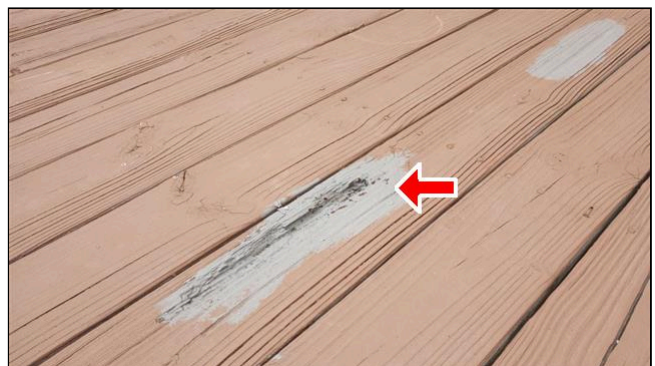
(3) Moisture damage is located to various deck components. Further evaluation and repair by a qualified person is recommended.

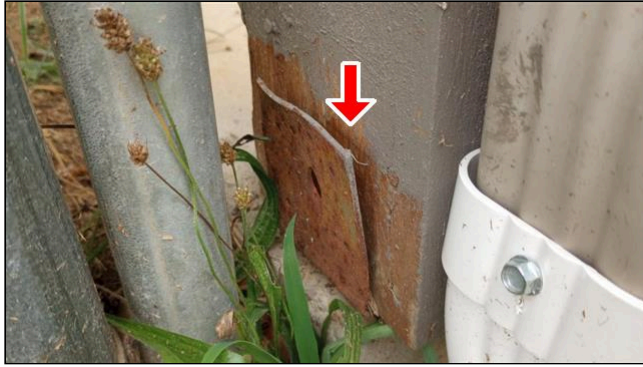
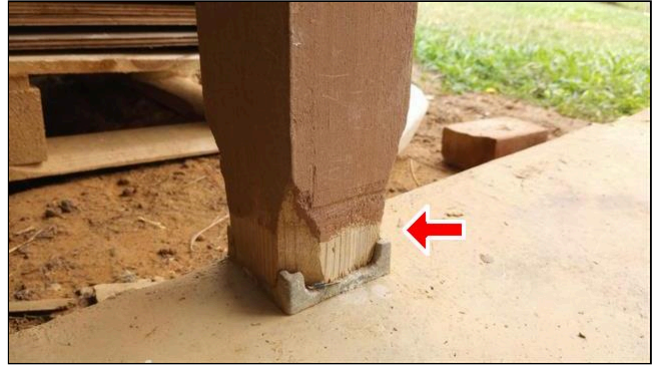
(4) Posts at the rear deck do not appear to be properly fastened to their brackets. Repair by a qualified person is recommended to help prevent damage or movement.

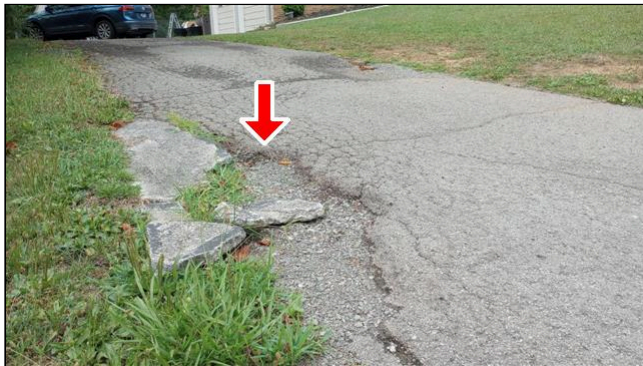
2.4 Item 1 (Picture)

(1) Differences in elevation are located to the walkway(s) which is a tripping hazard. Repair as needed by a qualified person is recommended.

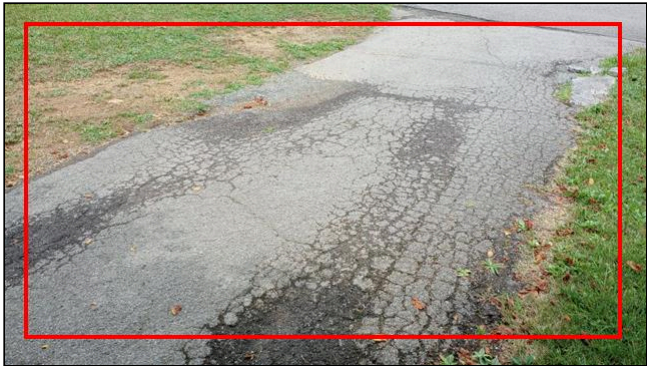
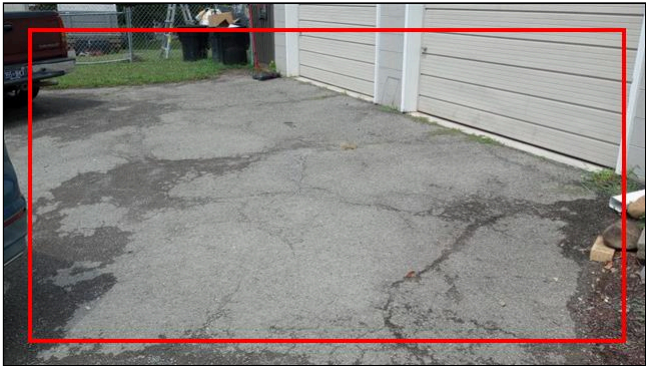
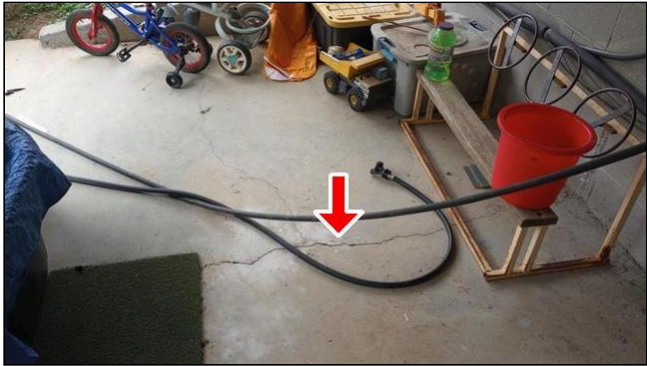
(2) Minor cracks were located to the flatwork around the exterior. Resealing these areas as desired by a qualified person is recommended to prevent further damage.

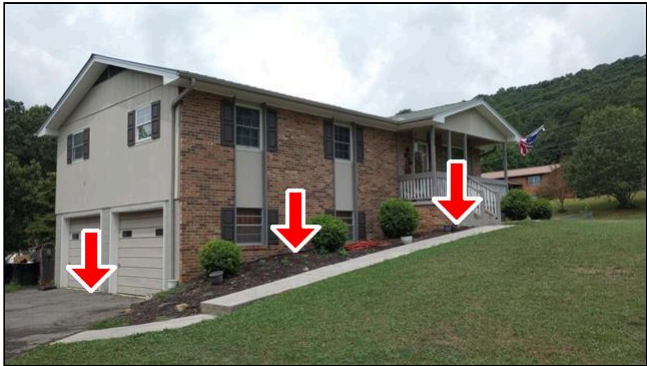
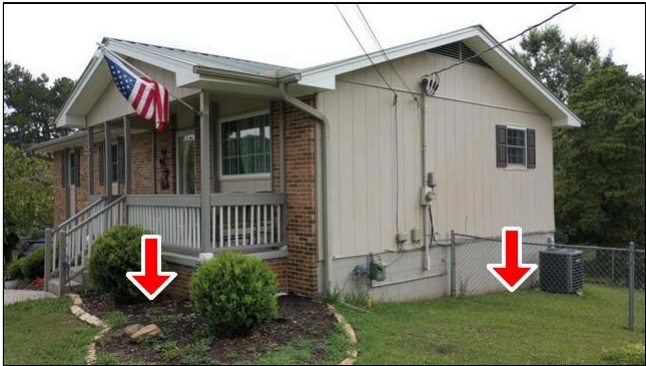
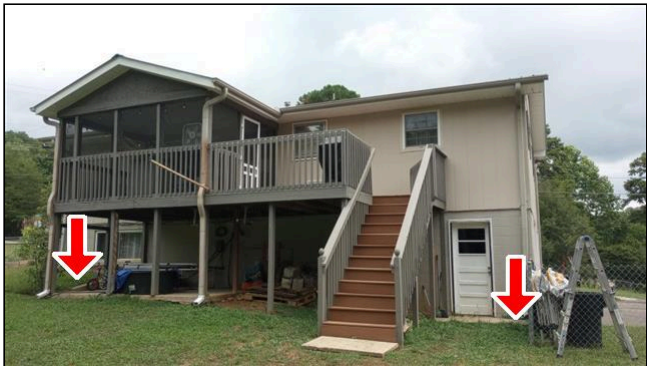
(3) Unable to determine if the grading and flatwork around the exterior sufficiently drains water away from the house during heavy rainfall. Recommend monitoring and making corrections as needed.

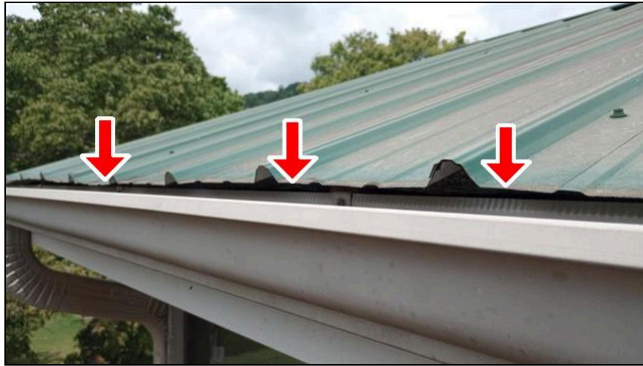
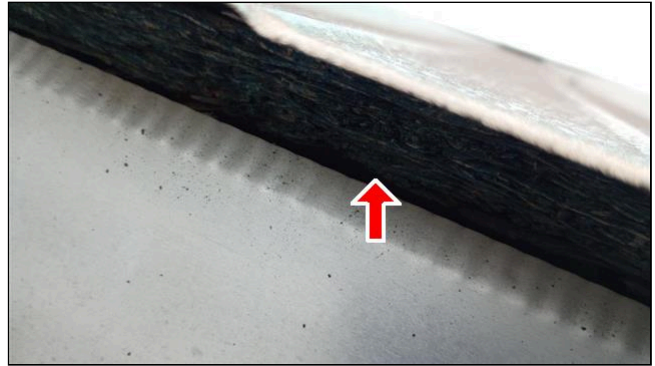
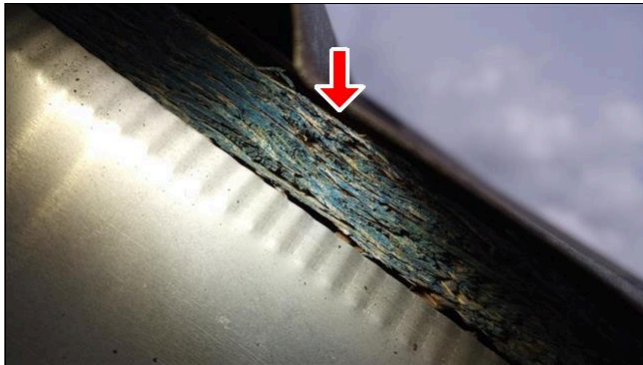
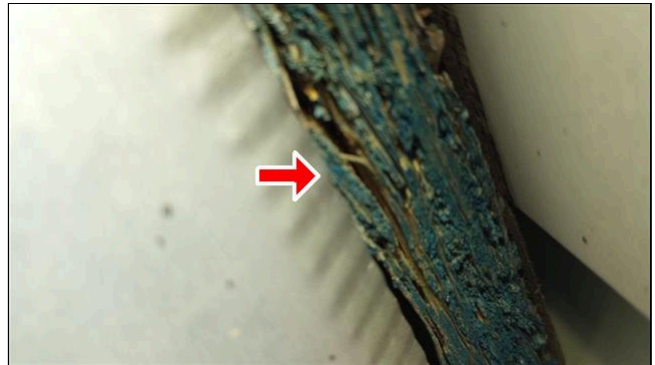
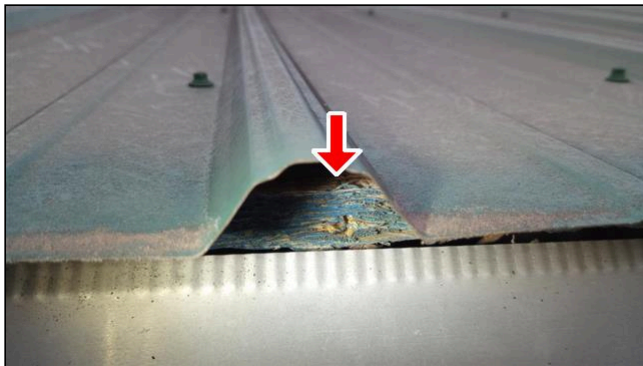
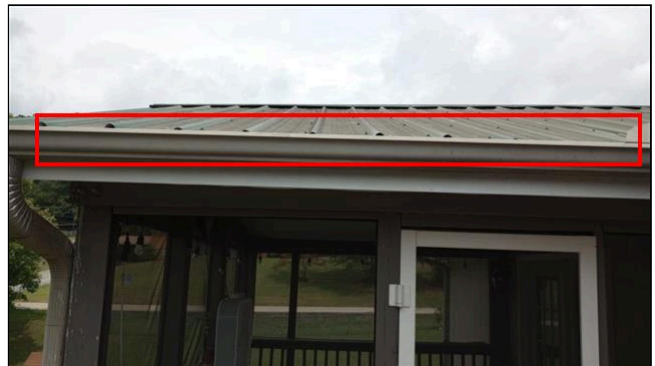
(1) Moisture damage is located to roof sheathing at the rear exterior and many areas were not visible. Further evaluation and repair by a qualified person is recommended.

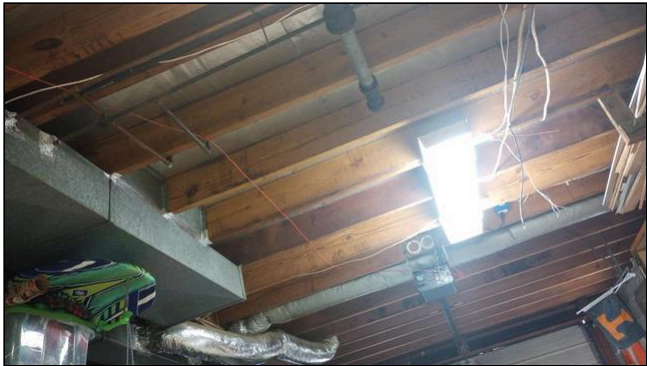
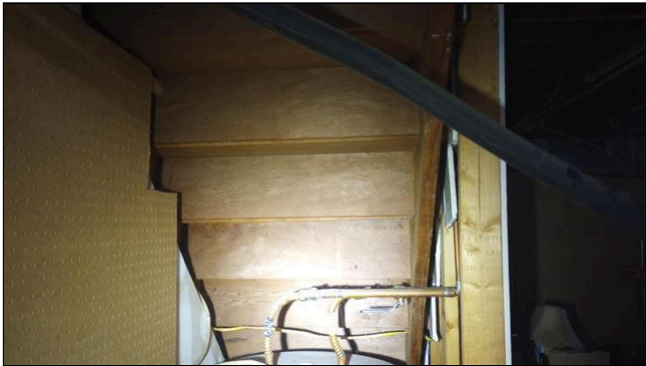
(1) Gaps (exposed floor structure) were located to the fire separation wall/ceiling between the garage and dwelling. Repair by a qualified person is recommended for improved fire protection.

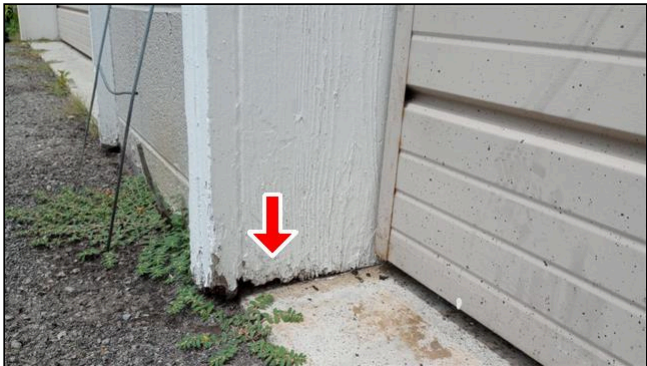
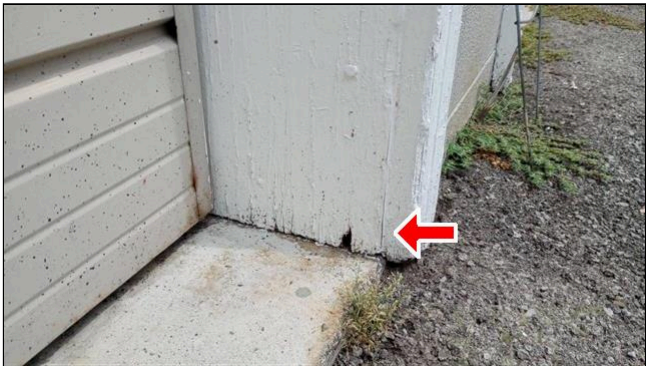
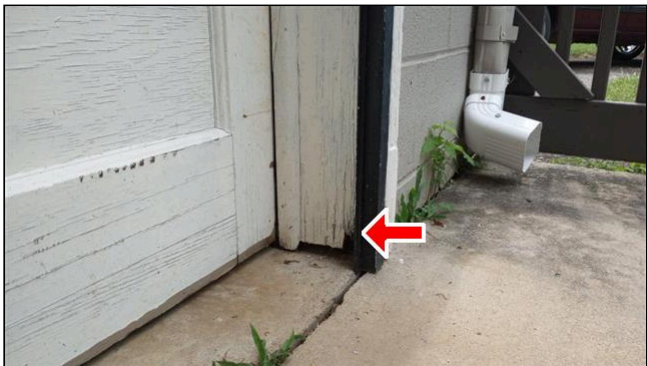
(1) Moisture damage is located to the garage door / casing. Repair by a qualified person is recommended.

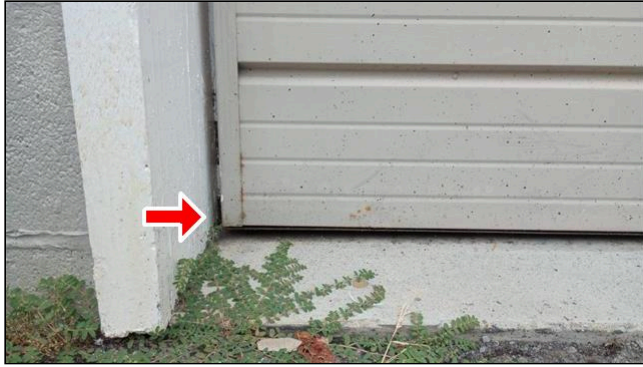
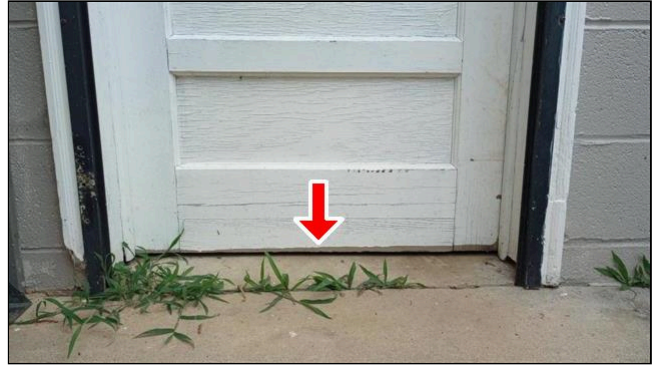
(2) Gaps are located at the garage door(s) which may allow water and pest intrusion. Correction is recommended.

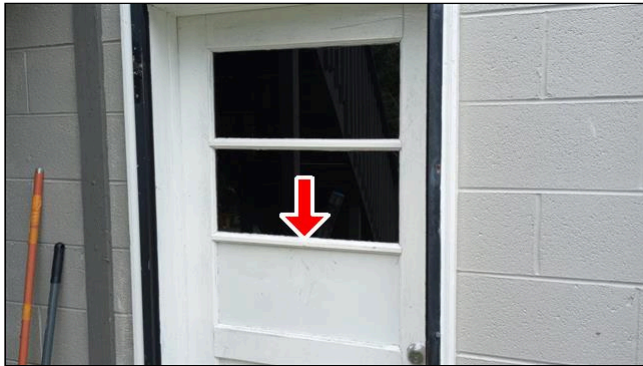
3.3 Item 10 (Picture)

(4) One of the window panes at the side garage door is missing and has been replaced with a non-conforming item. Repair by a qualified person is recommended.

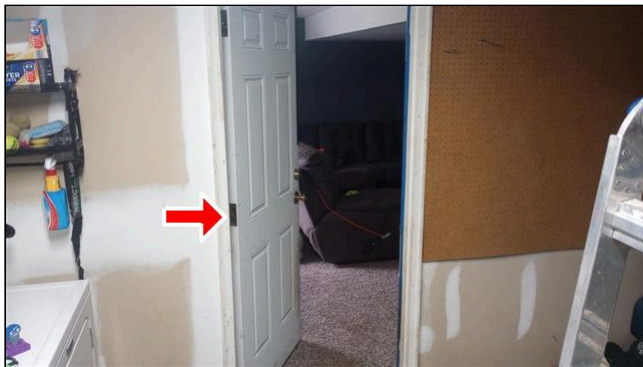
3.4 Item 1 (Picture)

The door between the garage and dwelling does not close without manual assistance. Installation of a self-closing hinge(s) is recommended for improved fire protection.

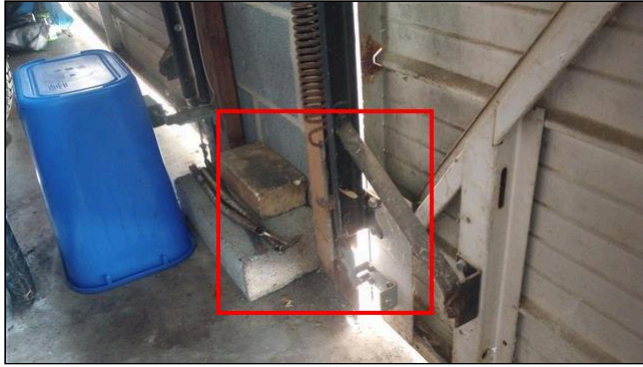
3.5 Item 1 (Picture)

(1) The garage door does not have safety reverse sensors and did not reverse when pressure was manually applied. Installation of sensors and or readjustment of the door opener is recommended for improved safety.
