ACE HOME INSPECTION

INSPECTION REPORT
124 Main Street
Knoxville Tennessee 37918

INSPECTED BY
Dave Ellis,
License No. 2885
Ace Home
Inspection

INSPECTION DATE
📅 3/6/2024
🕒 12:30 PM

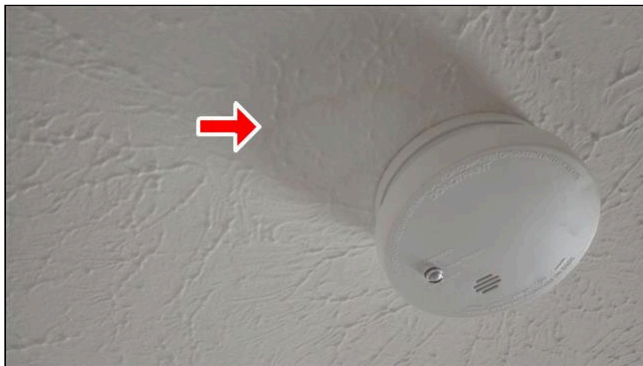
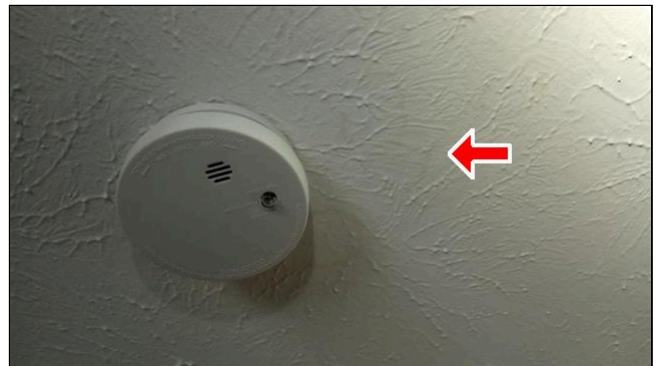
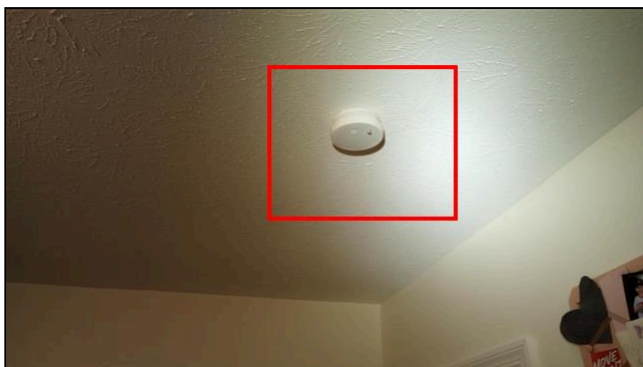
Minor staining was located to the ceiling in the first guest bedroom which indicates a possible or previous leak, however no current moisture was detected when tested. Cleaning and further monitoring for any changes is recommended.

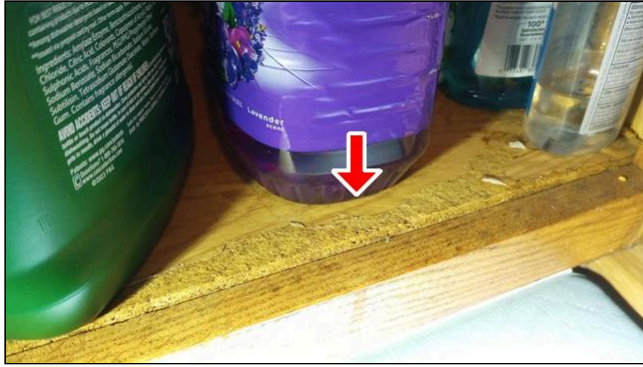
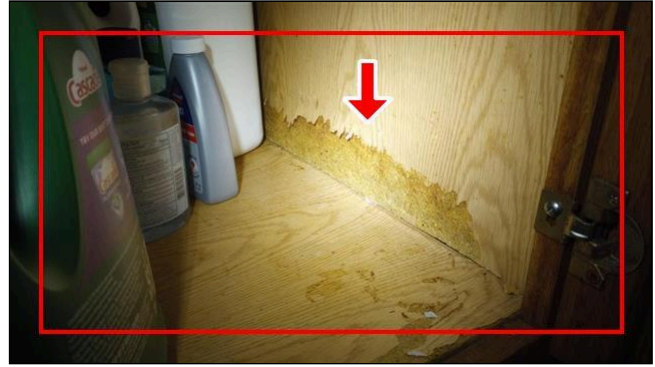
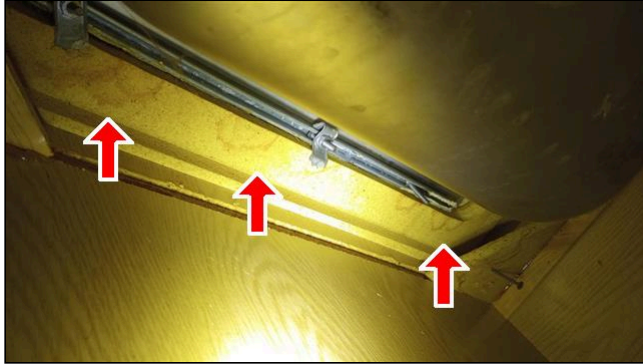
(1) Minor warping, staining and damage was located in the cabinet below the kitchen sink which indicates a possible / previous leak or spill, however no current moisture was detected when tested. Cleaning and further monitoring for any changes is recommended.

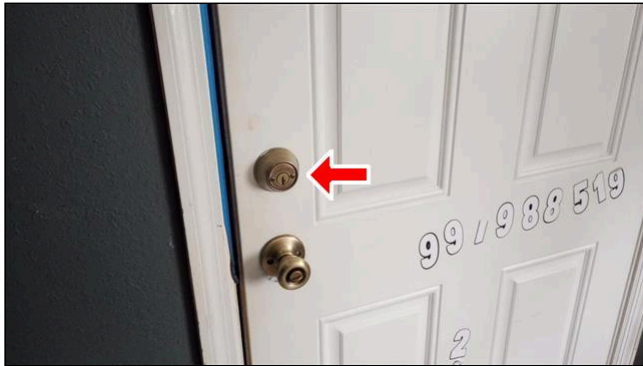
4.5 Item 1 (Picture)

(1) Installation of thumb-latch style locks wherever keyed interior locks are present is recommended to allow for proper emergency egress.

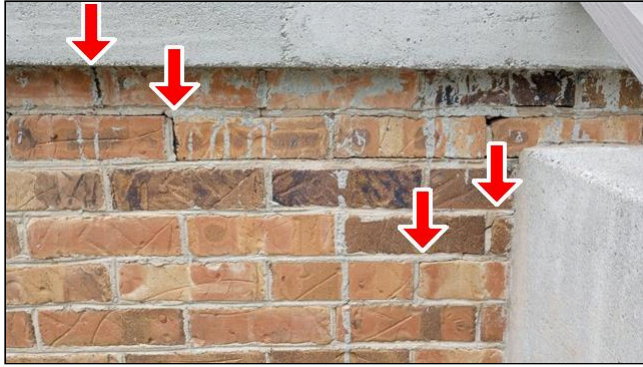
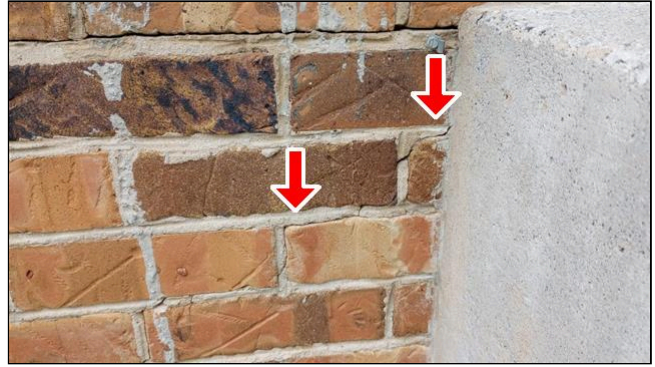
(1) Minor step cracking was located to the brick at the front exterior which indicates possible or previous movement. Resealing and continued monitoring for any changes is recommended.

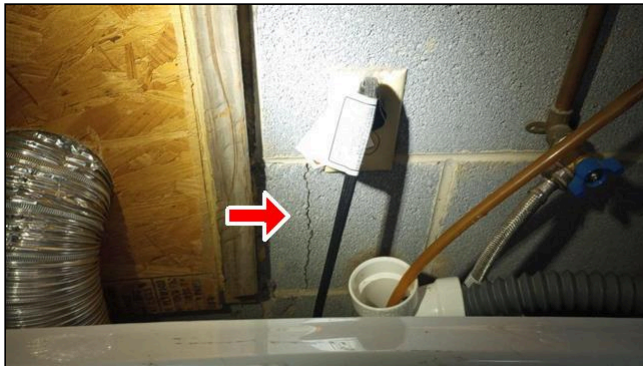
5.1 Item 1 (Picture)

A broken block was located to the structural wall located behind the washing machine (garage) which indicates possible or previous movement. Resealing and continued monitoring for any changes is recommended.

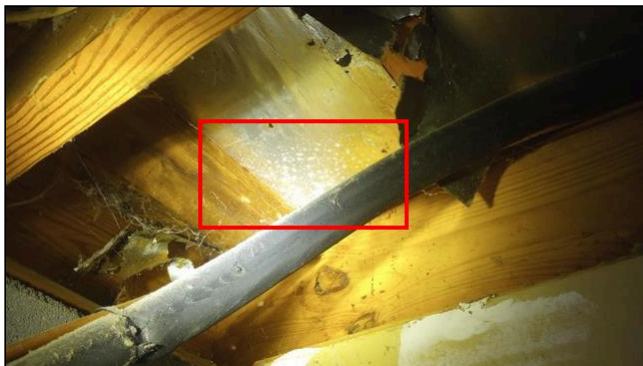
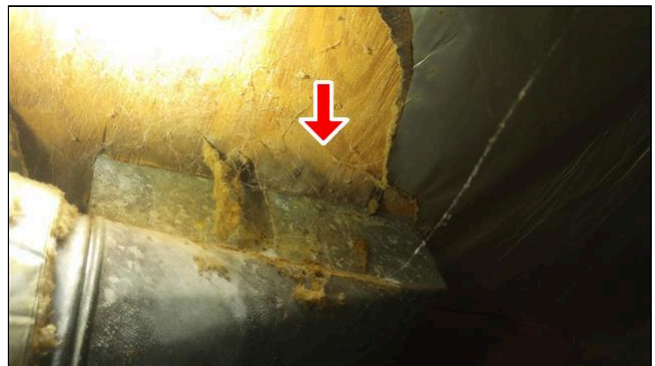
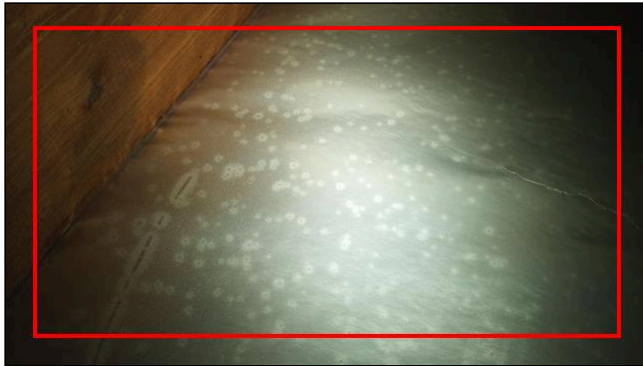
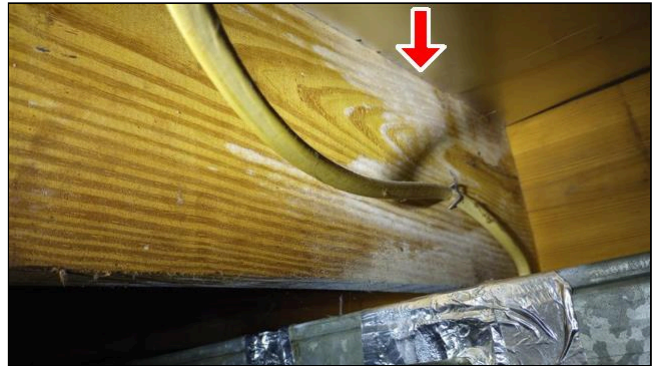
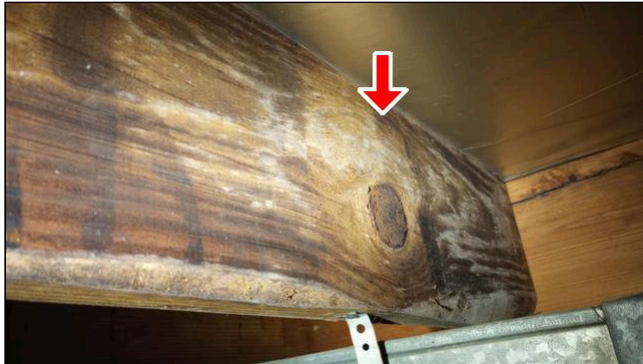
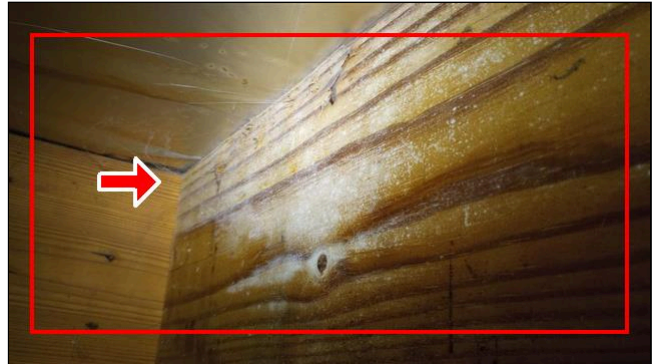
(1) Light and dark-colored staining was located to the floor structure in various areas of the garage. Further evaluation and cleaning/removal if needed by a qualified person is recommended to prevent possible deterioration and possible mold growth.

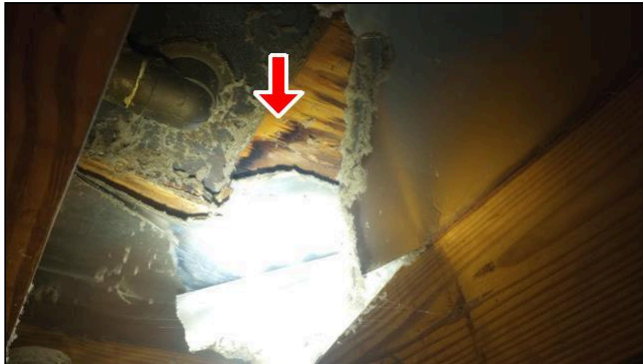
5.2 Item 7 (Picture)

(2) Staining and moisture was located to the subfloor below the guest bathtub which indicates a possible leak. Further evaluation and repair as needed by a licensed plumber is recommended.

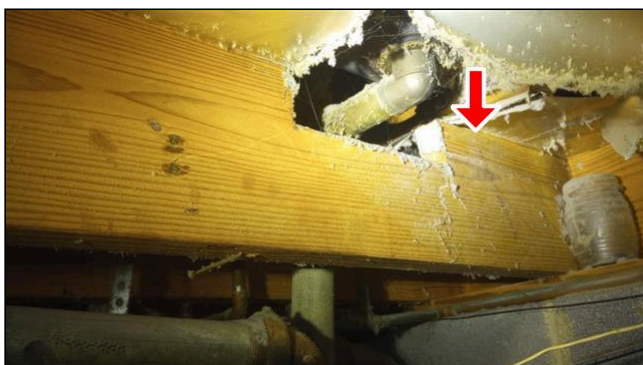
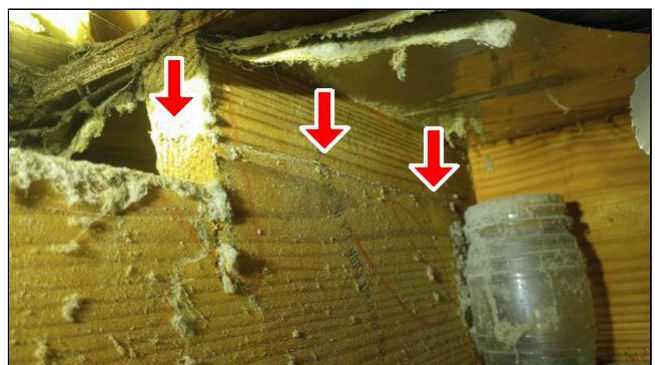
(3) A broken floor joist was located adjacent to a notch below the guest bathroom. Further evaluation and repair as needed by a qualified carpenter is recommended to ensure proper structural support.

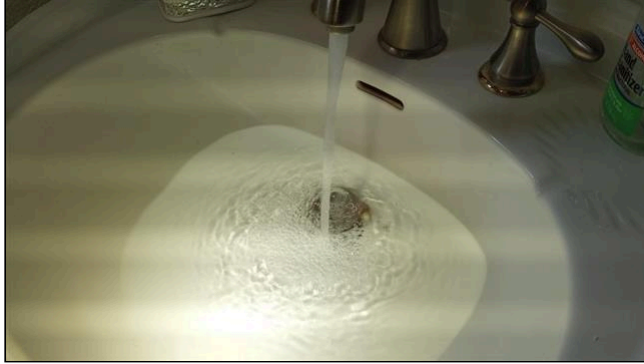
6.0 Item 1 (Picture)

(1) The sink in the master bedroom drained slowly when tested which indicates a possible clog in the drain line. Further evaluation and correction by a licensed plumber is recommended.

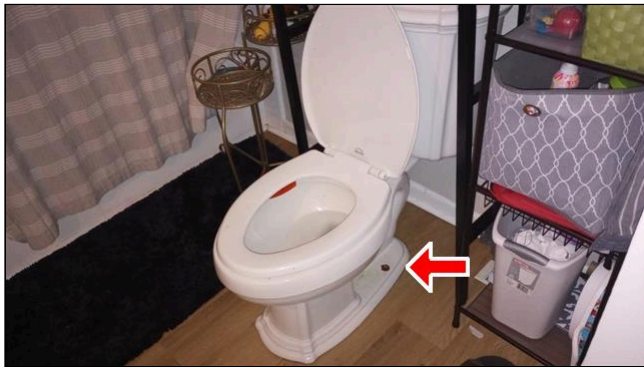
6.0 Item 2 (Picture)

(2) The toilet in the guest bathroom is loose at the floor. Repairs may involve re-setting the toilet on a new wax seal. I recommend a qualified licensed plumber repair or correct as needed.

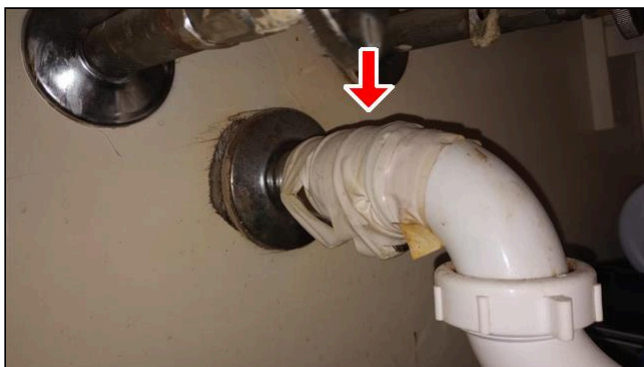
6.0 Item 14 (Picture)

(5) A drain line below the guest bathroom sink has been taped for an unknown reason. Continued monitoring for any changes is recommended. This area was not fully visible.

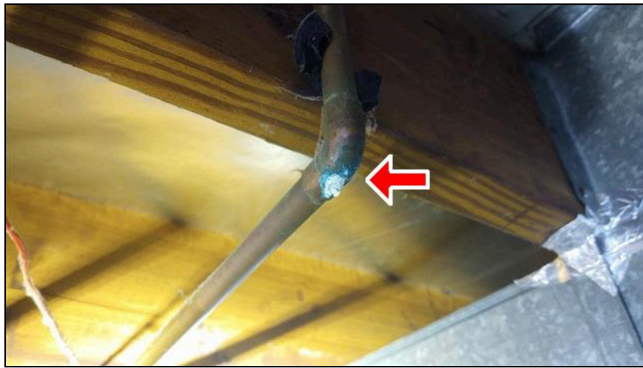
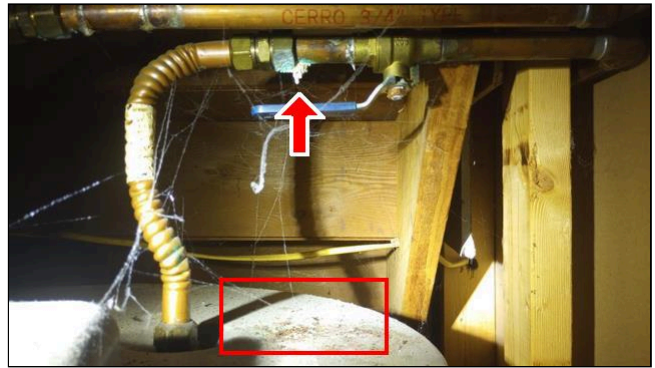
(1) Staining and corrosion was located to a water supply line(s) at the garage which indicates a possible/previous leak, however no current moisture was detected when tested. Cleaning and

continued monitoring for any changes is recommended.

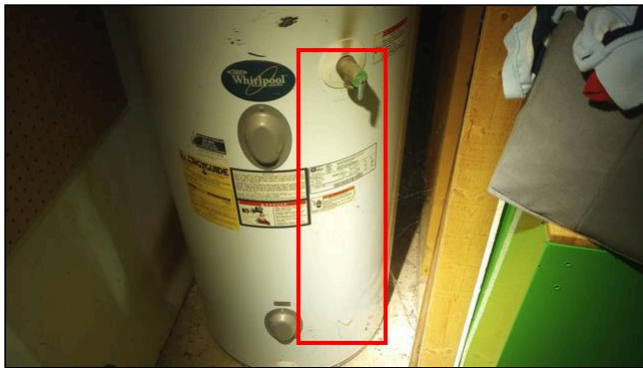
6.2 Item 1 (Picture)

(1) The TPR valve on water heater needs a 3/4" rigid pipe (not flex) to extend to the exterior and not run uphill for safety. (PVC must be rated for approved hot water use). I recommend repairs by a licensed plumbing contractor.

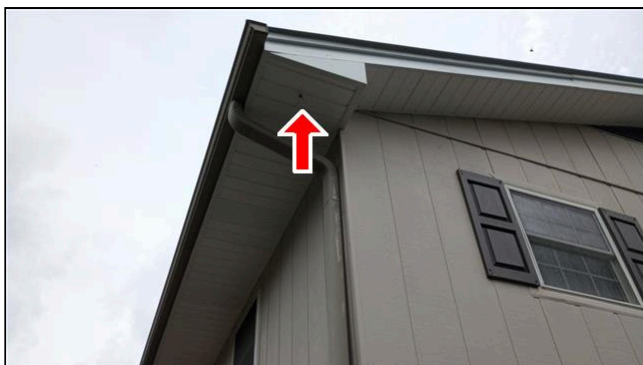
7.2 Item 1 (Picture)

(1) Exposed wires were located at the rear soffit which is a possible shock and fire hazard, however they could not be tested for power due to the location. Further evaluation and repair as needed by a licensed electrician is recommended.

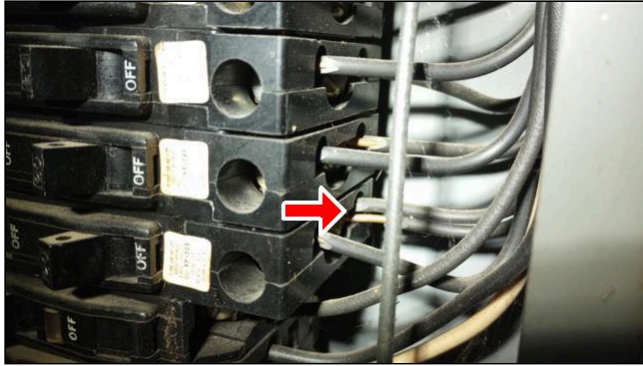
7.2 Item 2 (Picture)

(2) A double-tapped breaker was located in the electrical panel which may loosen connections and cause overheating. Further evaluation and repair by a licensed electrician is recommended.

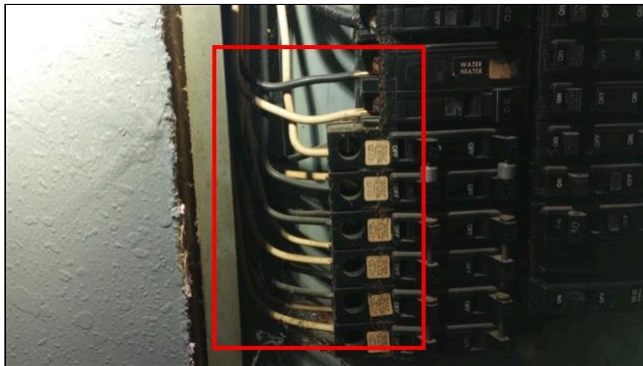
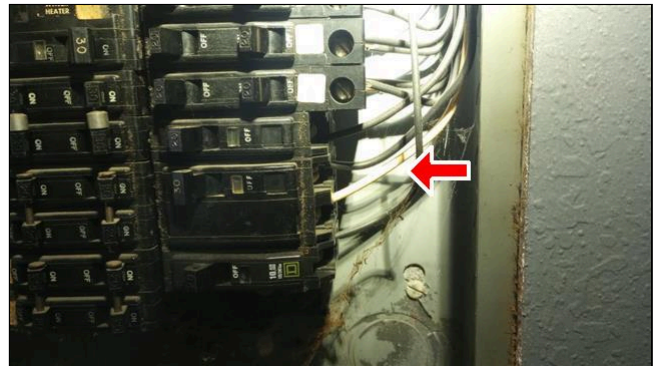
(3) Unmarked white wires, which are normally reserved for neutral conductors, were located going to breakers. Sometimes (but not always) the electrician fails to re-identify the wires with black tape or a marker. Although this is not necessarily a hazardous condition further evaluation by a licensed electrician is recommended.

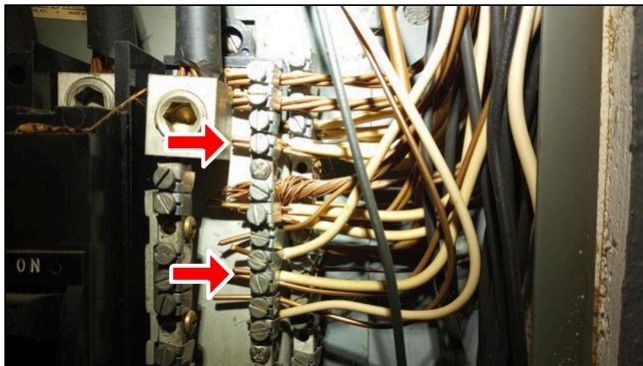
7.2 Item 5 (Picture)

(4) A double-tapped bus bar was located in the electrical panel which may loosen connections. Further evaluation and repair by a licensed electrician is recommended for improved safety.

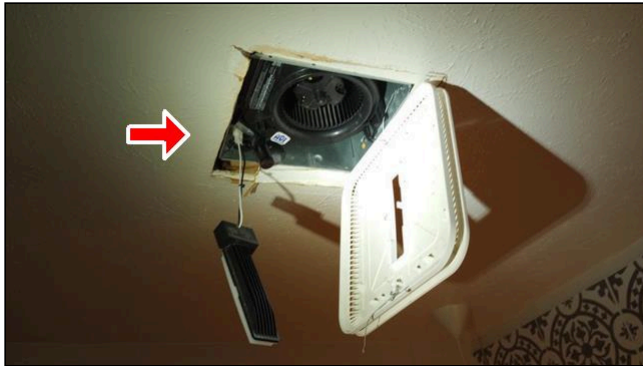
7.3 Item 1 (Picture)

(1) The bathroom light and vent fan was disconnected upon arrival and did not operate when using the adjacent switches. Further evaluation and repair as needed by a licensed electrician is recommended.

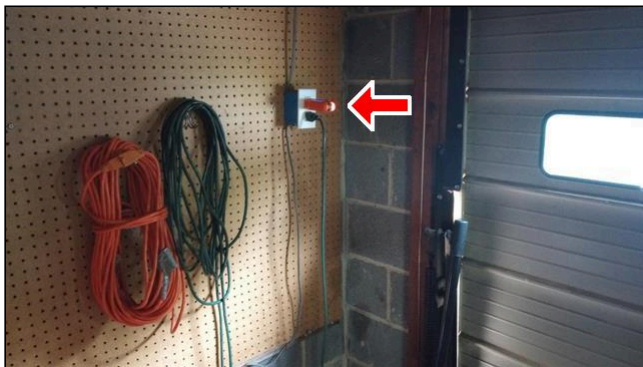
7.4 Item 1 (Picture)

A receptacle at the garage has reverse polarity which is a shock hazard. Further evaluation and repair by a licensed electrician is recommended.

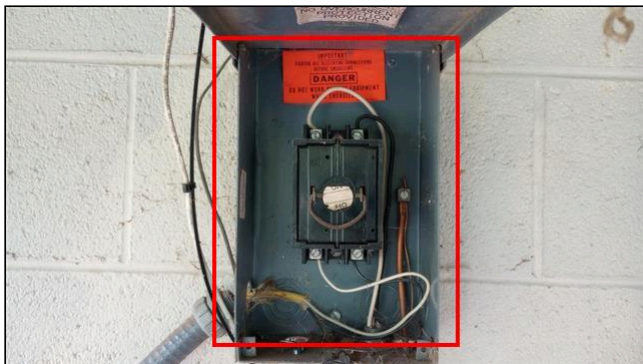
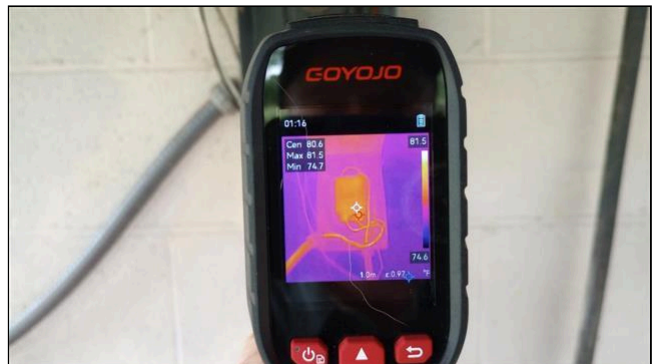
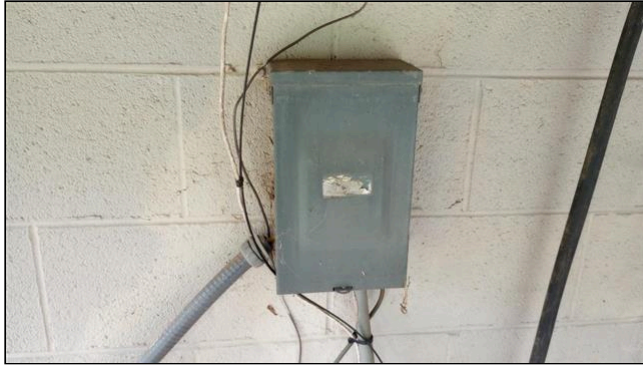
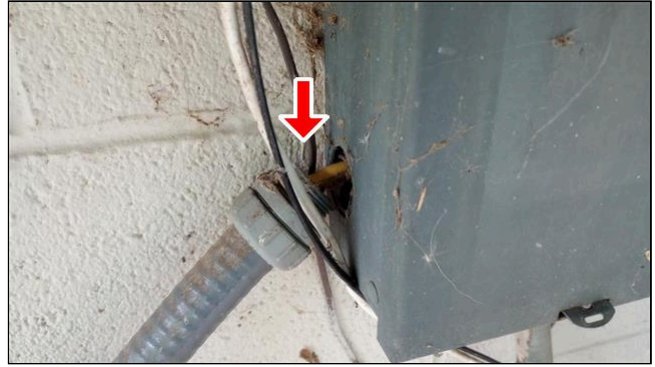
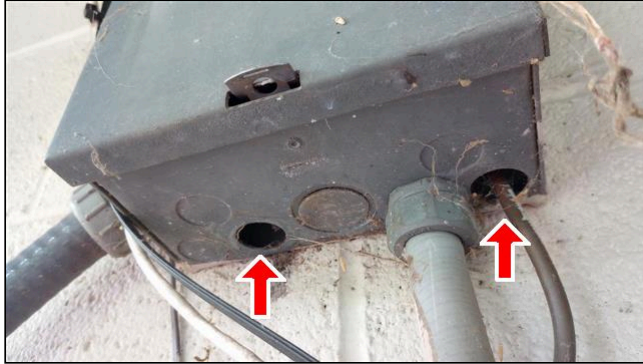
(1) A fused sub-panel was located at the rear exterior below the deck. Installation of knock-out filler plates and resealing the loose conduit by a licensed electrician is recommended for improved safety.

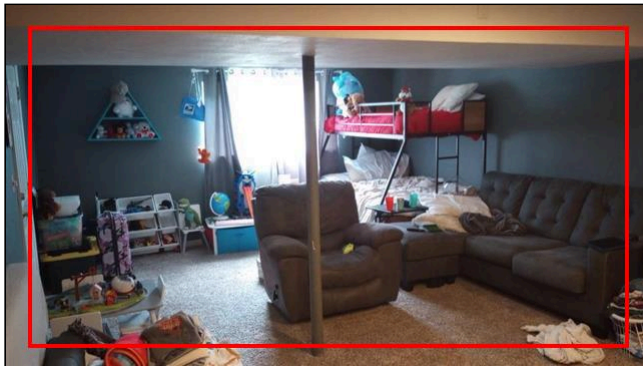
7.7 Item 1 (Picture)

(1) A smoke alarm was not located downstairs. Recommend installing according to the manufacturer's instructions. Inquiring with the State Fire Marshall's office is also recommended to see about receiving a 'free' alarm (the State made me include that last part).

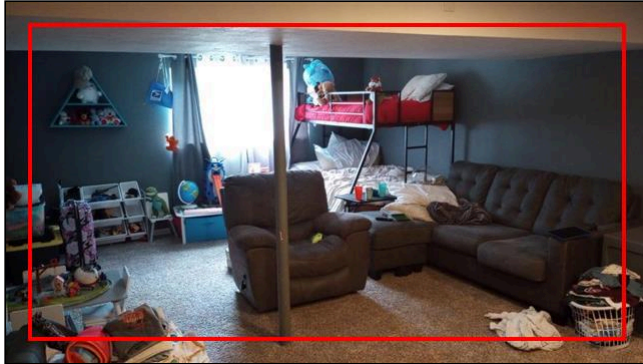
7.8 Item 1 (Picture)

(1) A carbon monoxide detector was not located downstairs. Recommend installing according to the manufacturer's instructions.

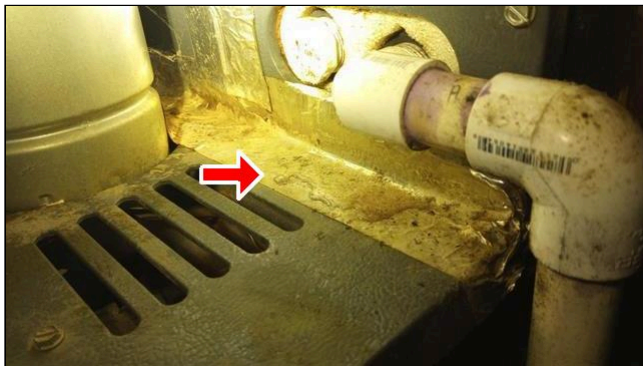
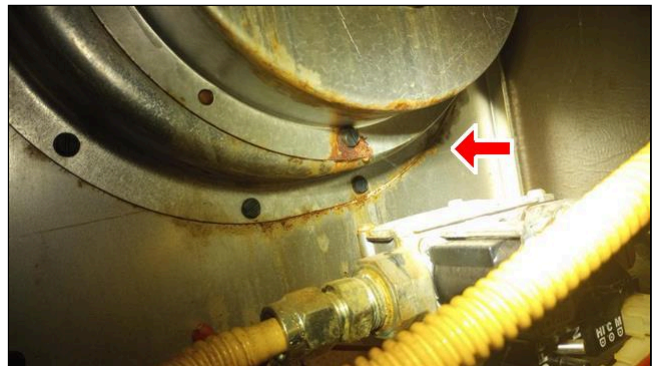
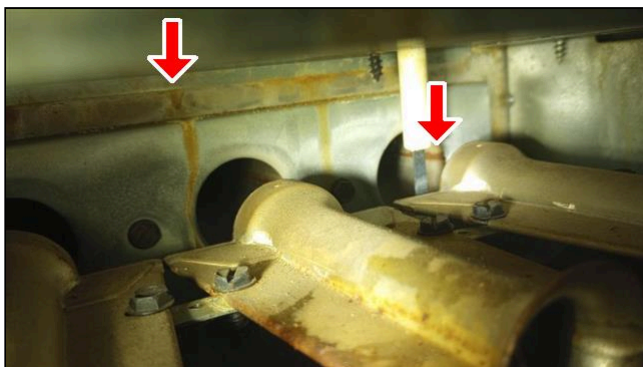
(1) Dripping water and minor rust was located on and in the furnace (including the burn chamber) which indicates a possible leak. Further evaluation, repair and regular servicing by a licensed HVAC technician is recommended.

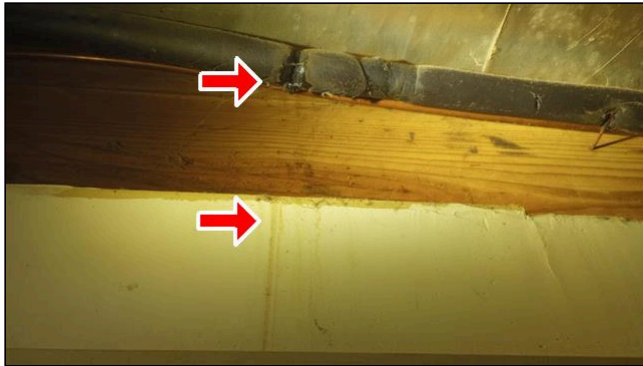
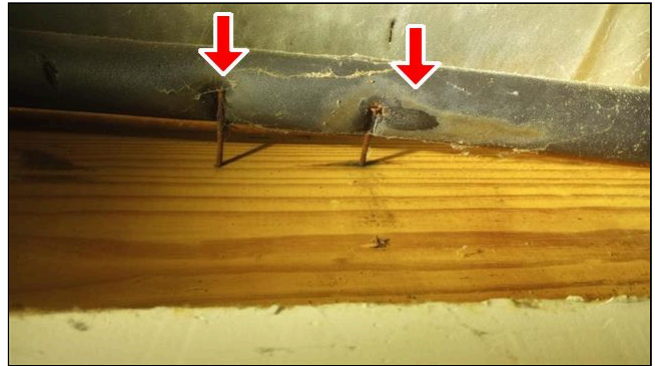
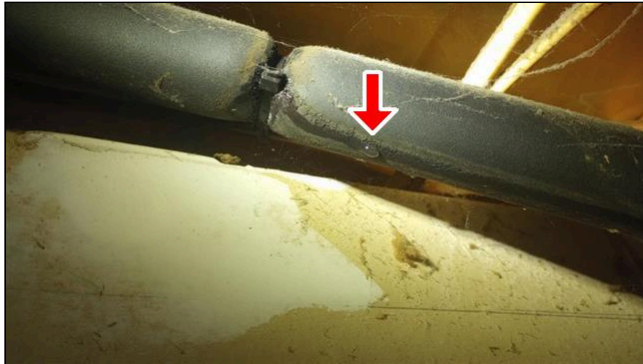
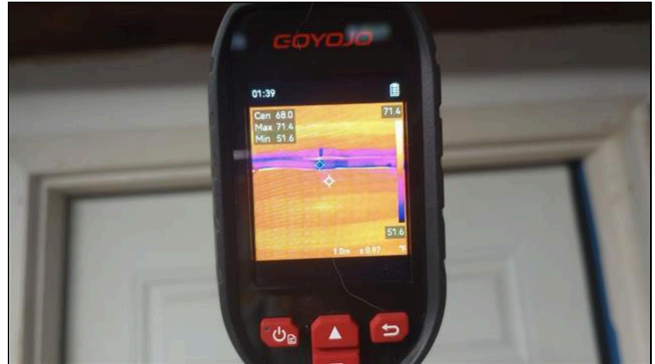
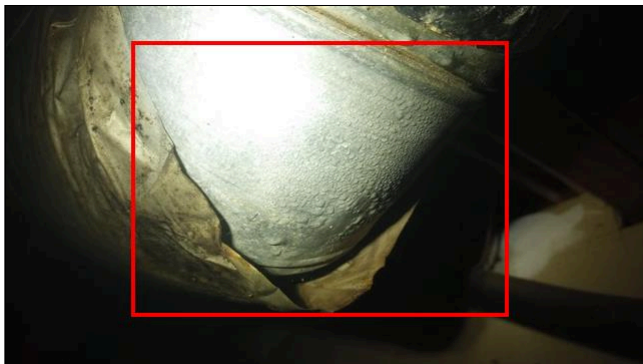
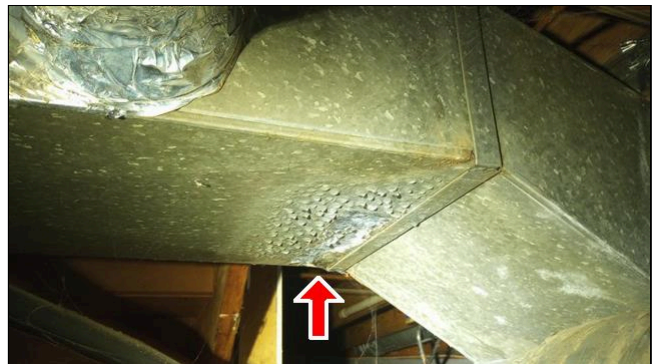
(1) Significant condensation buildup and dripping water was located along the refrigerant line set and ductwork in various areas. Further evaluation and repair as needed by a licensed HVAC technician is recommended.

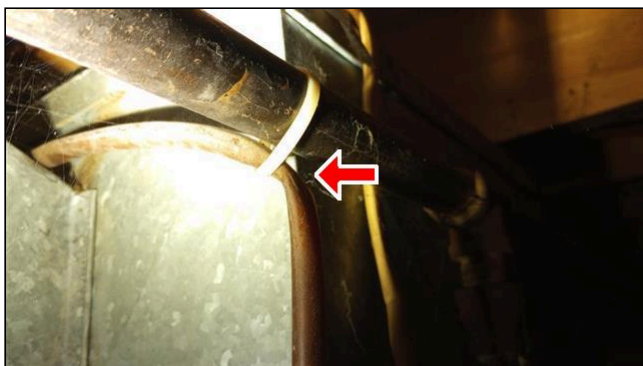
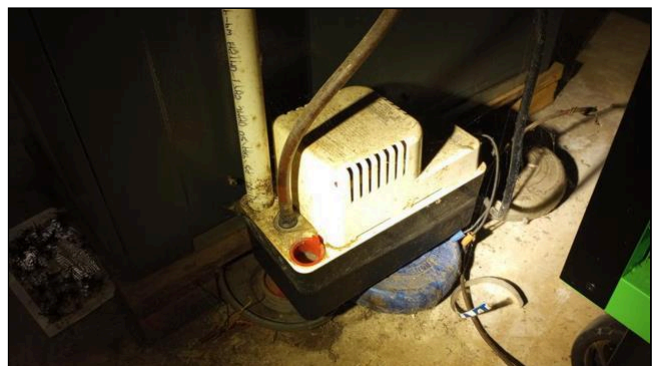
(2) The condensate drain line appears to be kinked. Correction is recommended to allow for proper drainage.

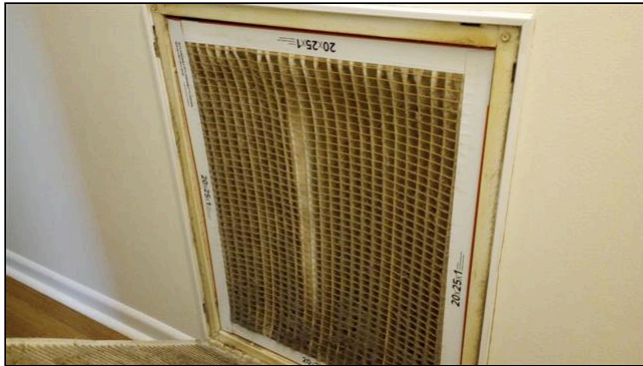
8.2 Item 10 (Picture)

(4) Replacement of the dirty filter at the return is recommended per regular maintenance.

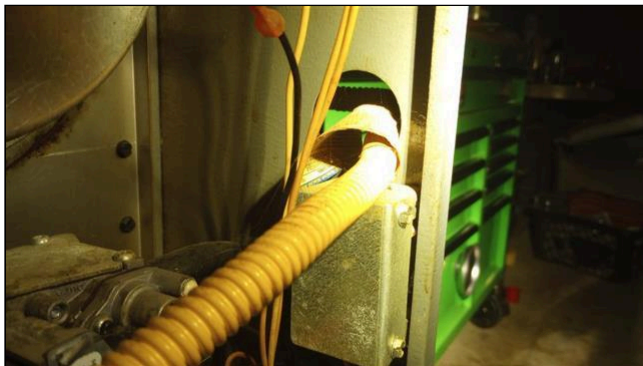
8.2 Item 11 (Picture)

(5) Installation of a rigid gas line where it currently penetrates the furnace jacket by a licensed HVAC technician is recommended for improved safety.

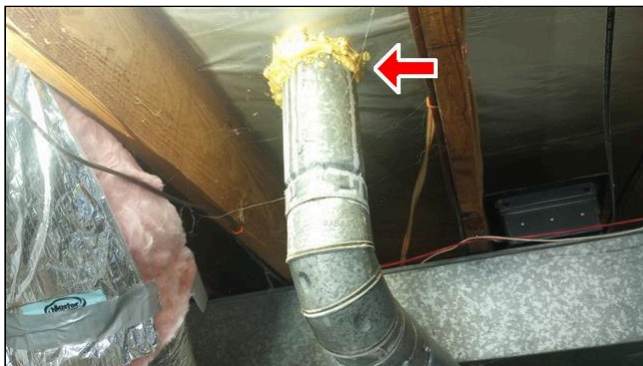
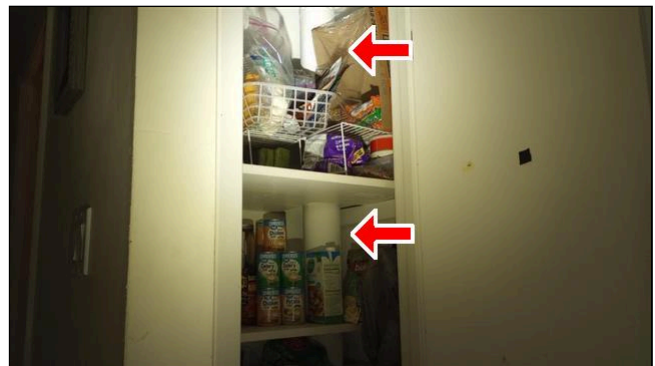
The furnace flue does not appear to have proper clearance from combustibles and may be in contact with stored items in the kitchen pantry. Providing proper clearance as needed by a qualified person is recommended.

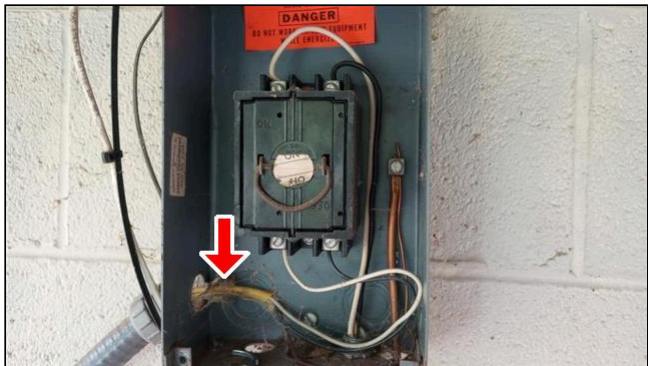
8.6 Item 1 (Picture)

(1) Wires going to a 30 amp fuse (at the HVAC disconnect) do not appear large enough to blow the fuse if needed which can cause overheating, and the fuse appears to be oversized for the condenser which can prevent proper operation. Further evaluation and repair as needed by a licensed electrician or HVAC technician is recommended.
